February 3, 2023

Helping Up Mission / House of Freedom ("Client")
1029 East Baltimore Street
Baltimore, MD 21202

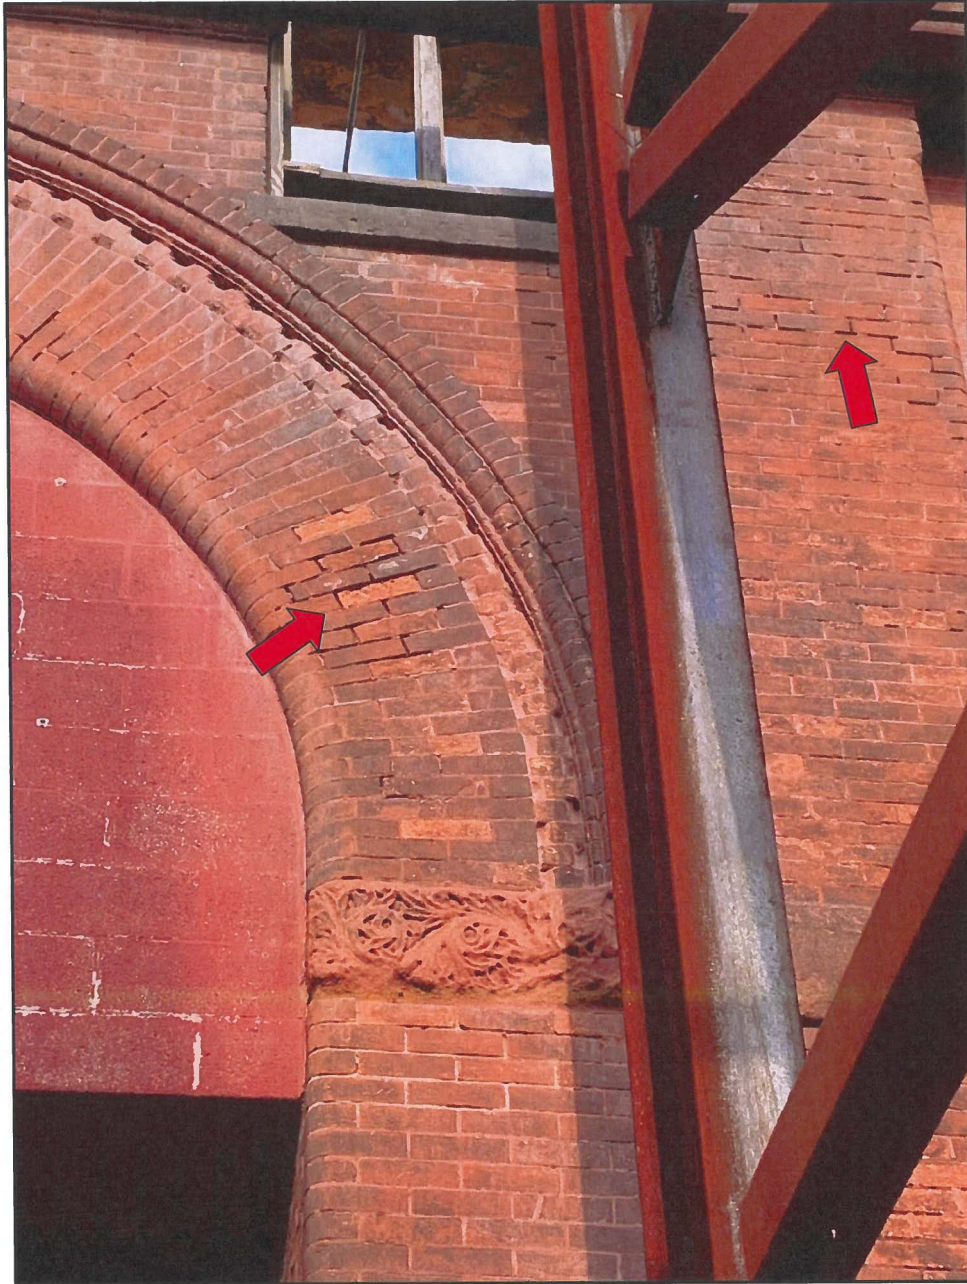
Photo 2
Hendler Building South Façade - Exterior Face
Note Deteriorated Brick and Eroded Mortar Joints

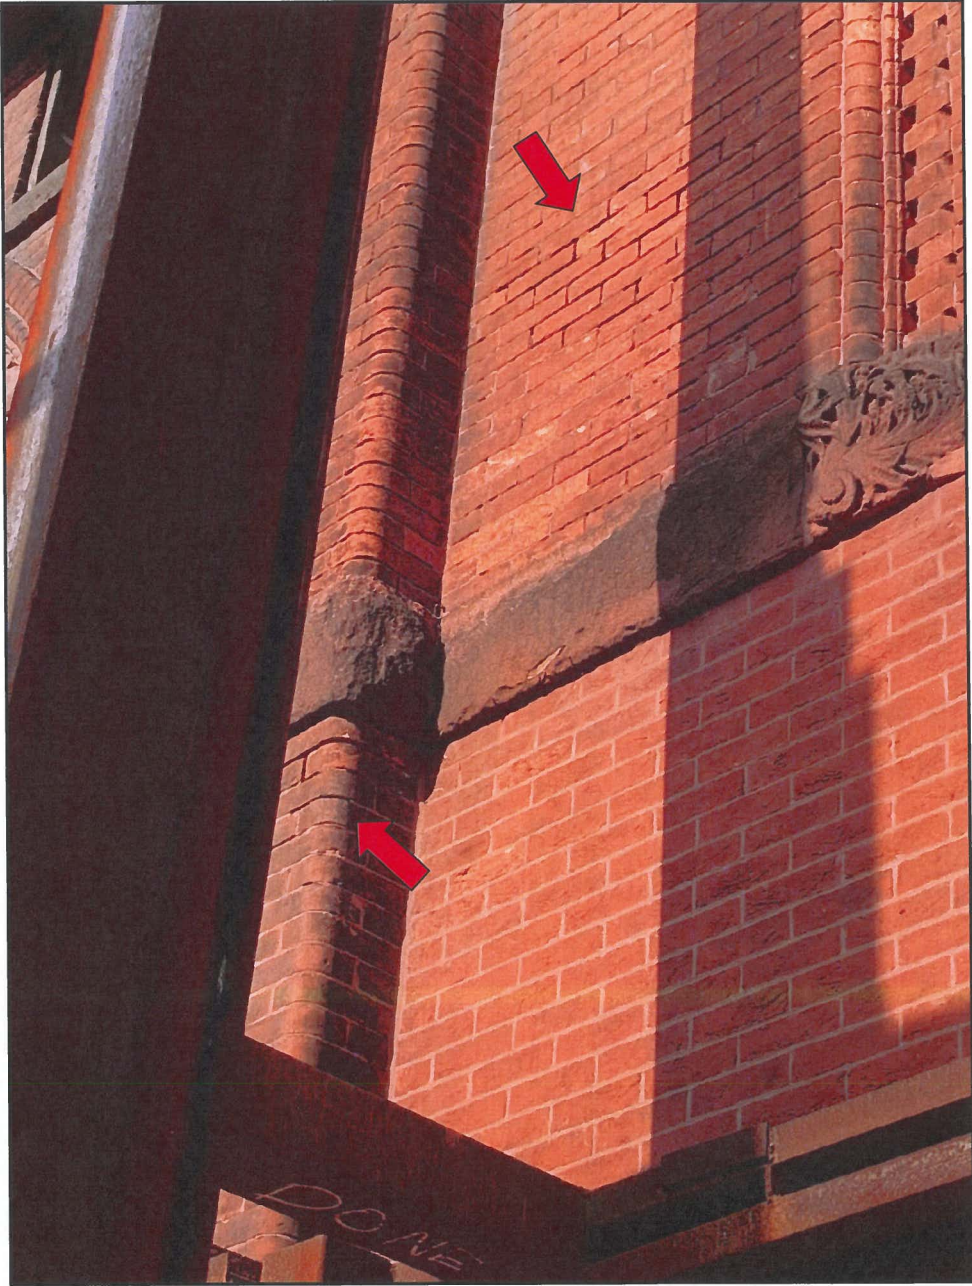
Photo 3
Hendler Building South Façade - Exterior Face
Note Deteriorated Brick and Eroded Mortar Joints

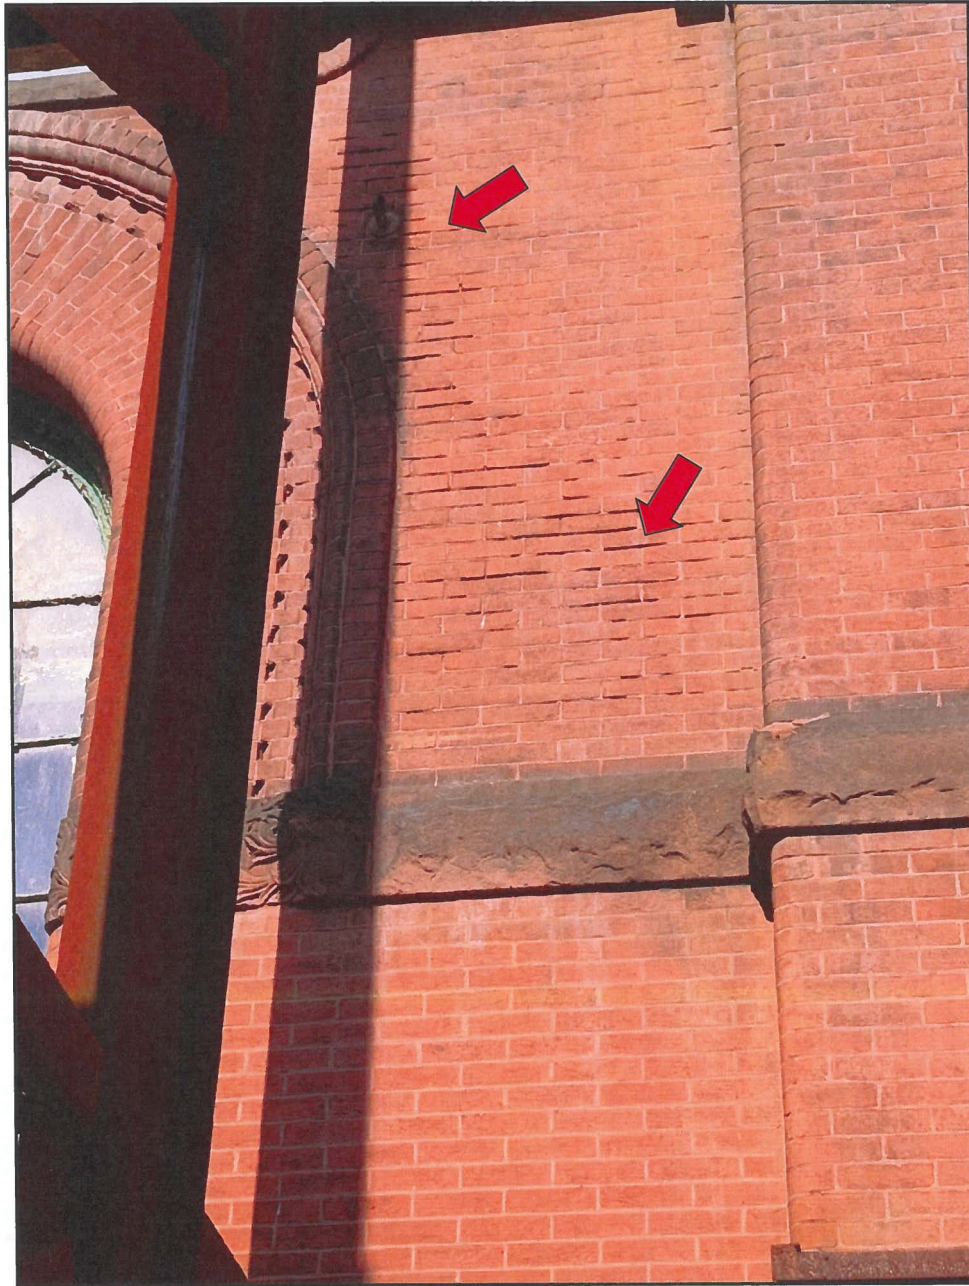
Photo 4
Hendler Building South Façade - Exterior Face
Note Deteriorated Brick and Eroded Mortar Joints

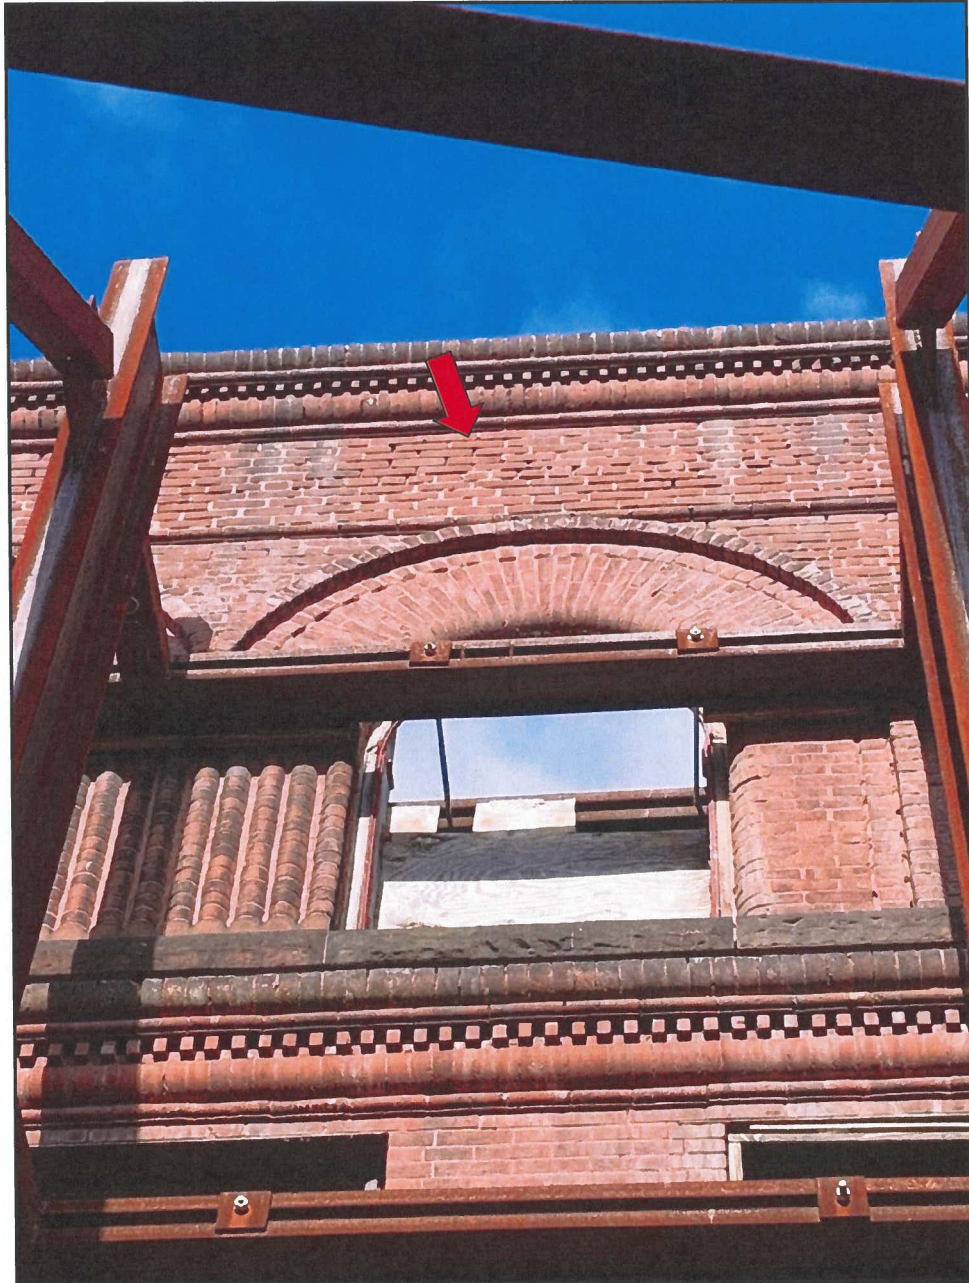
Photo 5
Hendler Building South Façade - Exterior Face
Note Deteriorated Brick and Eroded Mortar Joints

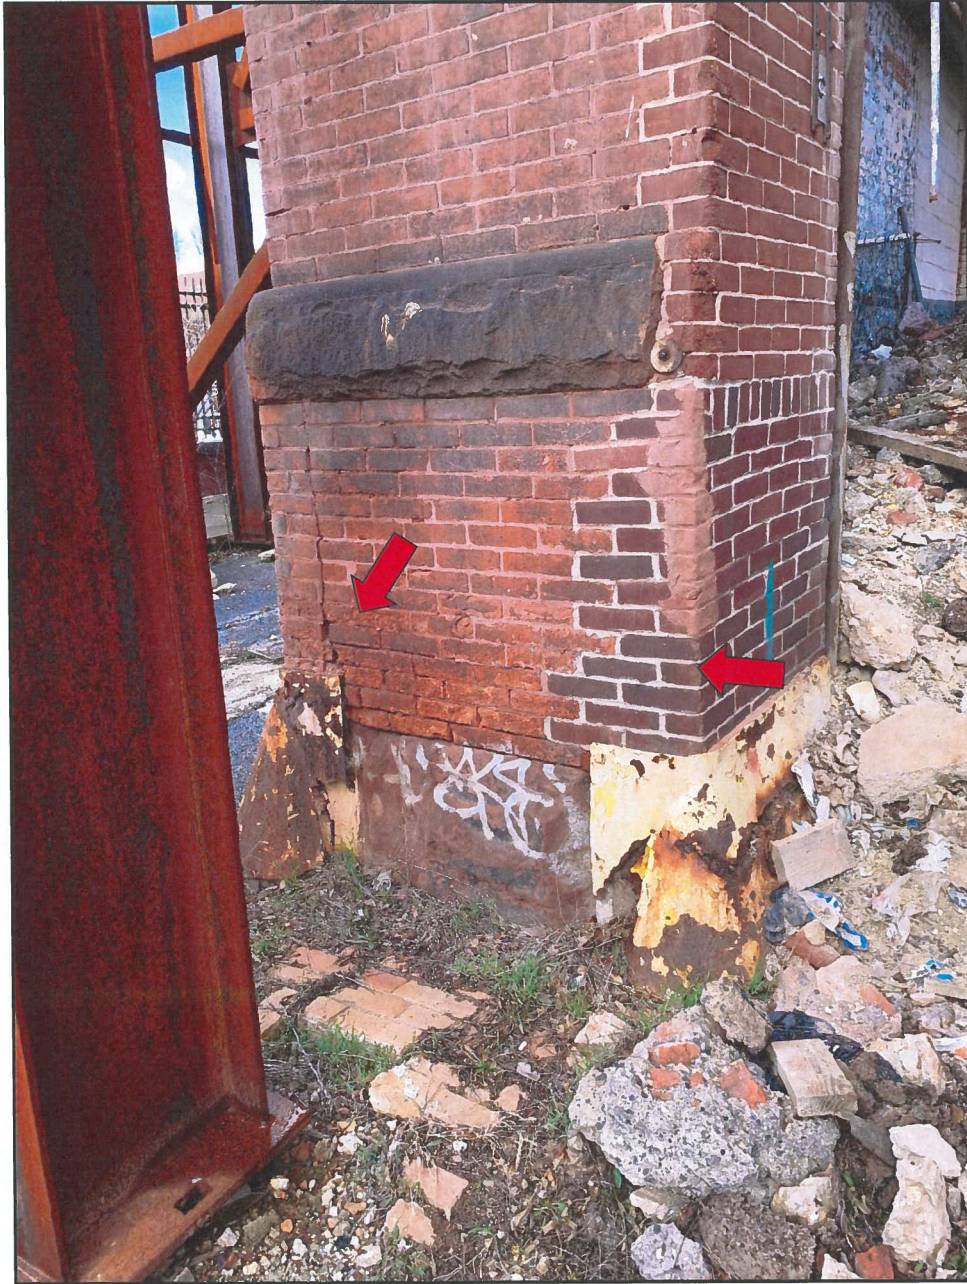
Photo 6
Hendler Building South Façade - Exterior Face
Note Deteriorated Brick and Eroded Mortar Joints
Cracks and Prior Repairs

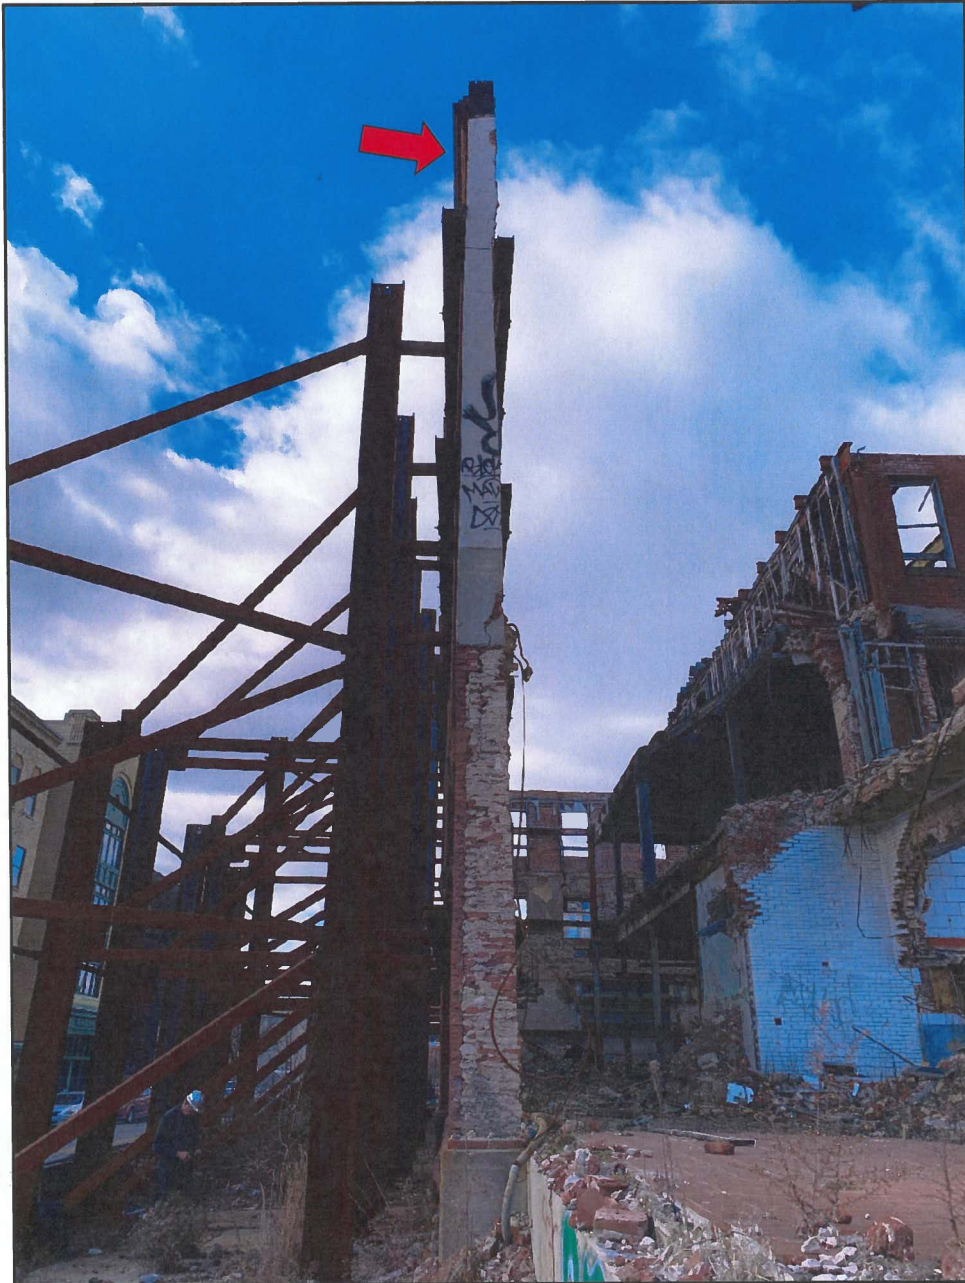
Photo 7
Hendler Building South Façade - Exterior Face
Note Lean in Upper Section of Façade

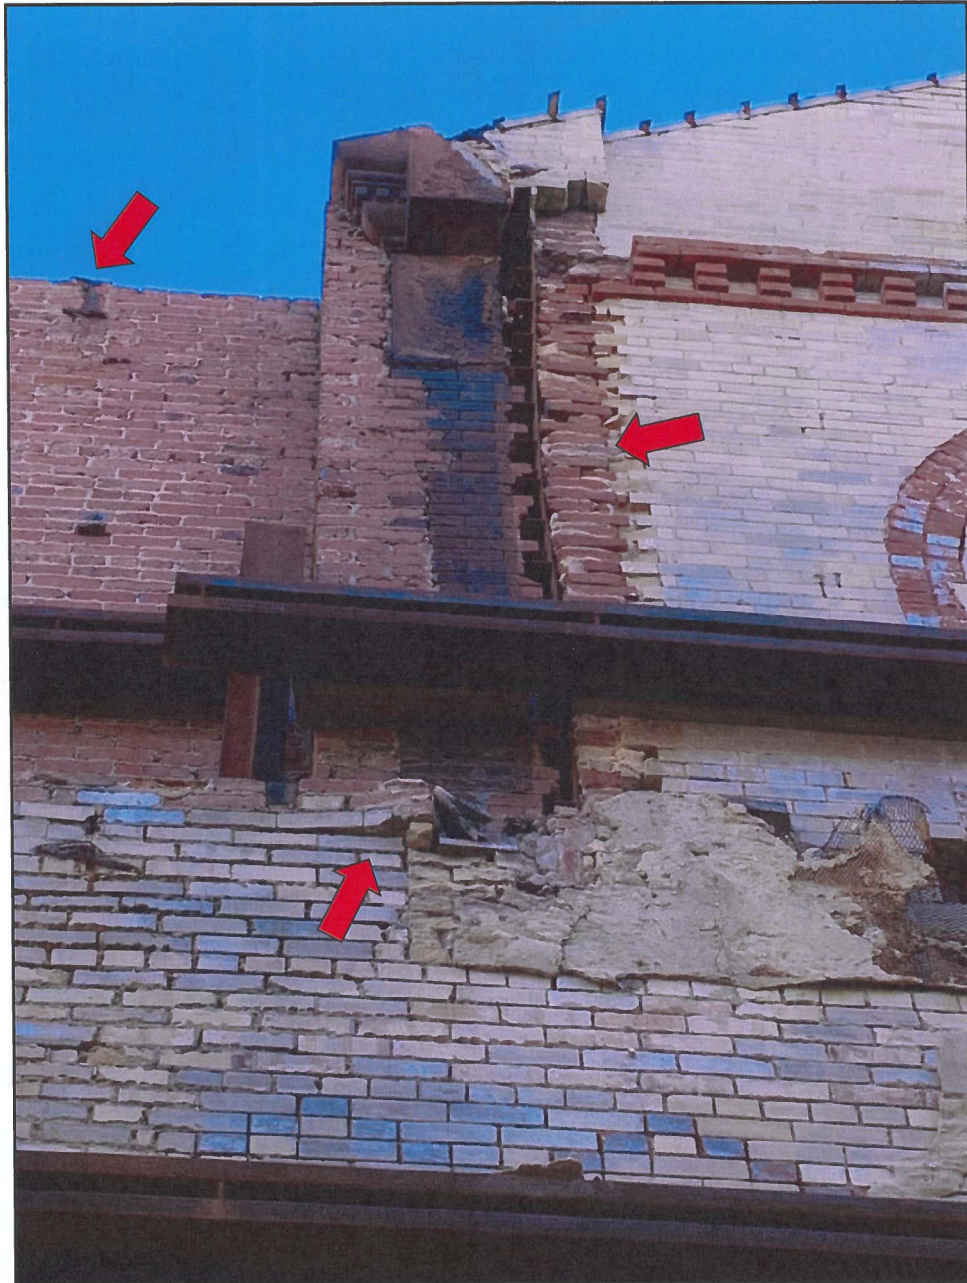
Photo 9
Hendler Building South Façade - Interior Face
Note Openings in Brick, Beam Pockets,
Eroded Mortar and Loose Brick

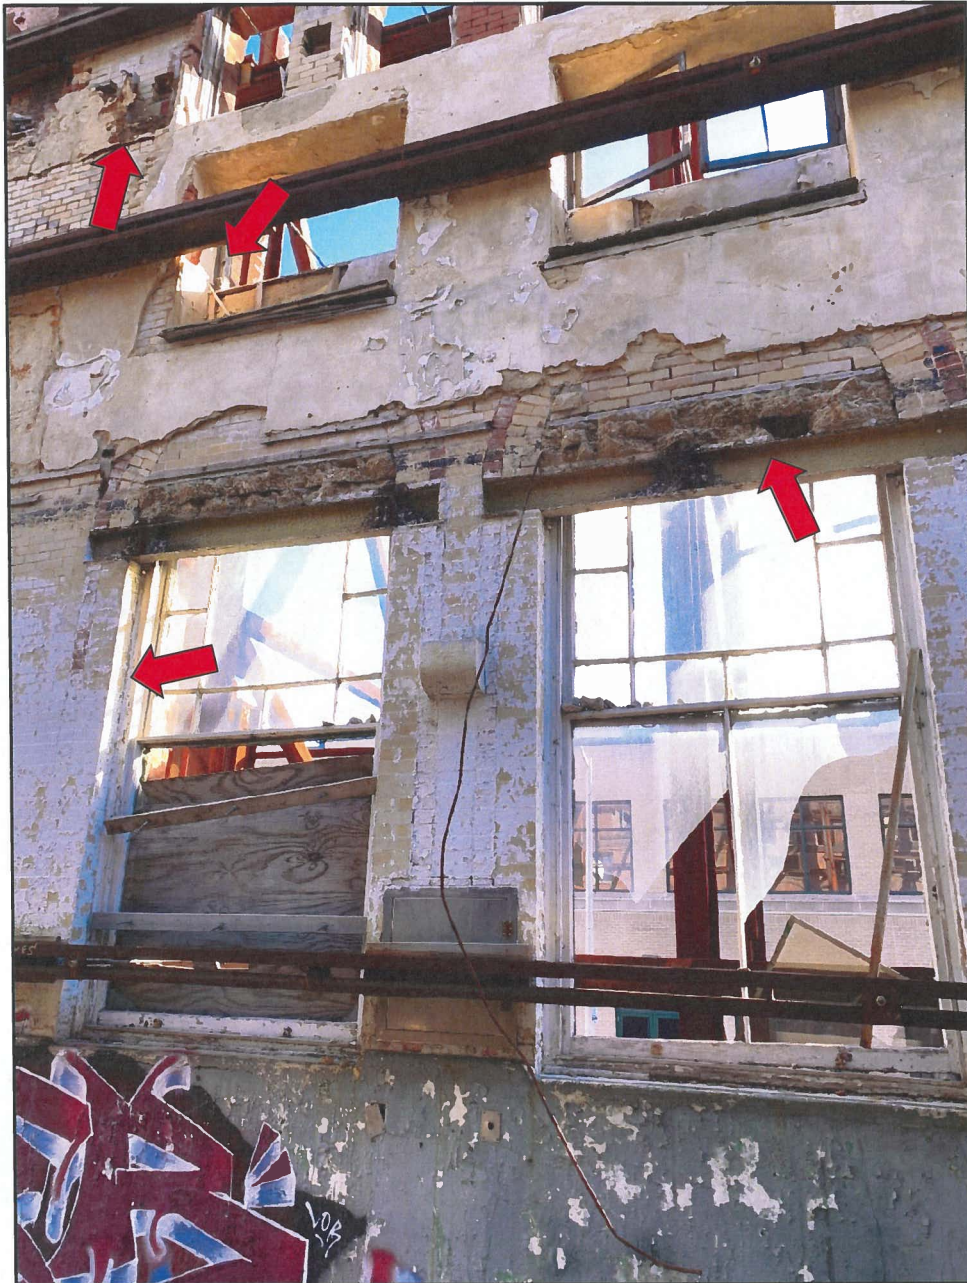
Photo 10
Hendler Building South Façade - Interior Face
Note Openings in Brick, Missing or Deteriorated Window Frames
and Embedded Concrete Floor

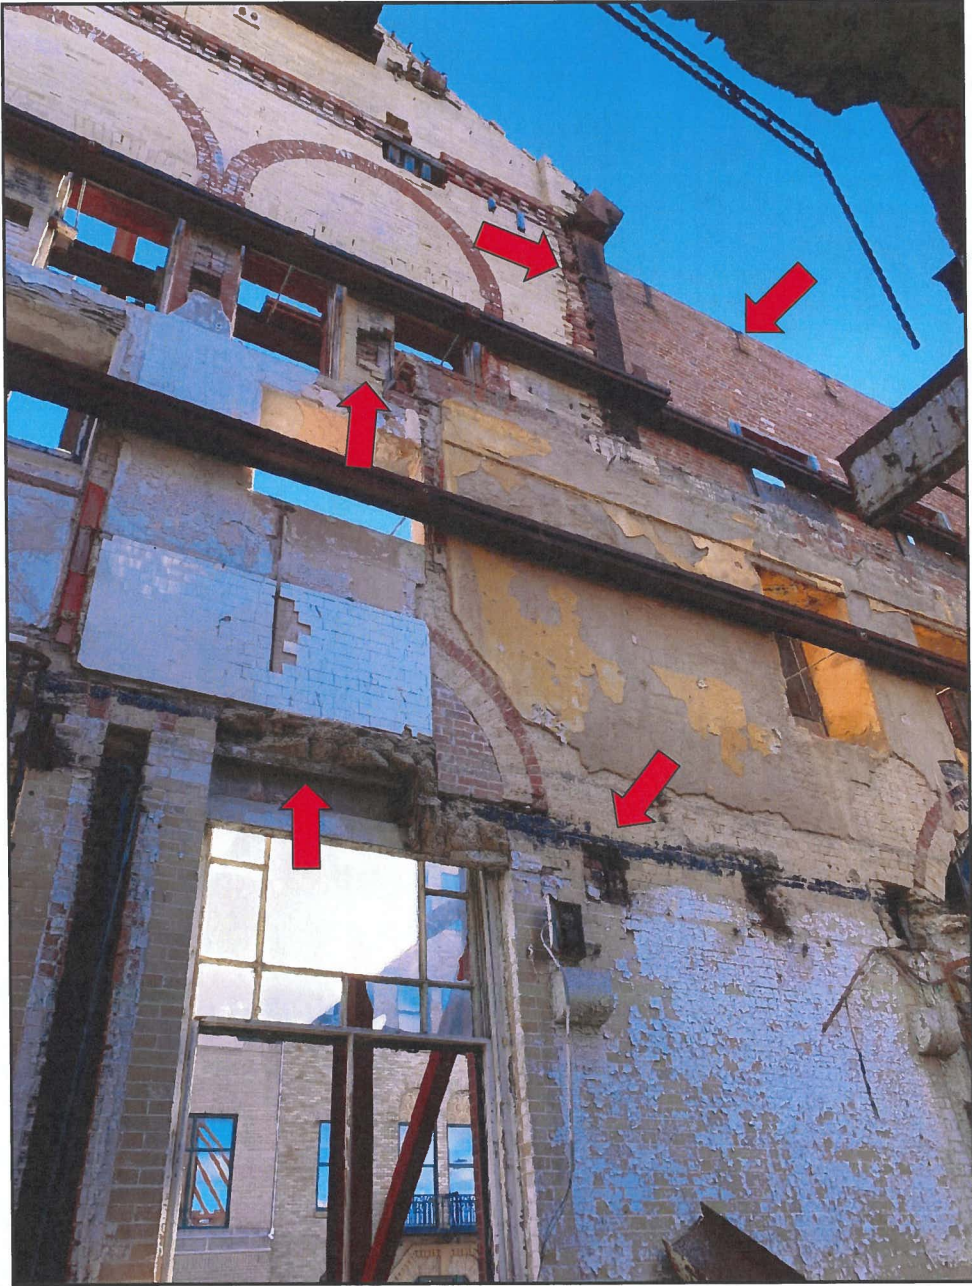
Photo 11
Hendler Building South Façade - Interior Face
Note Openings in Brick, Beam Pockets
and Embedded Concrete Floor

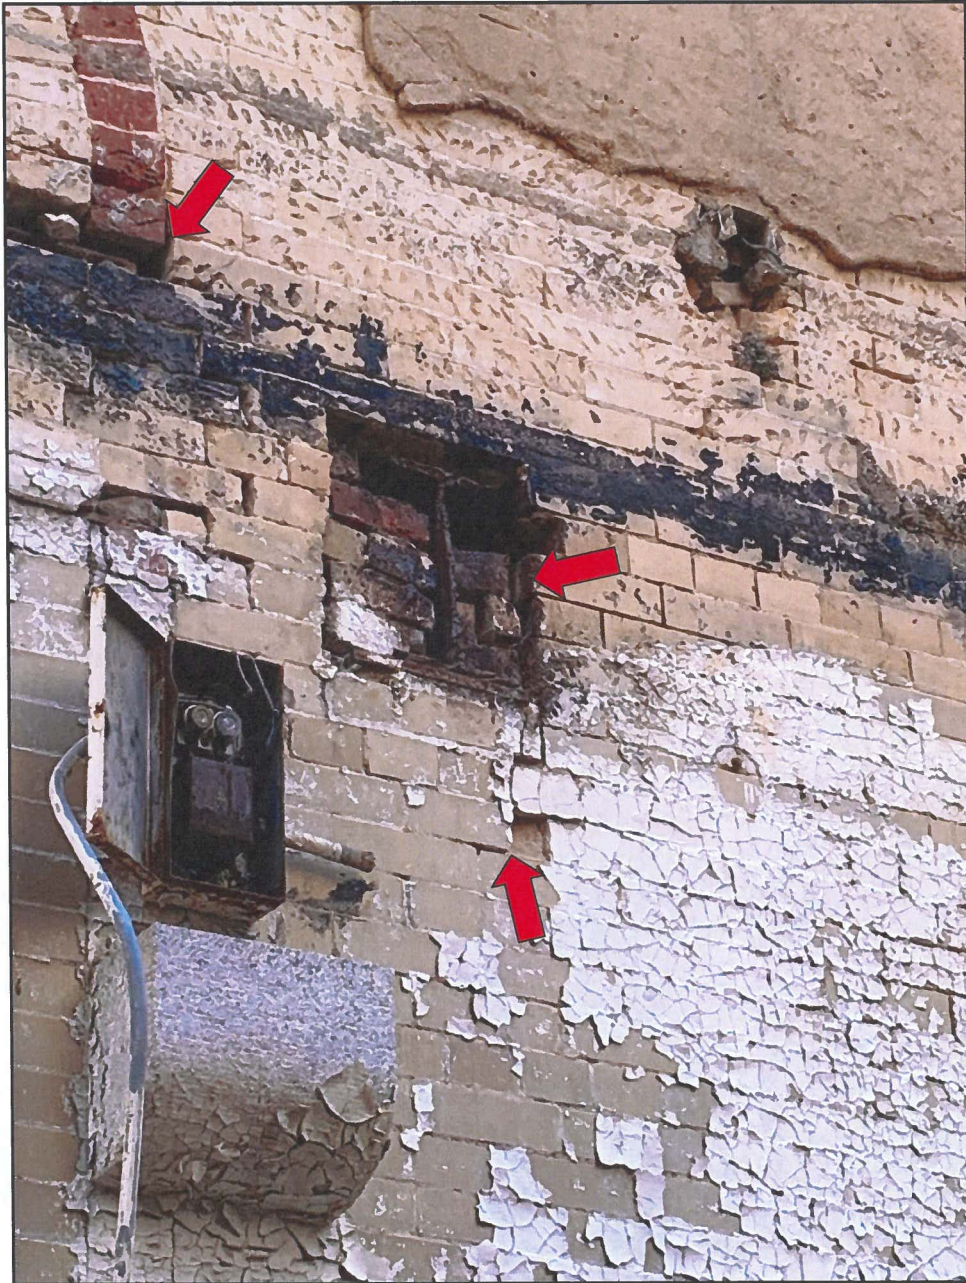
Photo 12
Hendler Building South Façade - Interior Face
Note Openings in Brick, Embedded Beam with Pack Rust
and Spalled Brick

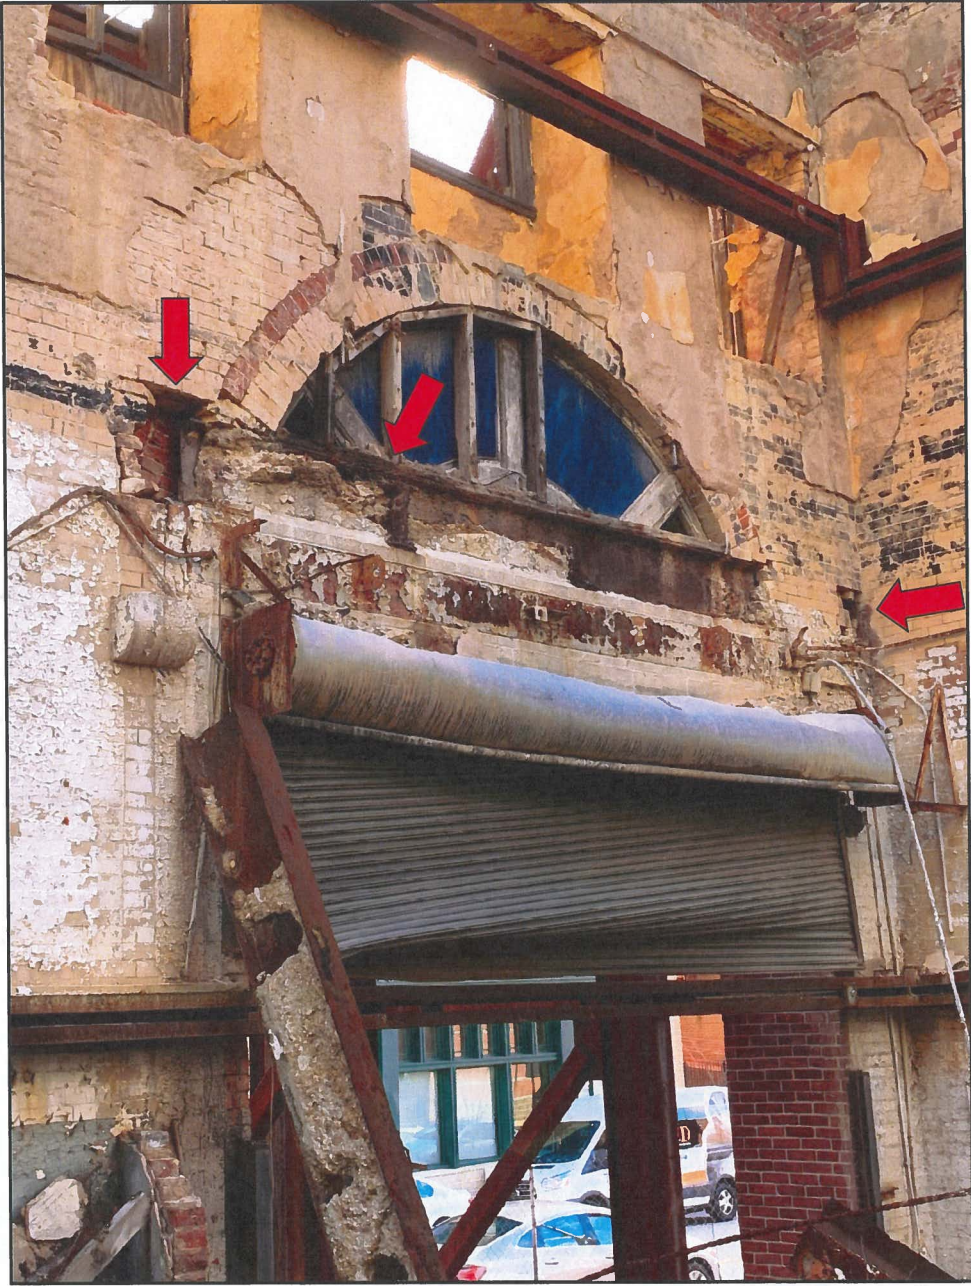
Photo 13
Hendler Building South Façade - Interior Face
Note Openings in Brick and Embedded Beam with Pack Rust

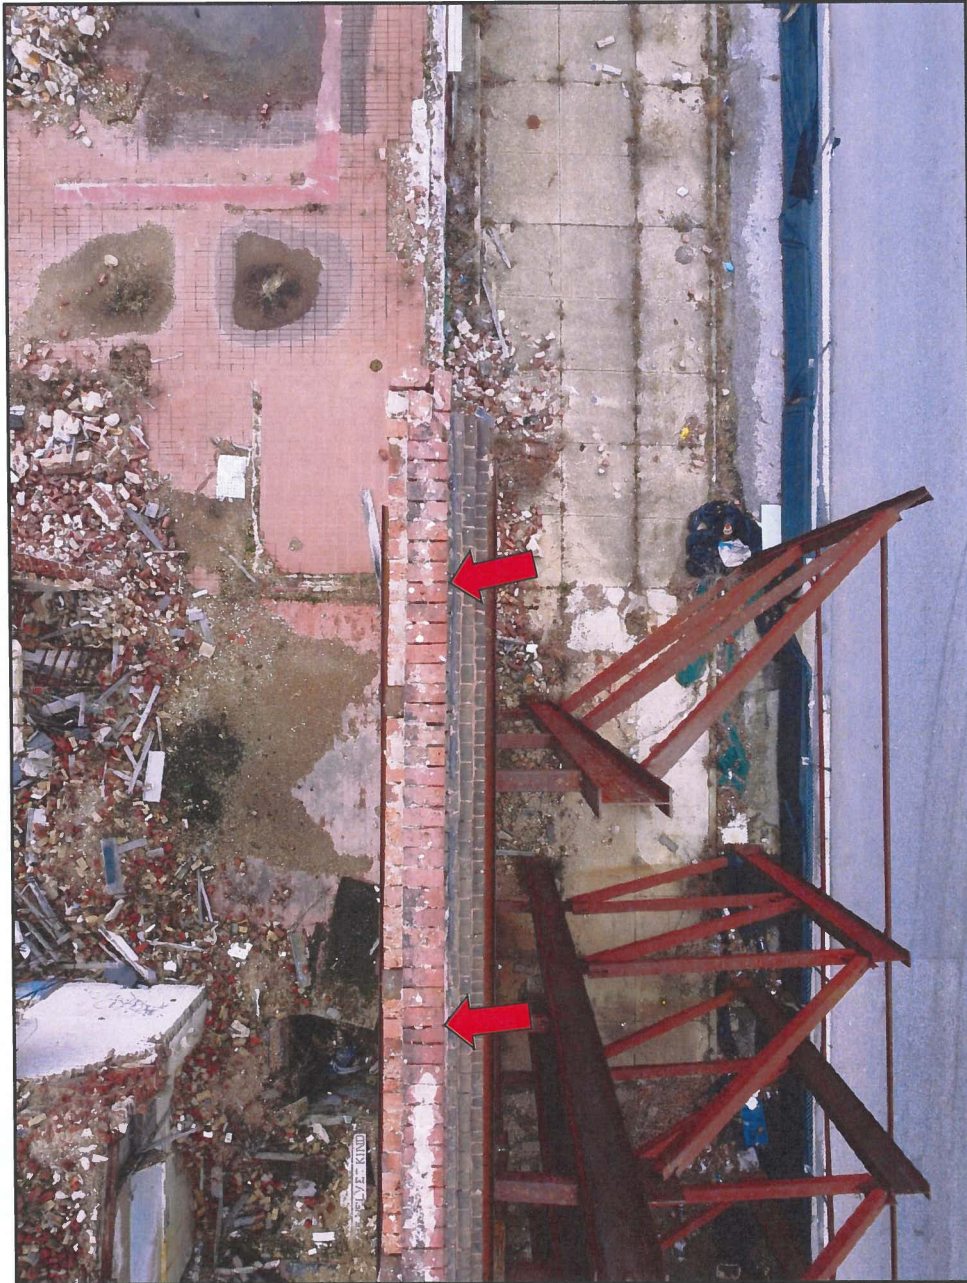
Photo 14
Hendler Building South Façade – Top Surface
Note Missing Coping and Openings in Brick

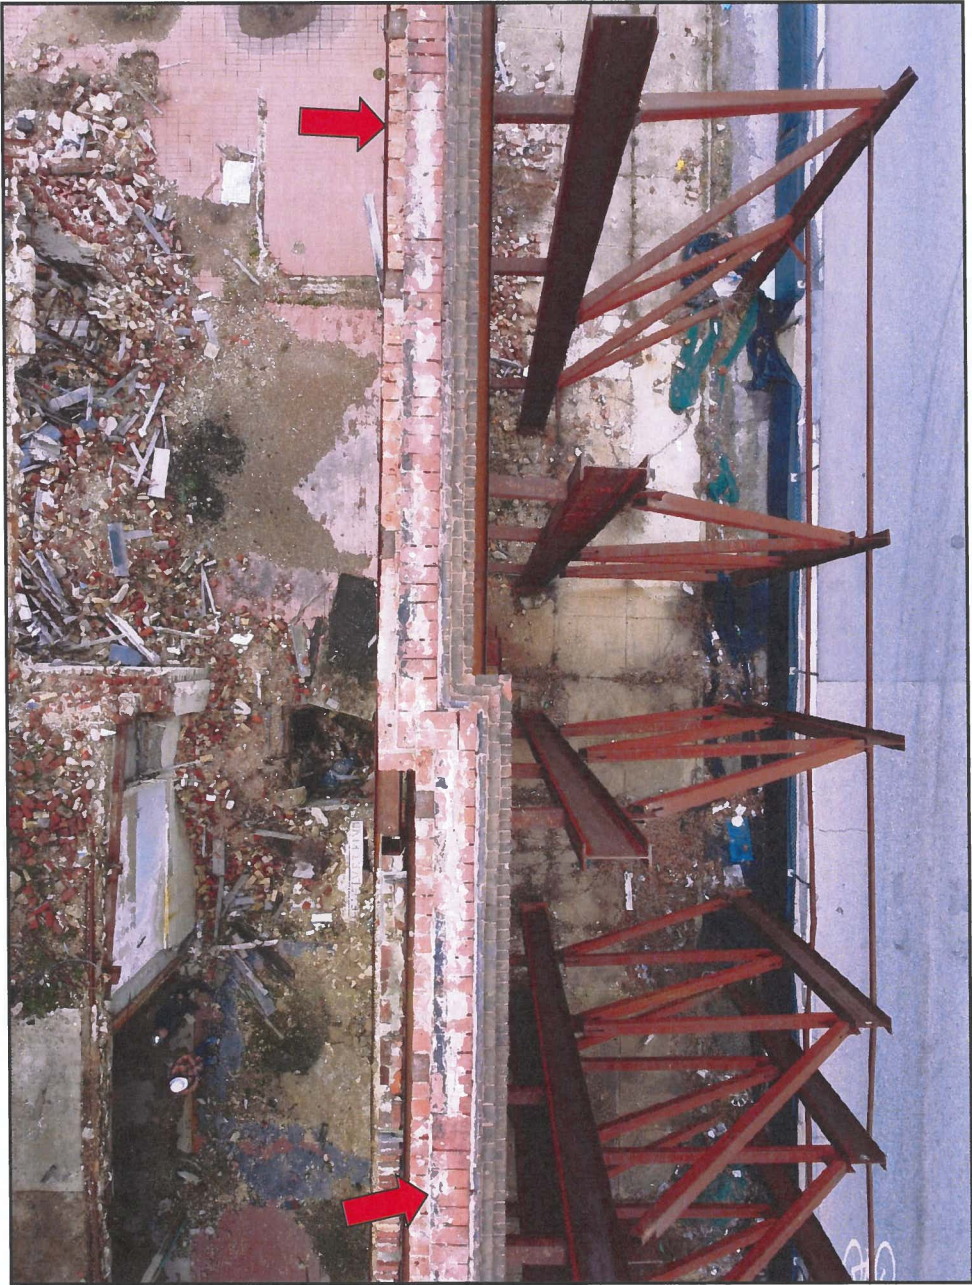
Photo 15
Hendler Building South Façade – Top Surface
Note Missing Coping and Openings in Brick

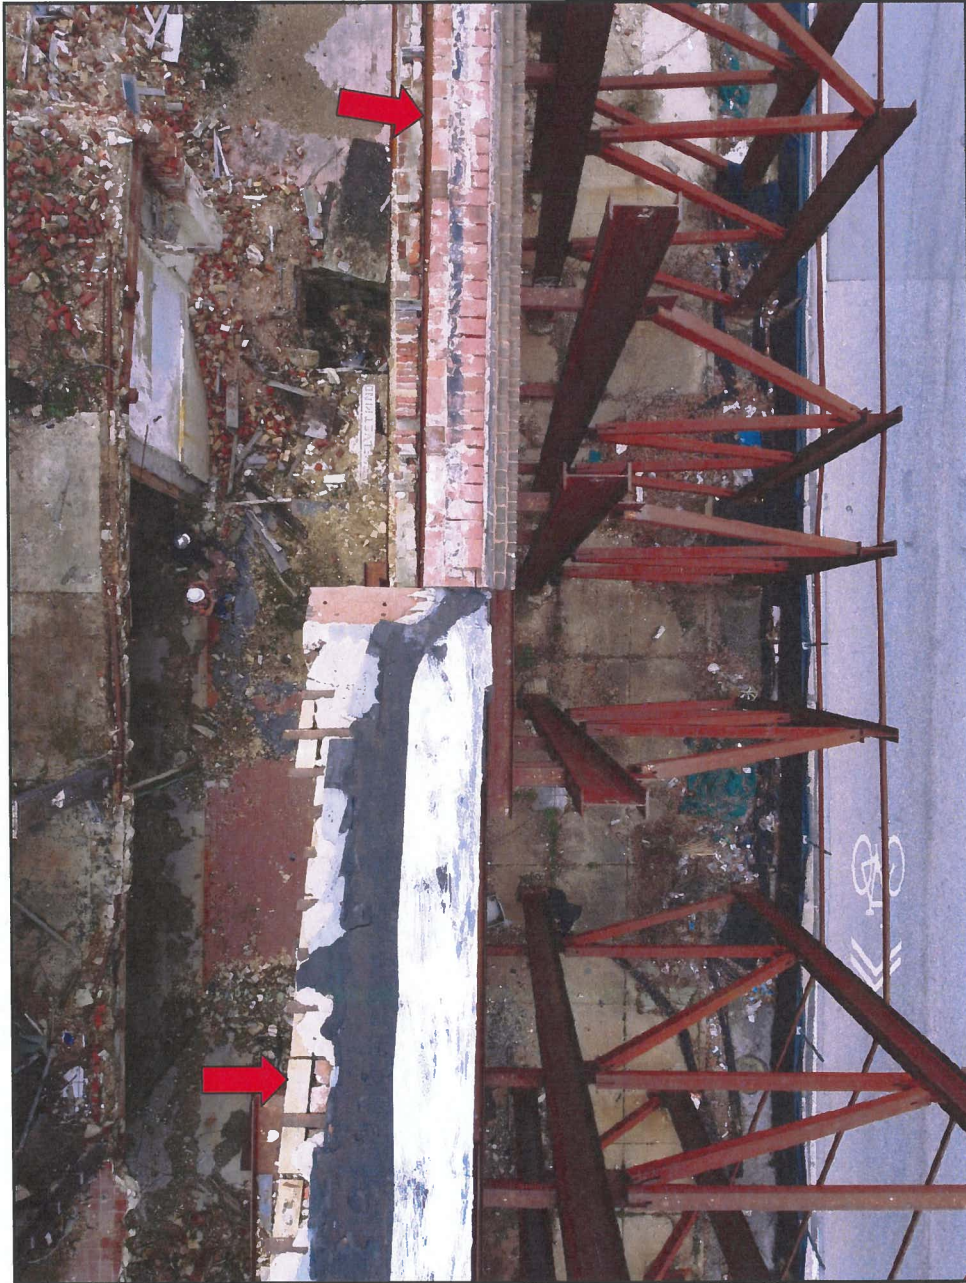
Photo 16
Hendler Building South Façade – Top Surface Above Pediment
Note Missing Coping and Openings in Brick

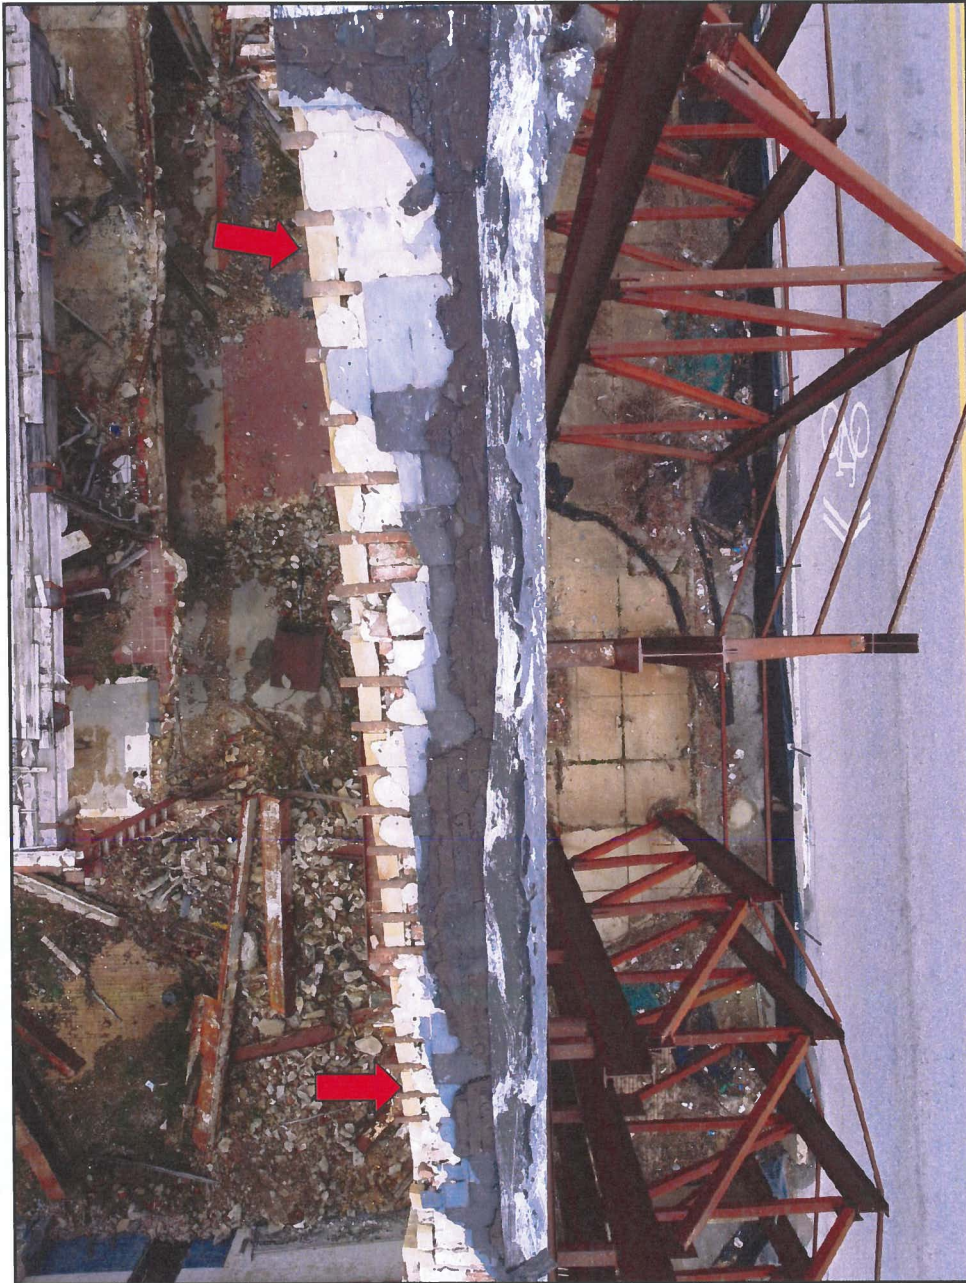
Photo 17
Hendler Building South Façade – Top Surface Above Pediment
Note Missing Coping and Openings in Brick

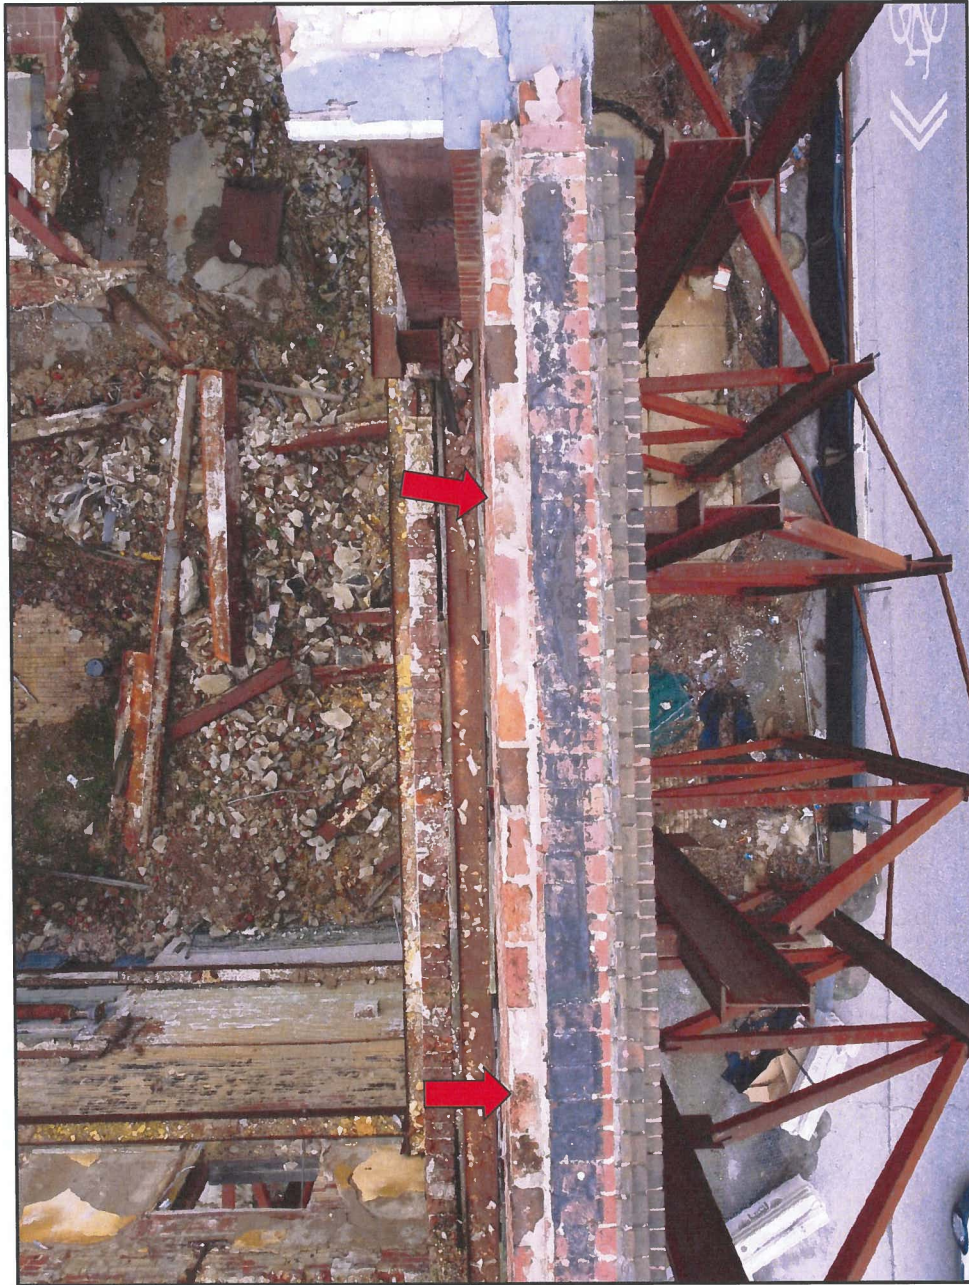
Photo 18
Hendler Building South Façade – Top Surface
Note Missing Coping

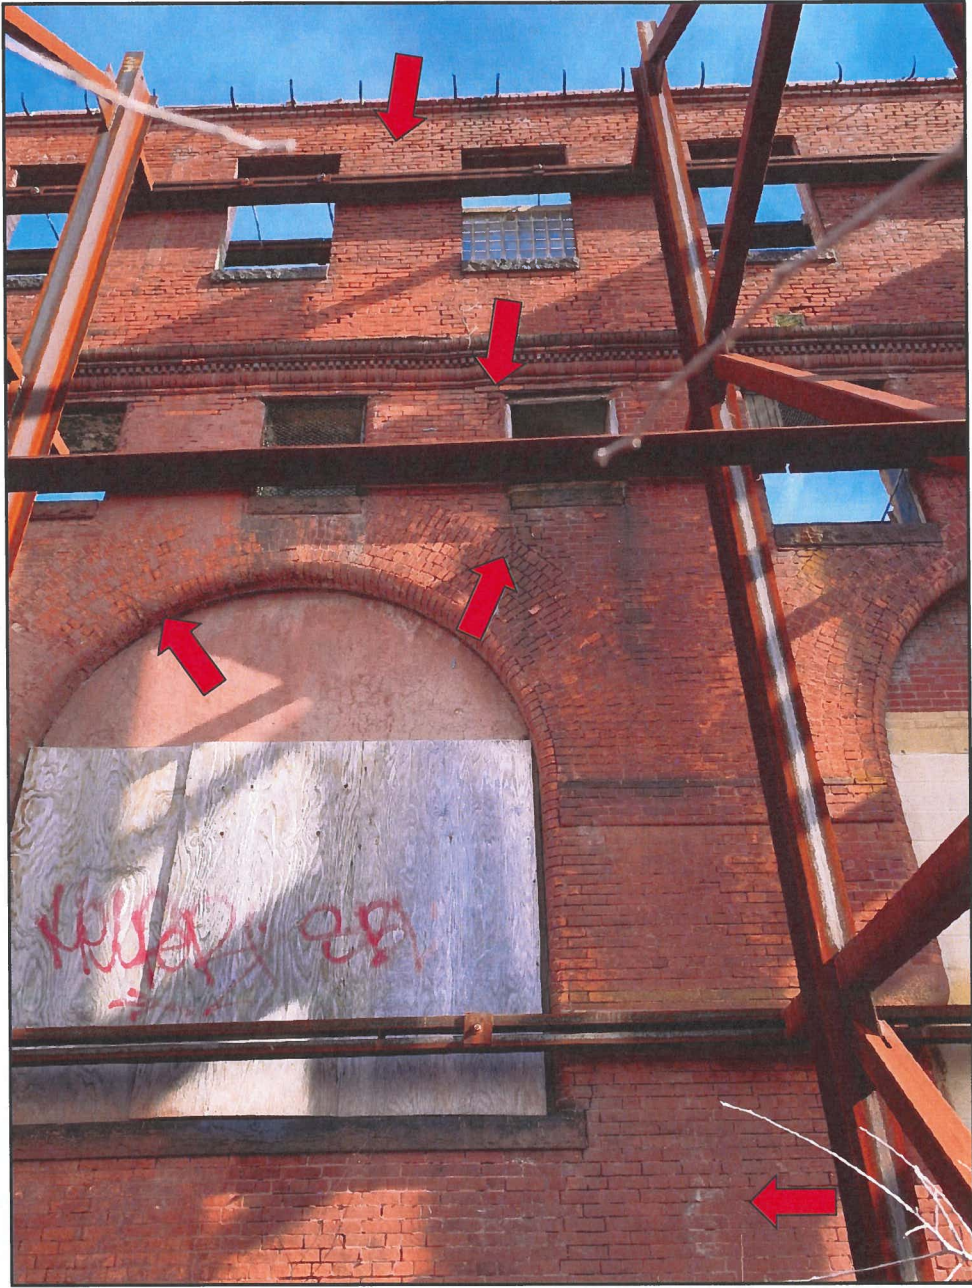
Photo 1
Hendler Building West Façade - Exterior Face
Note Deteriorated Brick and Mortar Joints, Cracks, Bulge
And Efflorescence

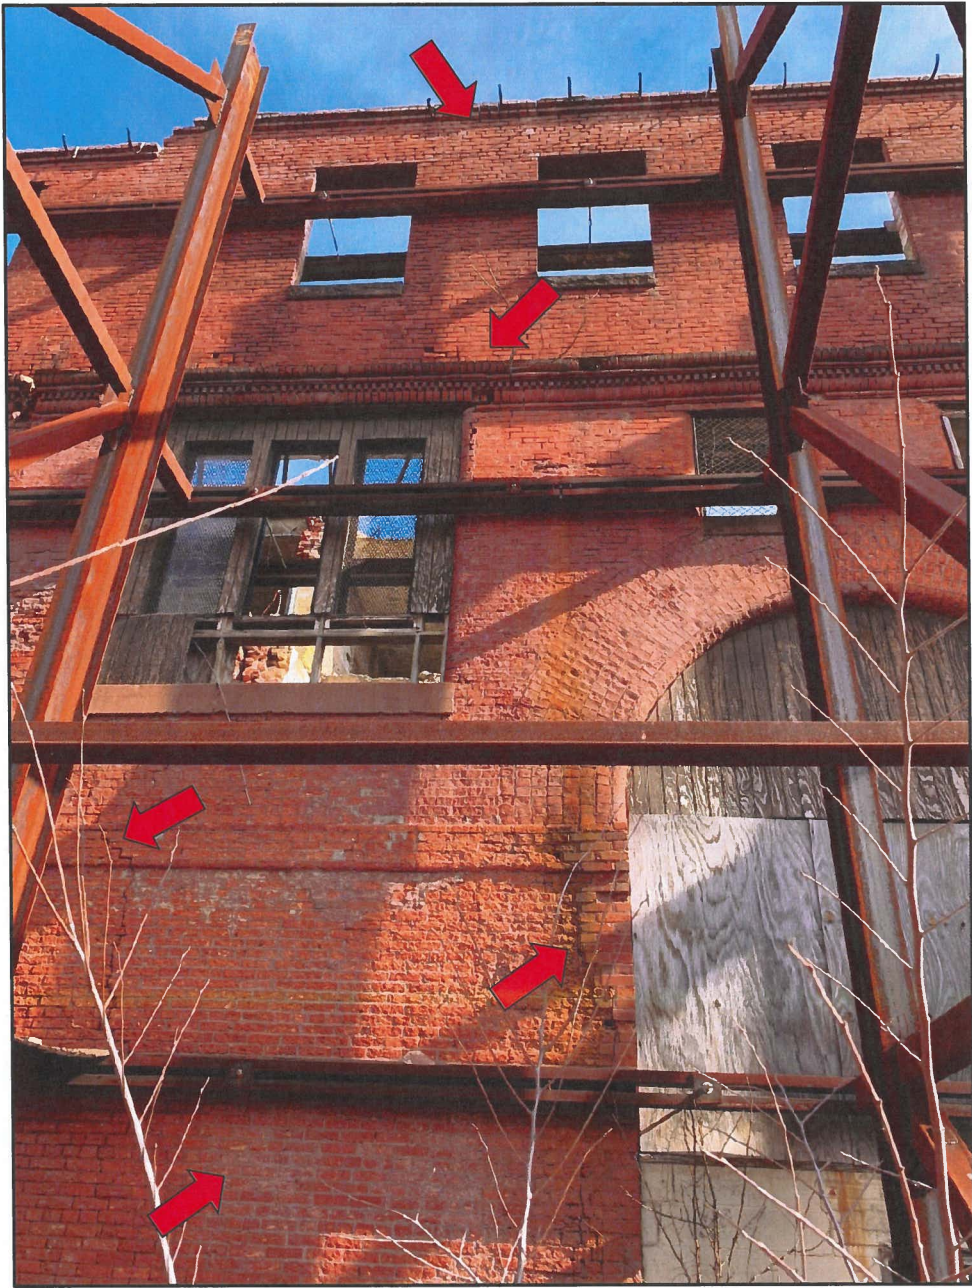
Photo 2
Hendler Building West Façade - Exterior Face
Note Deteriorated Brick and Mortar Joints, Cracks, Bulge
And Efflorescence
