February 3, 2023

Helping Up Mission / House of Freedom ("Client")
1029 East Baltimore Street
Baltimore, MD 21202

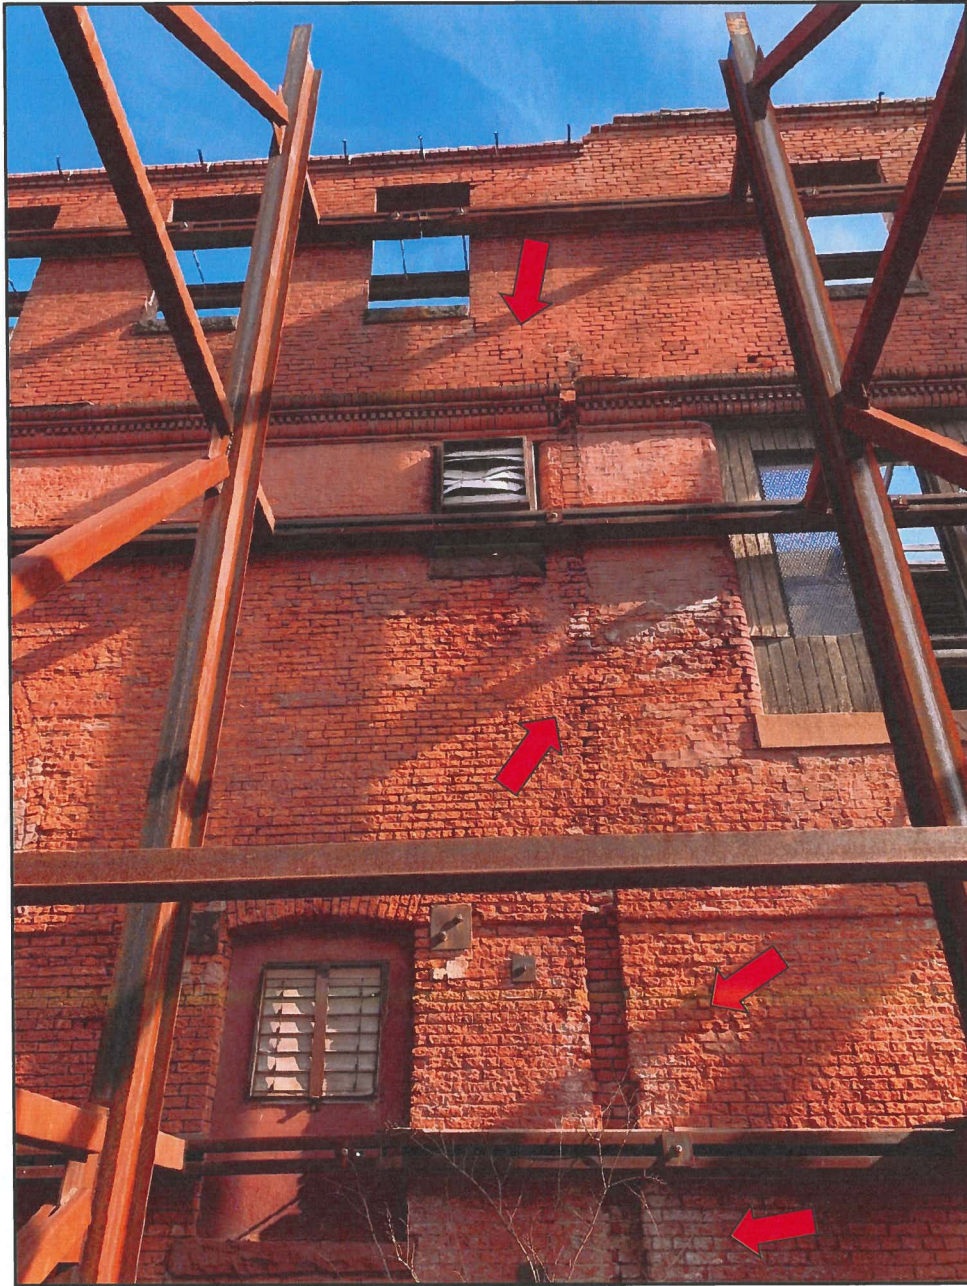
Photo 3
Hendler Building West Façade - Exterior Face
Note Severely Deteriorated Brick and Mortar Joints, Cracks,
and Efflorescence

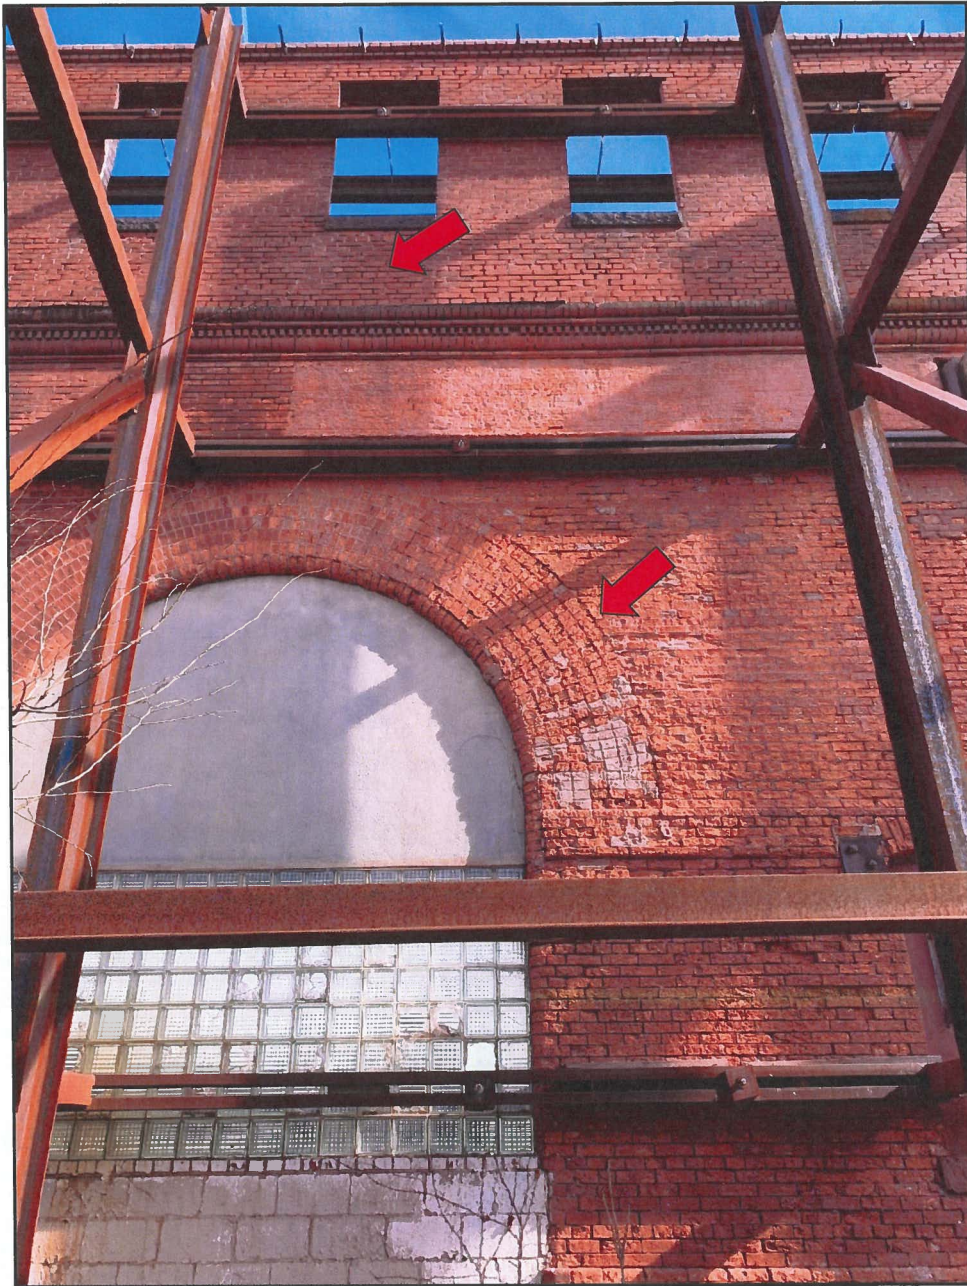
Photo 4
Hendler Building South Façade - Exterior Face
Note Severely Deteriorated Brick and Eroded Mortar Joints

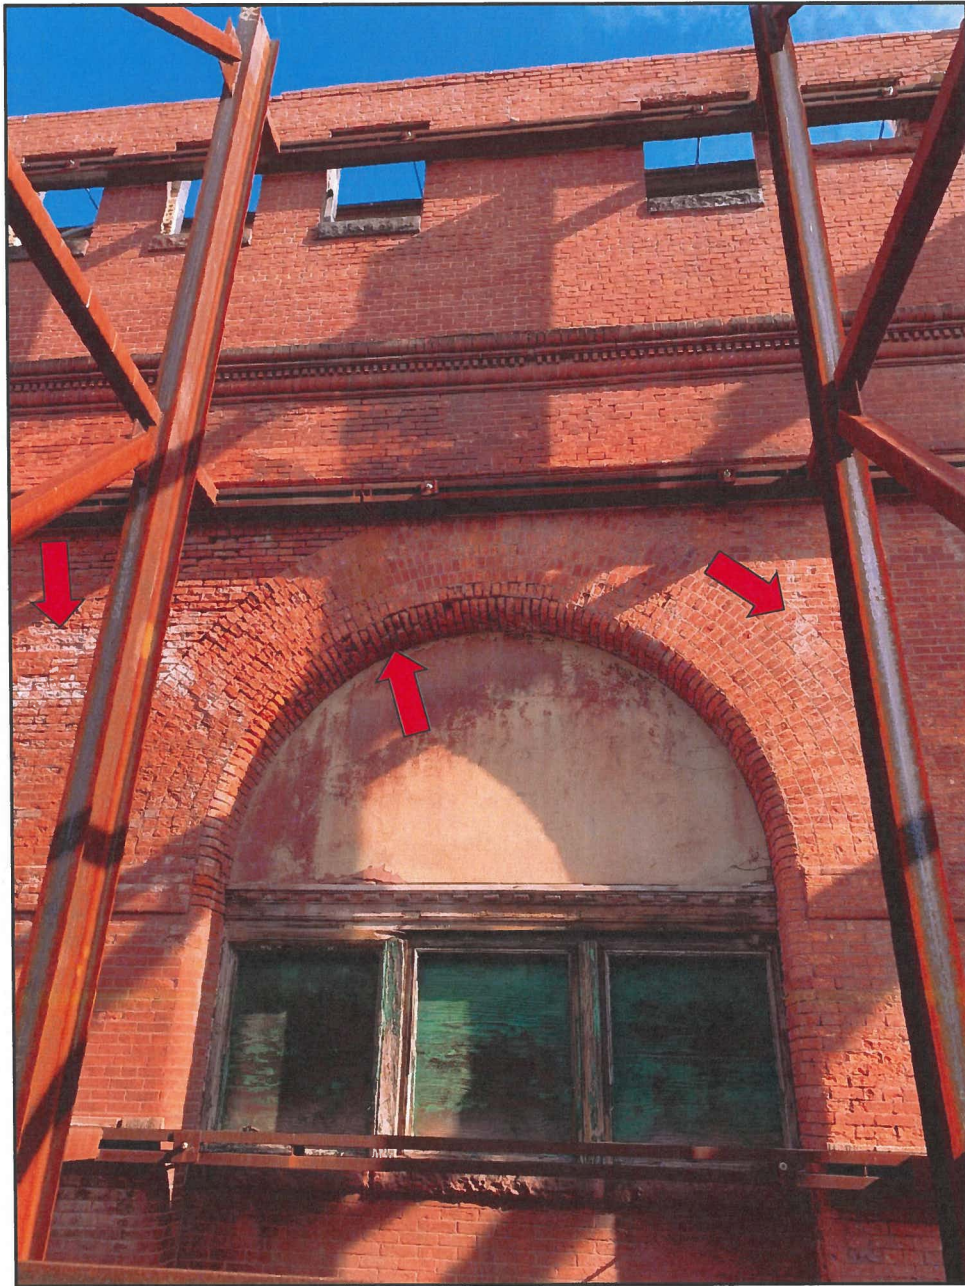
Photo 5
Hendler Building West Façade - Exterior Face
Note Severely Deteriorated Brick and Mortar Joints,
and Efflorescence

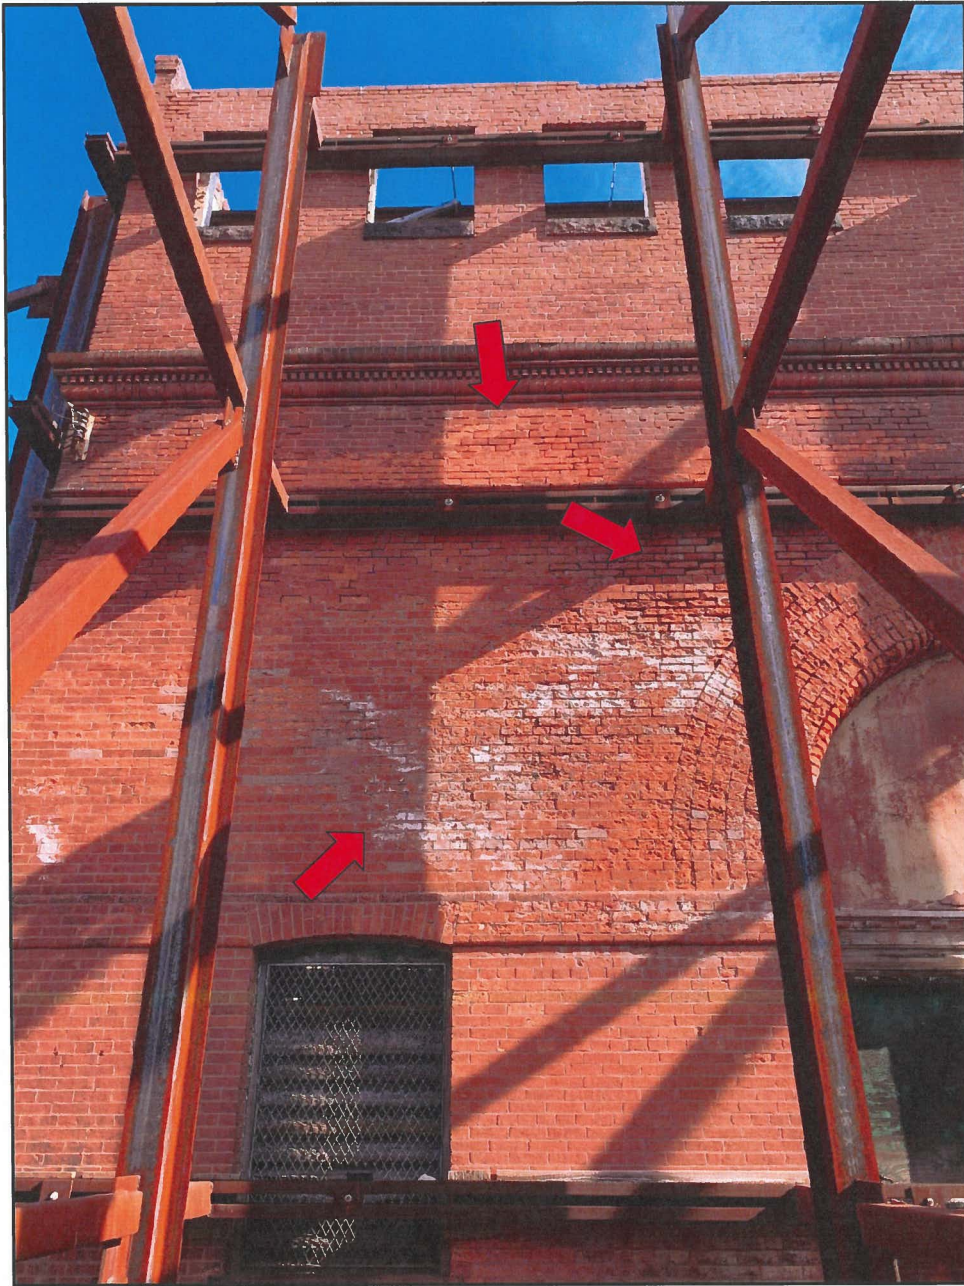
Photo 6
Hendler Building West Façade - Exterior Face
Note Severely Deteriorated Brick and Mortar Joints,
and Efflorescence

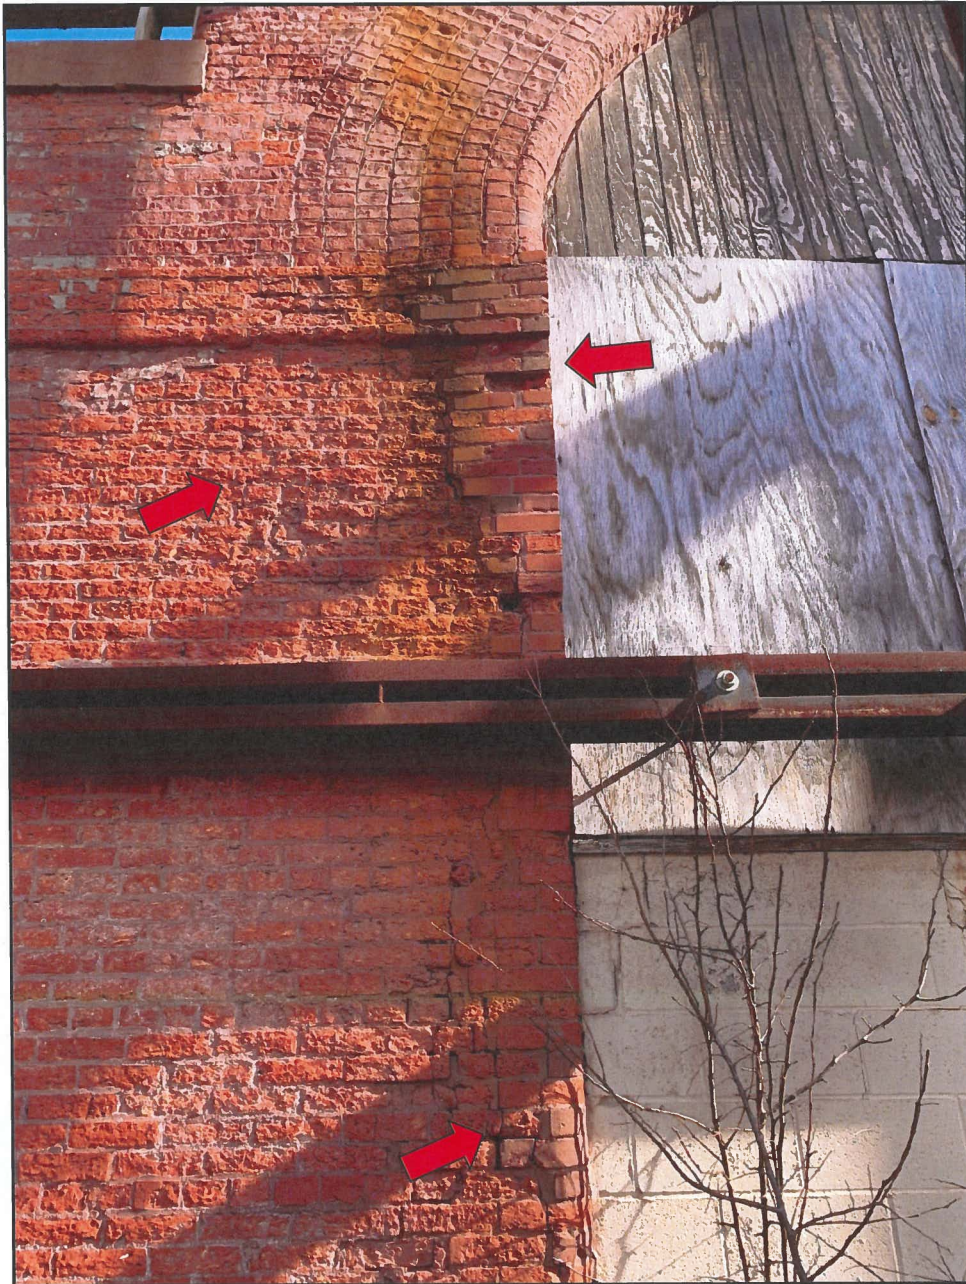
Photo 7
Hendler Building West Façade - Exterior Face
Note Severely Deteriorated Brick and Mortar Joints, Bulge
and Cracks

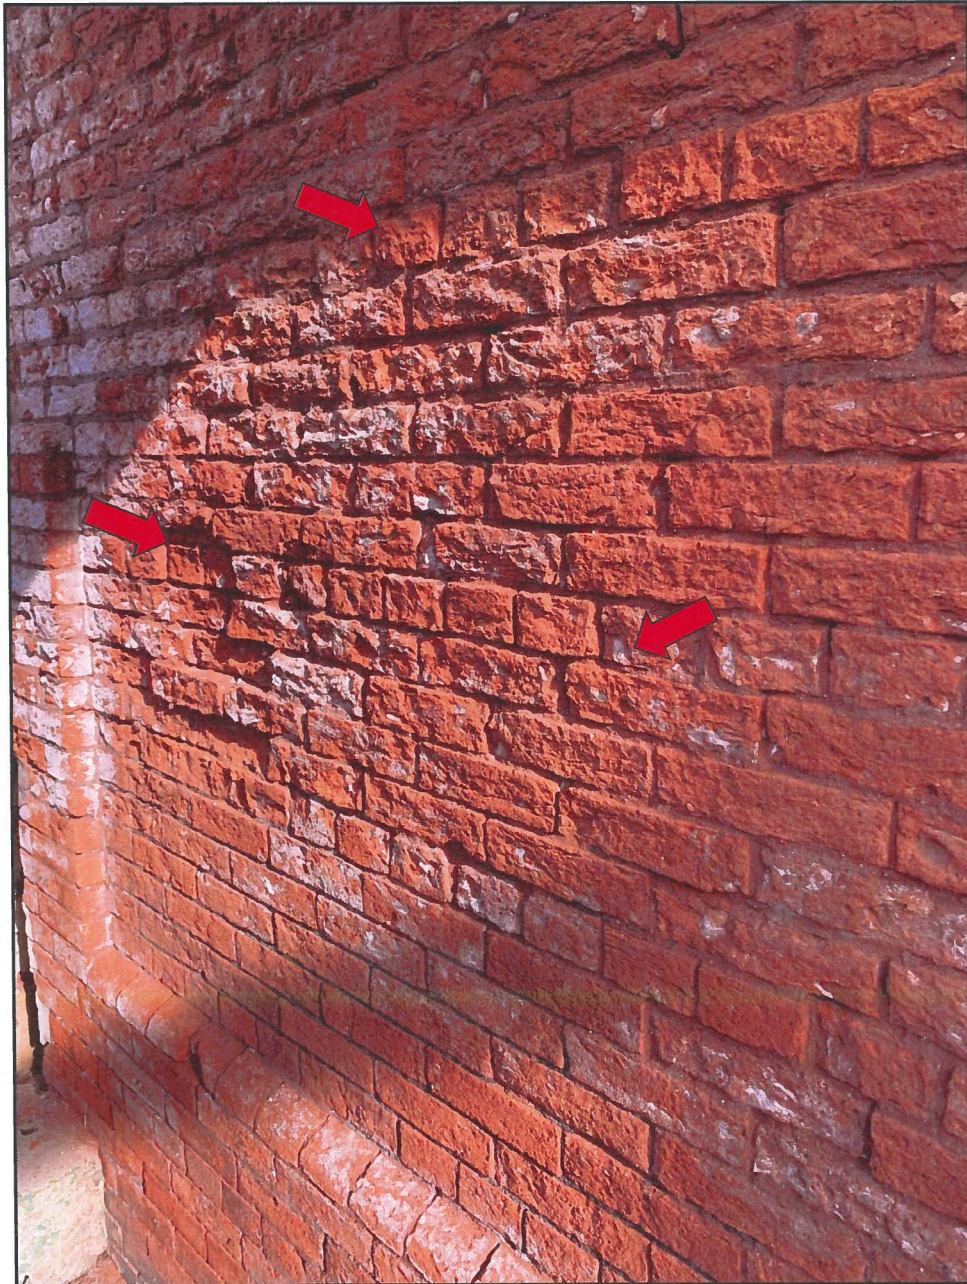
Photo 8
Hendler Building West Façade - Exterior Face
Note Severely Deteriorated Brick and Mortar Joints,
and Efflorescence

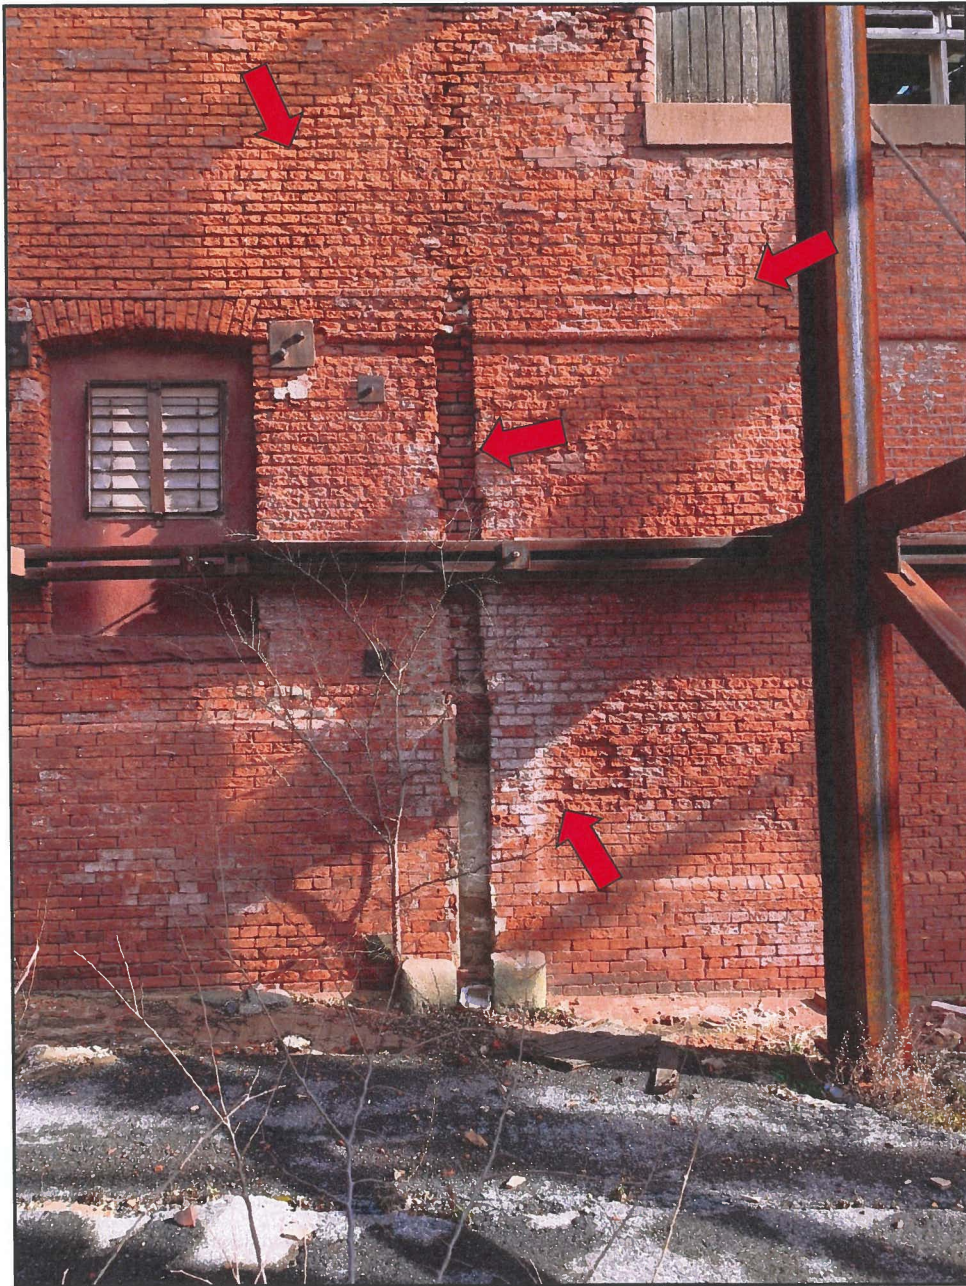
Photo 9
Hendler Building West Façade - Exterior Face
Note Severely Deteriorated Brick and Mortar Joints, Cracks
Slot in Wall and Efflorescence

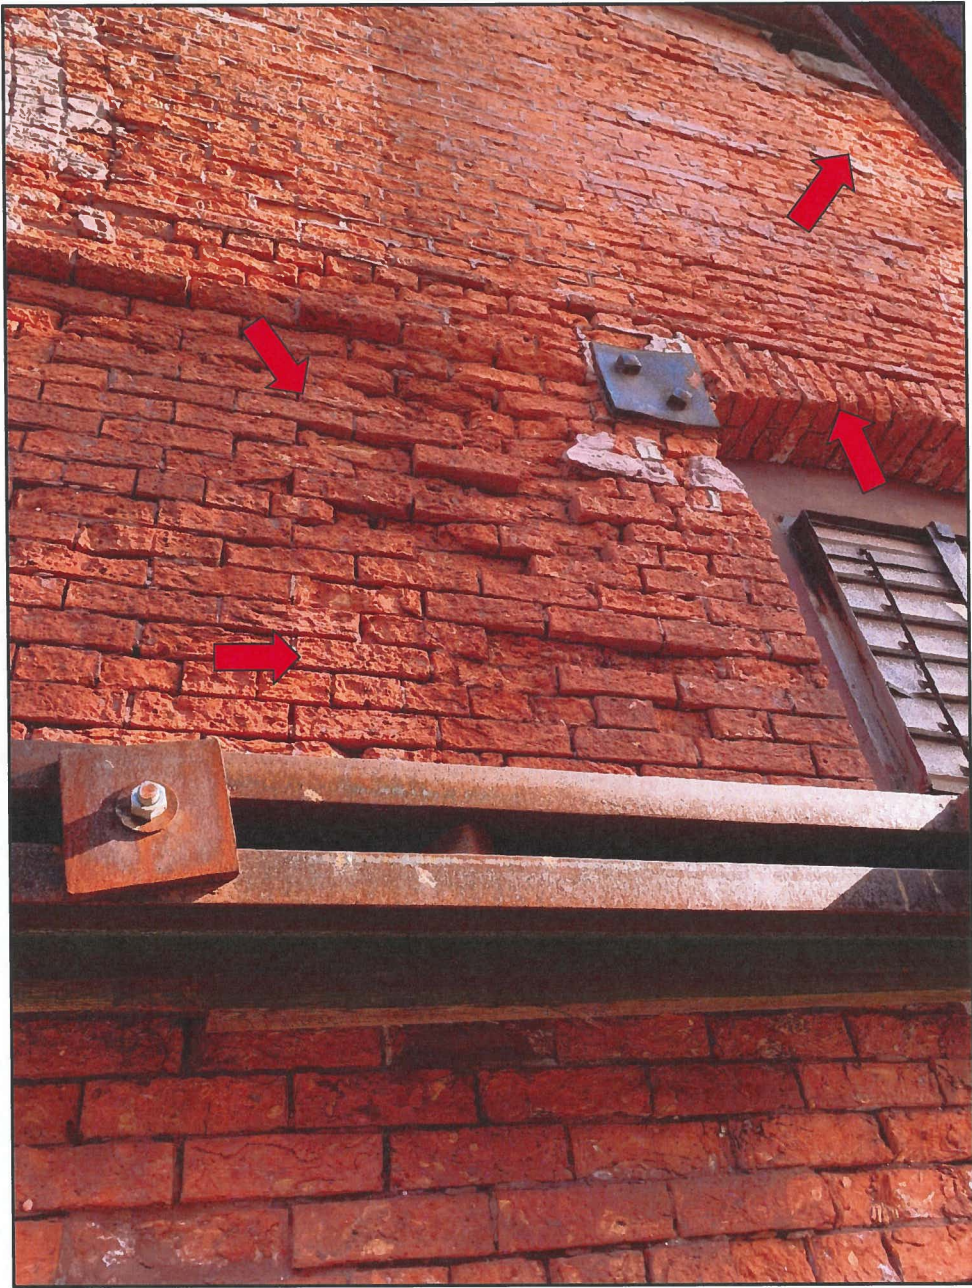
Photo 10
Hendler Building West Façade - Exterior Face
Note Severely Deteriorated Brick and Mortar Joints

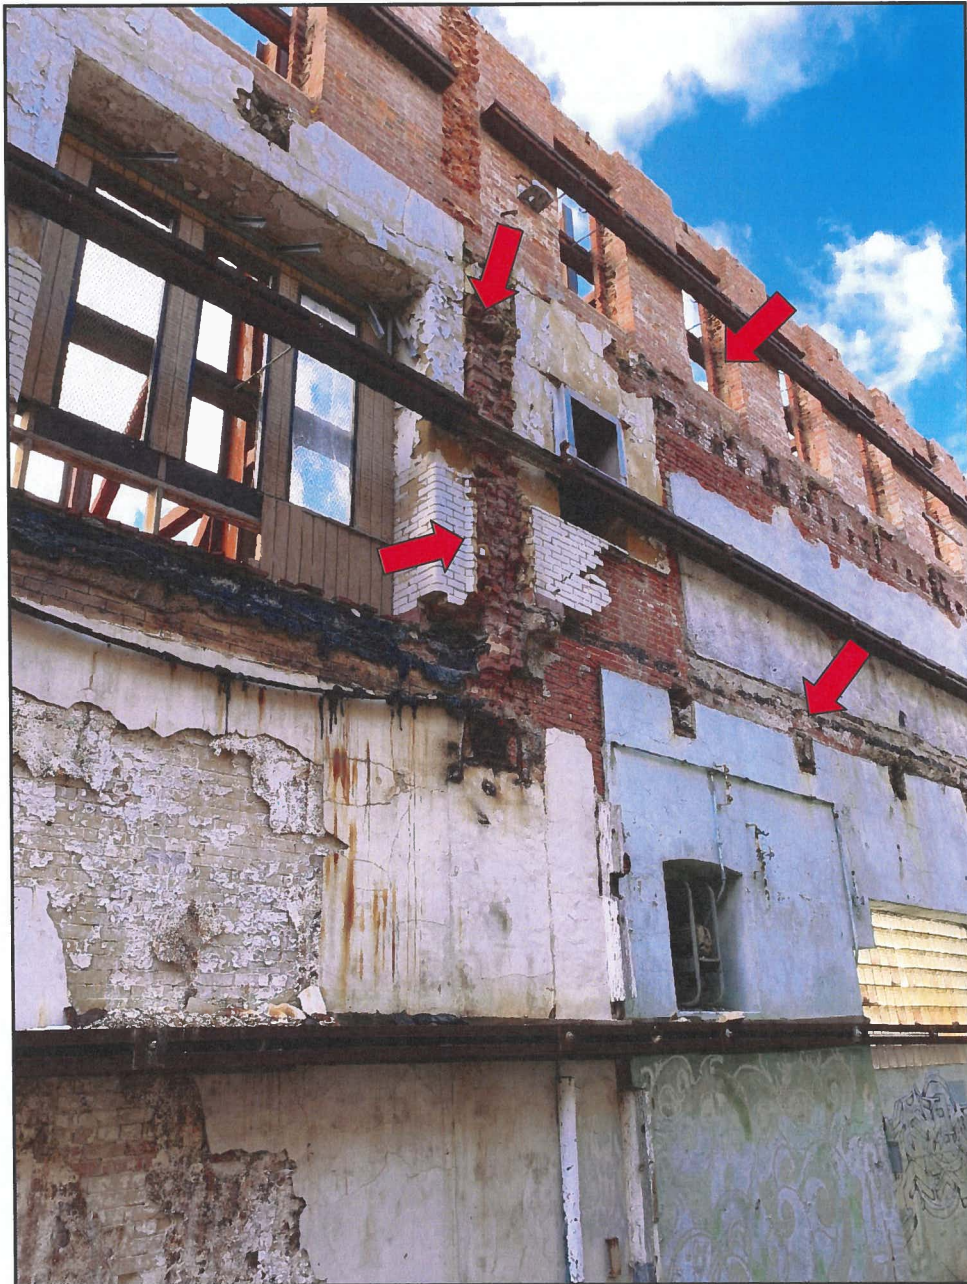
Photo 11
Hendler Building West Façade - Interior Face
Note Openings in Brick, Beam Pockets
and Missing Window Frames

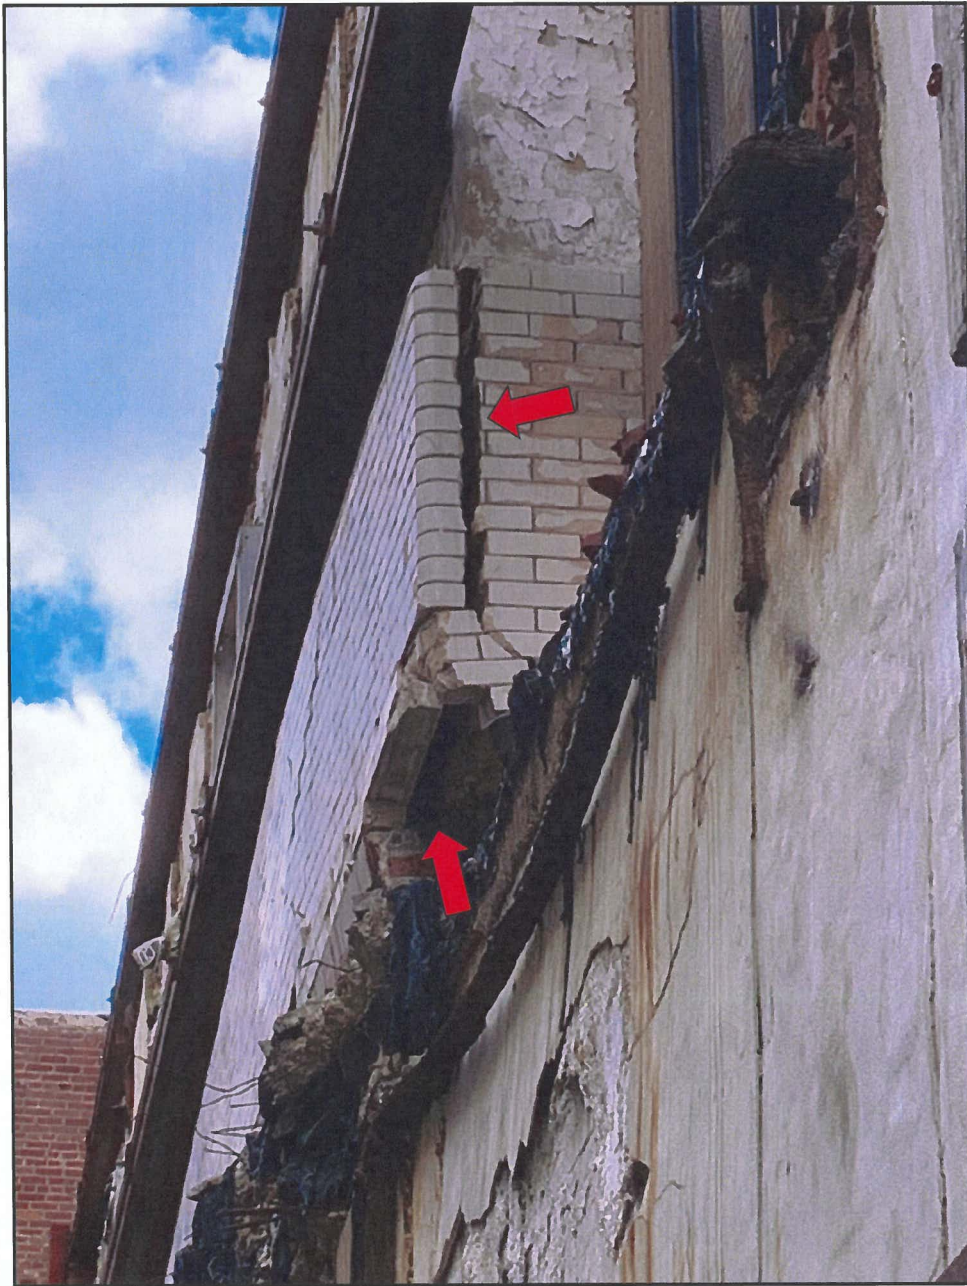
Photo 12
Hendler Building West Façade - Interior Face
Note Large Crack and Unsupported Brick Veneer

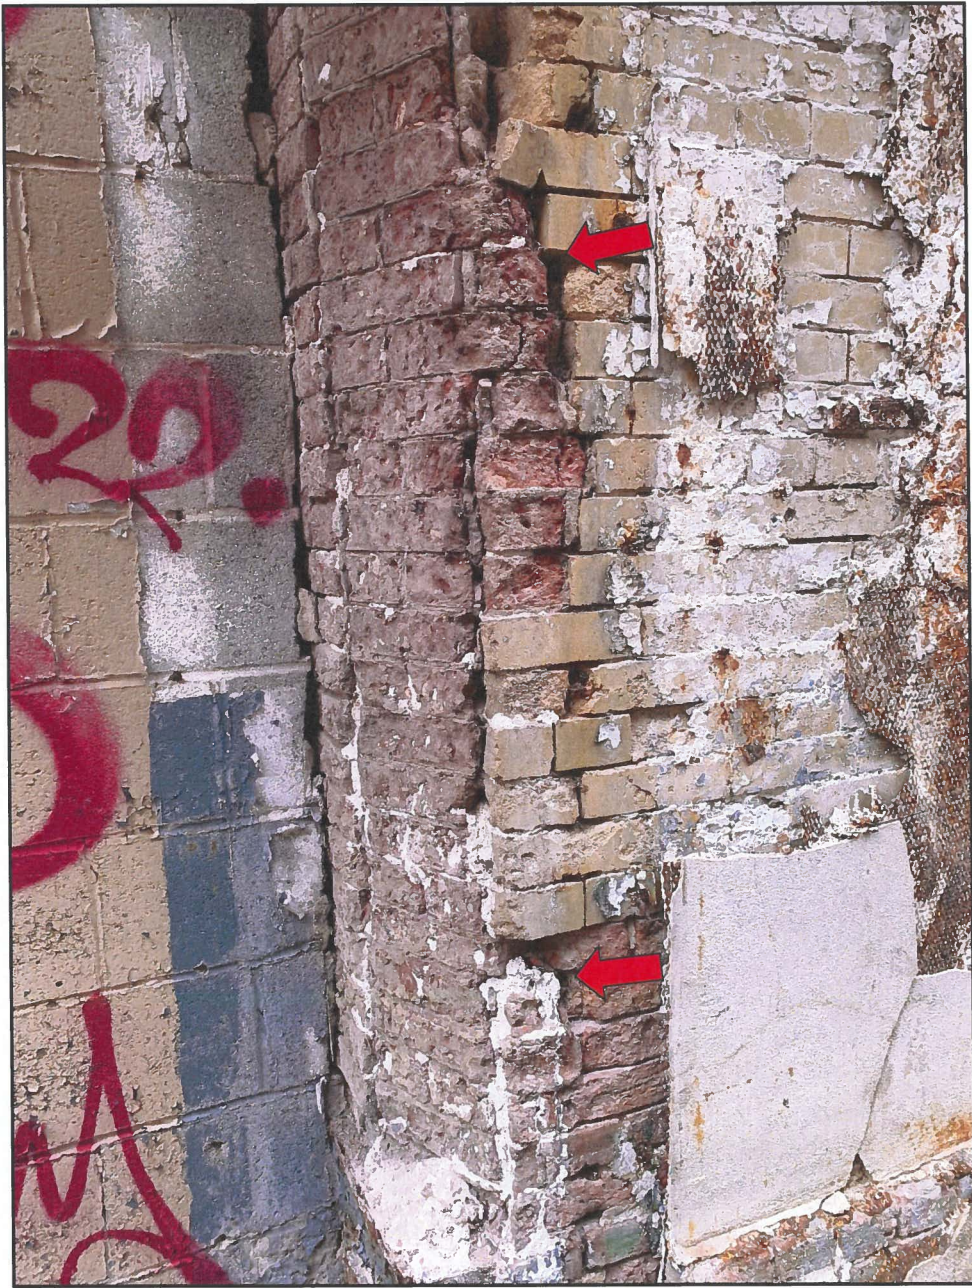
Photo 14
Hendler Building West Façade - Interior Face
Note Severely Deteriorated Brick and Mortar Joints

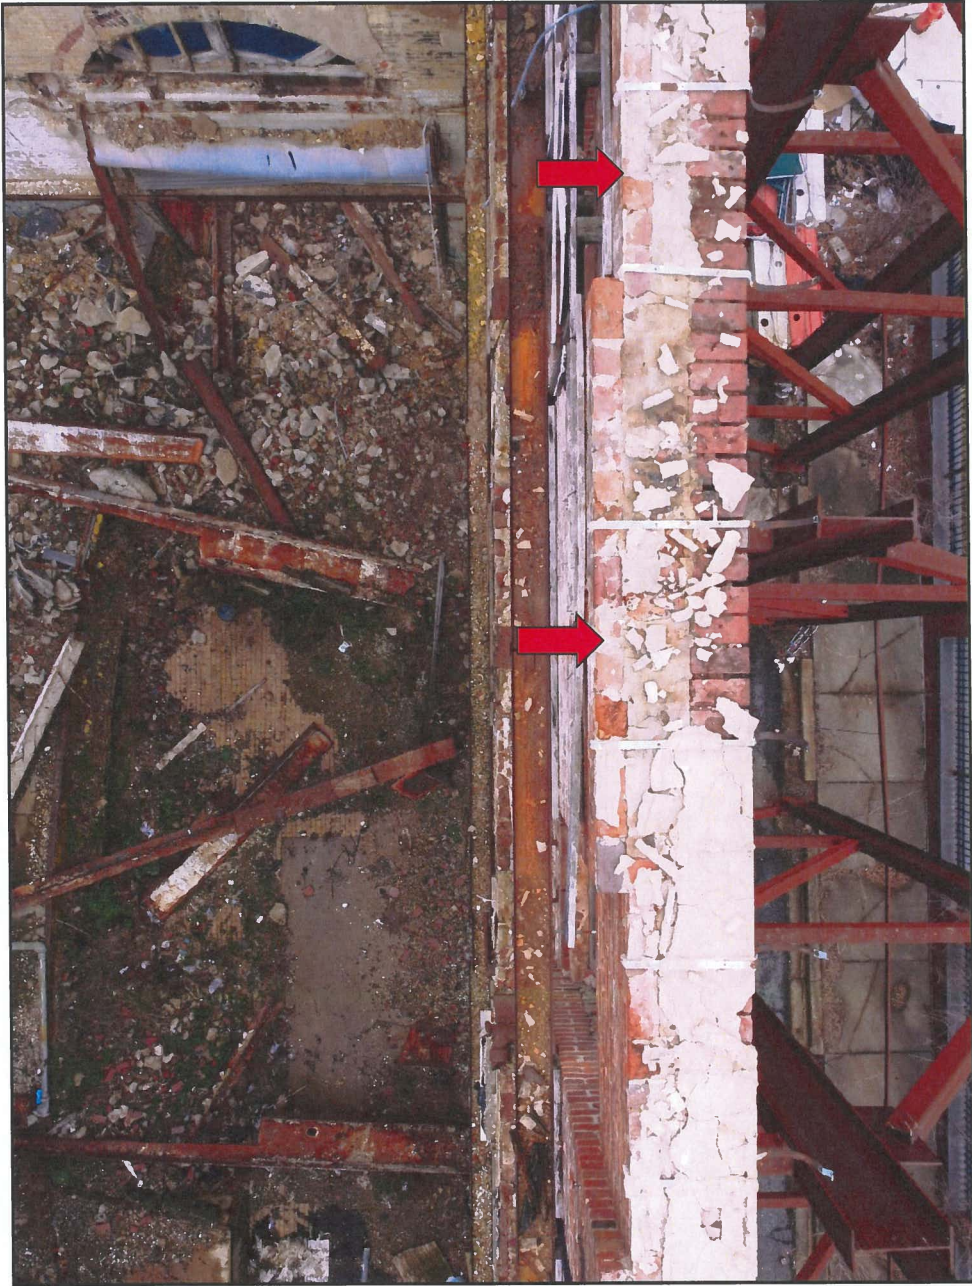
Photo 16
Hendler Building West Façade – Top Surface
Note Missing Coping and Openings in Brick

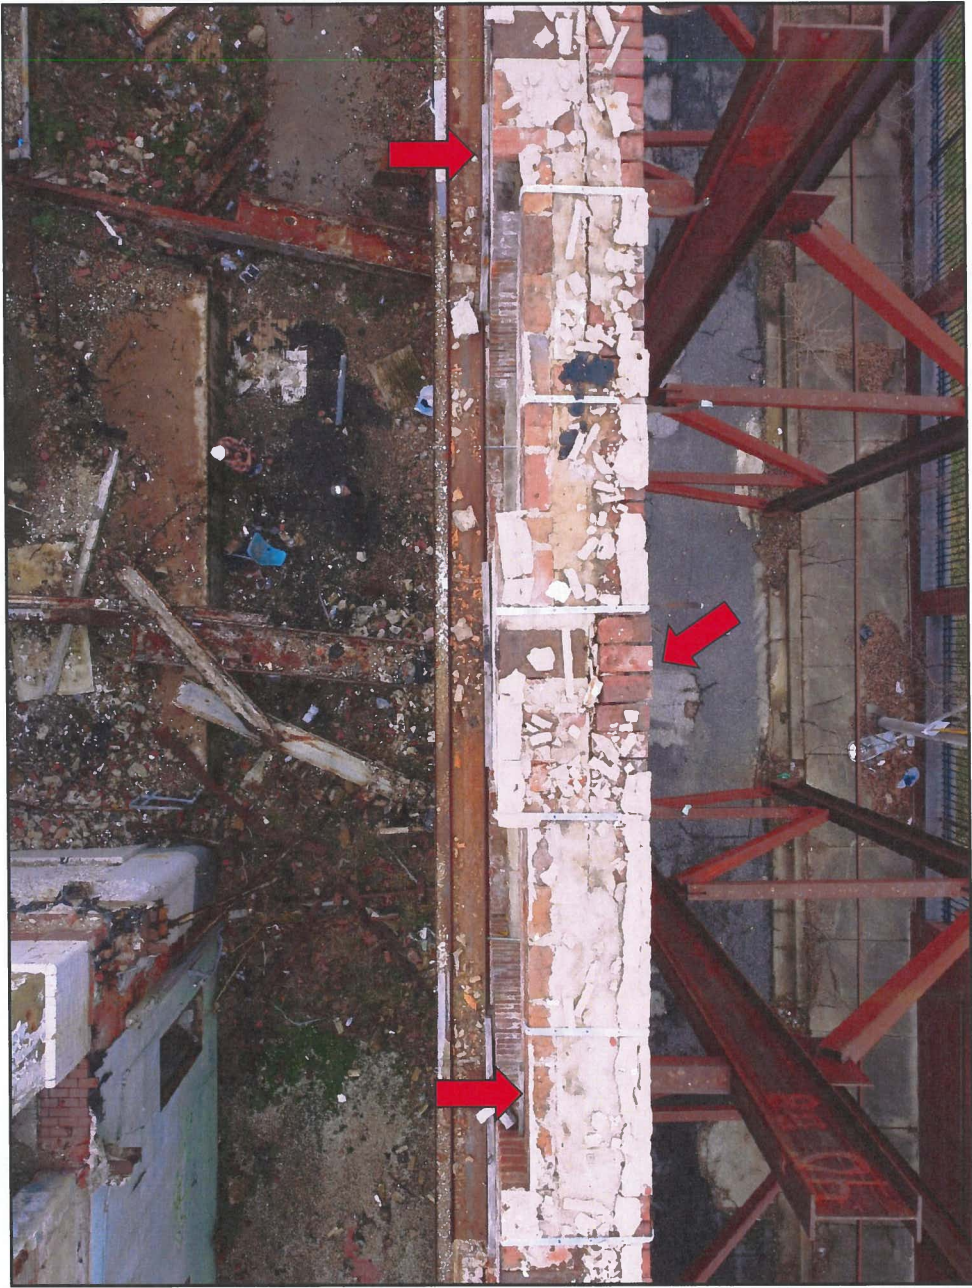
Photo 18
Hendler Building West Façade – Top Surface
Note Missing Coping and Openings in Brick

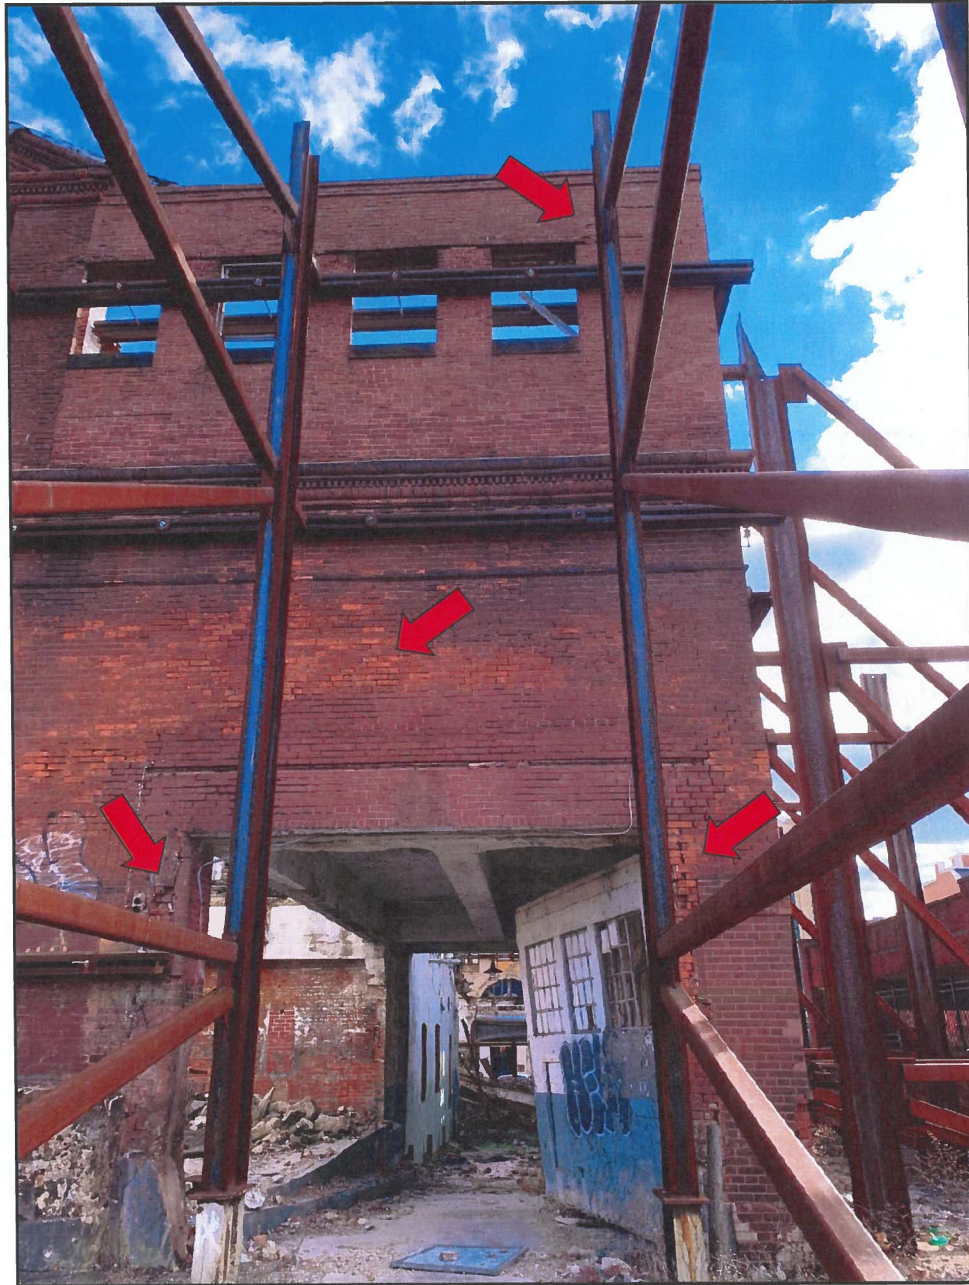
Photo 1
Hendler Building North Façade - Exterior Face
Note Deteriorated Brick and Eroded Mortar Joints
and Cracks

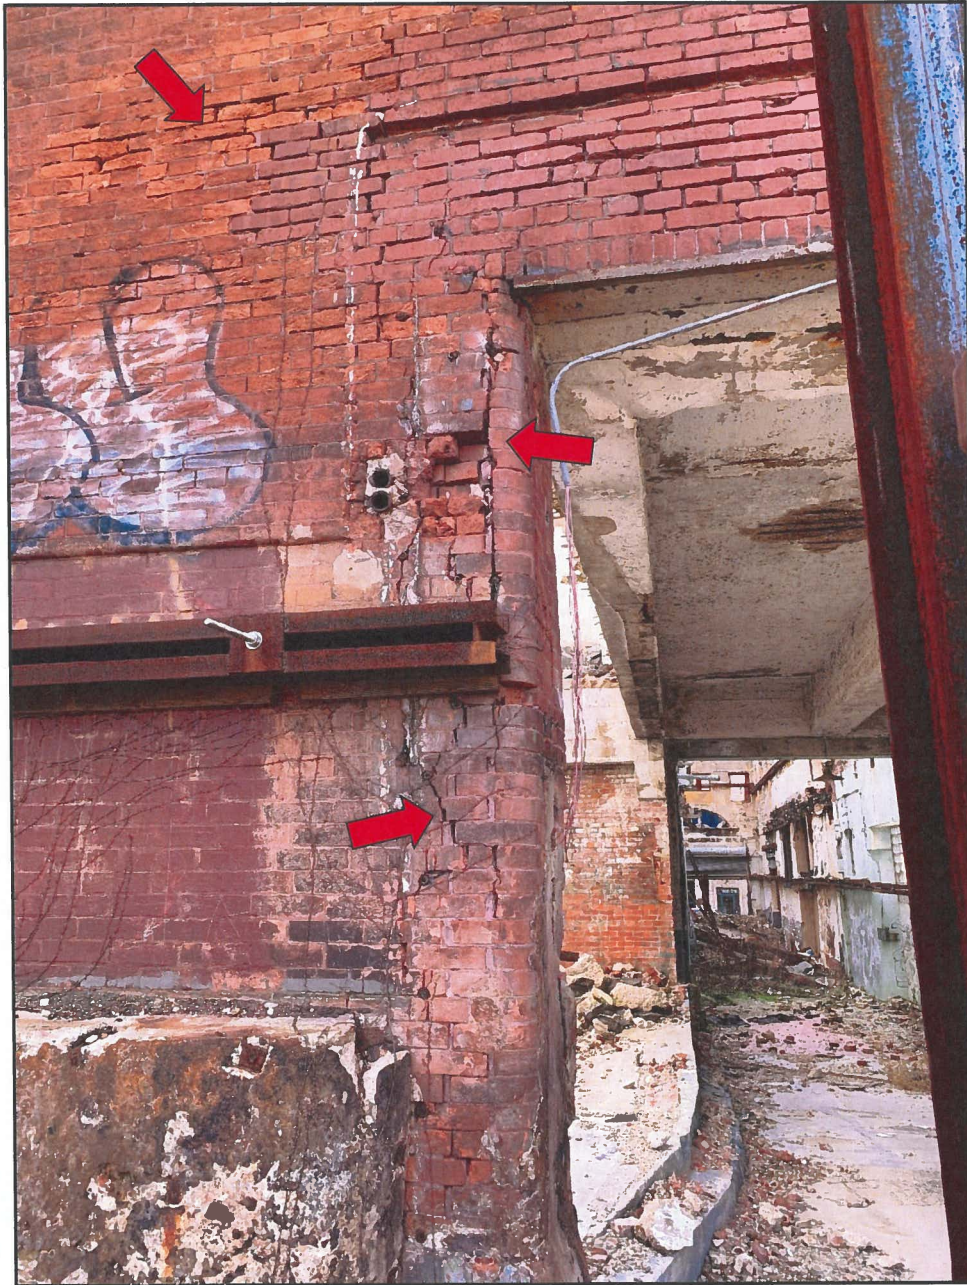
Photo 2
Hendler Building North Façade - Exterior Face
Note Deteriorated Brick and Eroded Mortar Joints
and Cracks

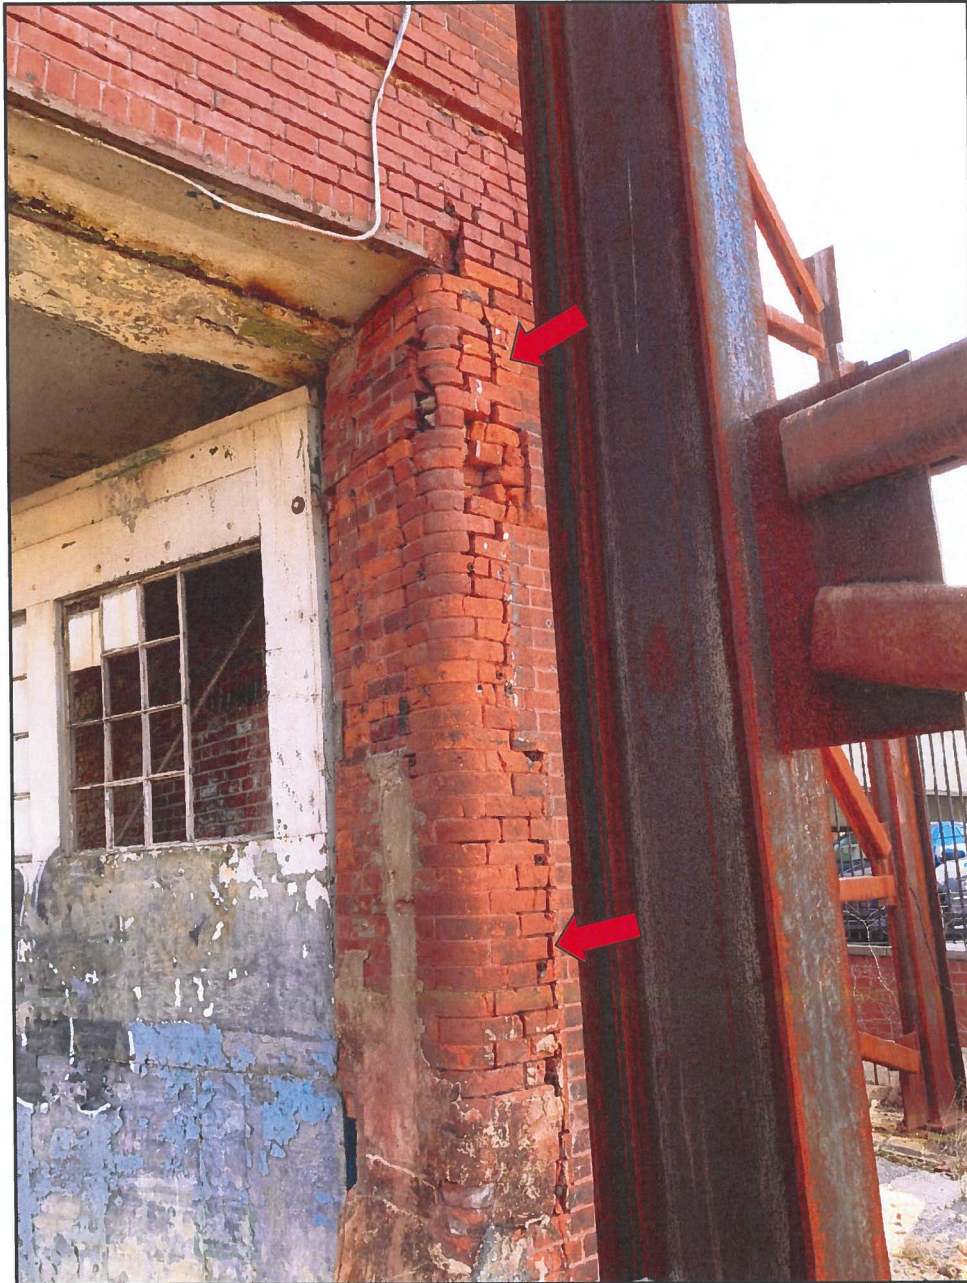
Photo 3
Hendler Building North Façade - Exterior Face
Note Deteriorated Brick and Eroded Mortar Joints
and Cracks

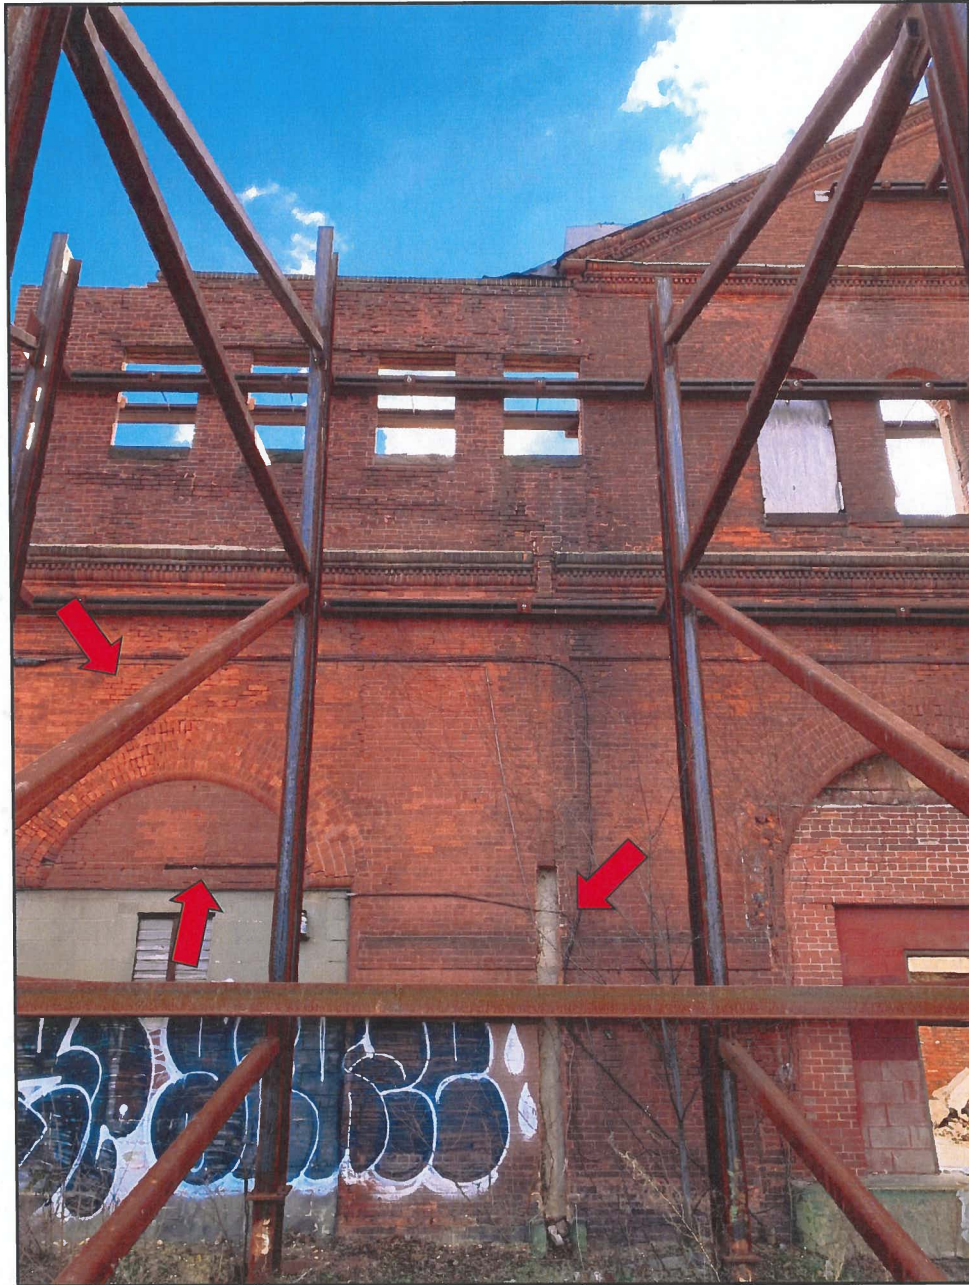
Photo 4
Hendler Building North Façade - Exterior Face
Note Deteriorated Brick and Eroded Mortar Joints,
Open Joint and Slot in Wall

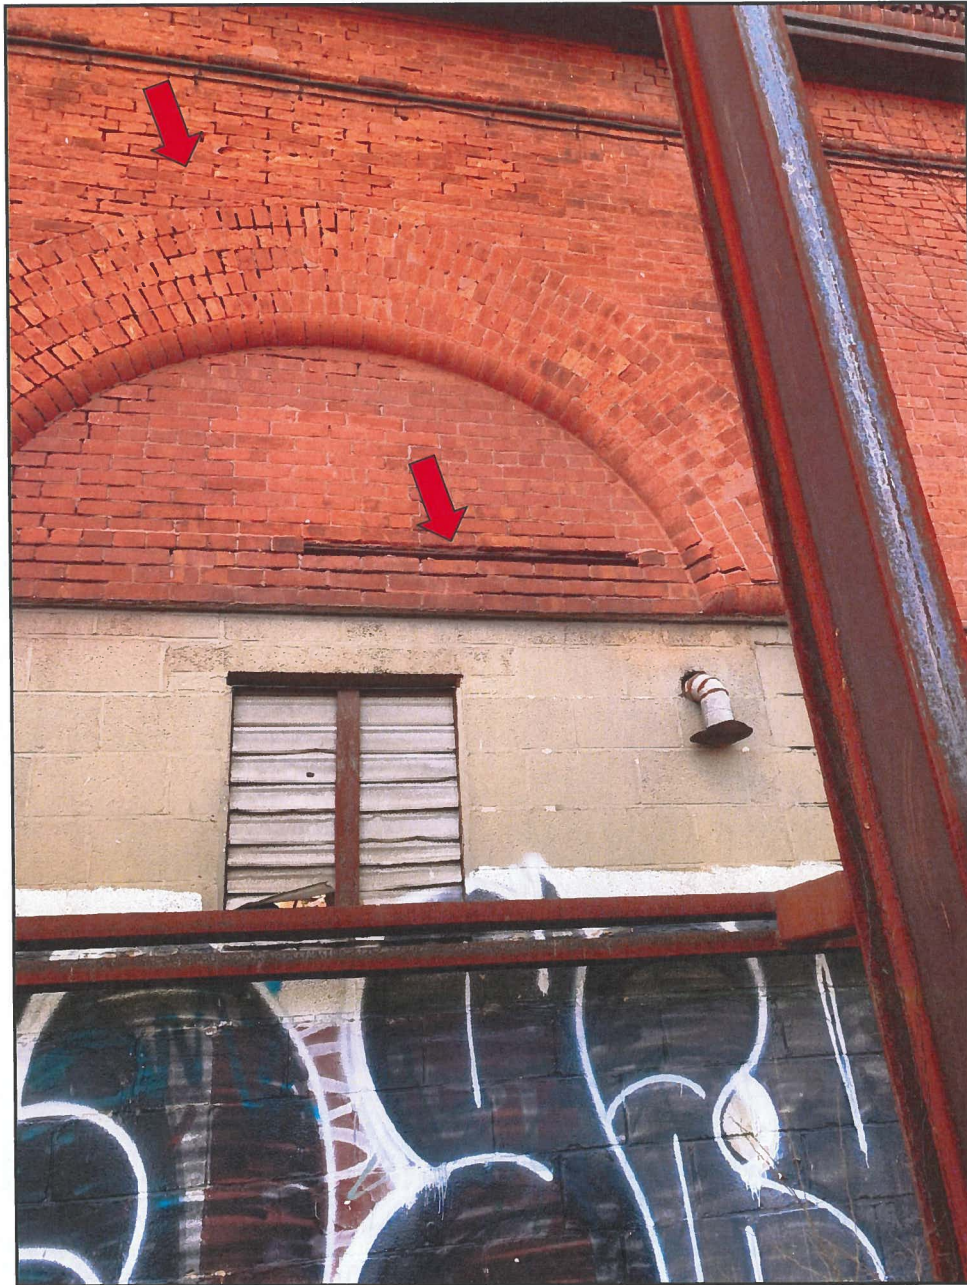
Photo 5
Hendler Building North Façade - Exterior Face
Note Deteriorated Brick and Eroded Mortar Joints,
and Deteriorated Lintel with Pack Rust
