February 3, 2023

Helping Up Mission / House of Freedom ("Client")
1029 East Baltimore Street
Baltimore, MD 21202

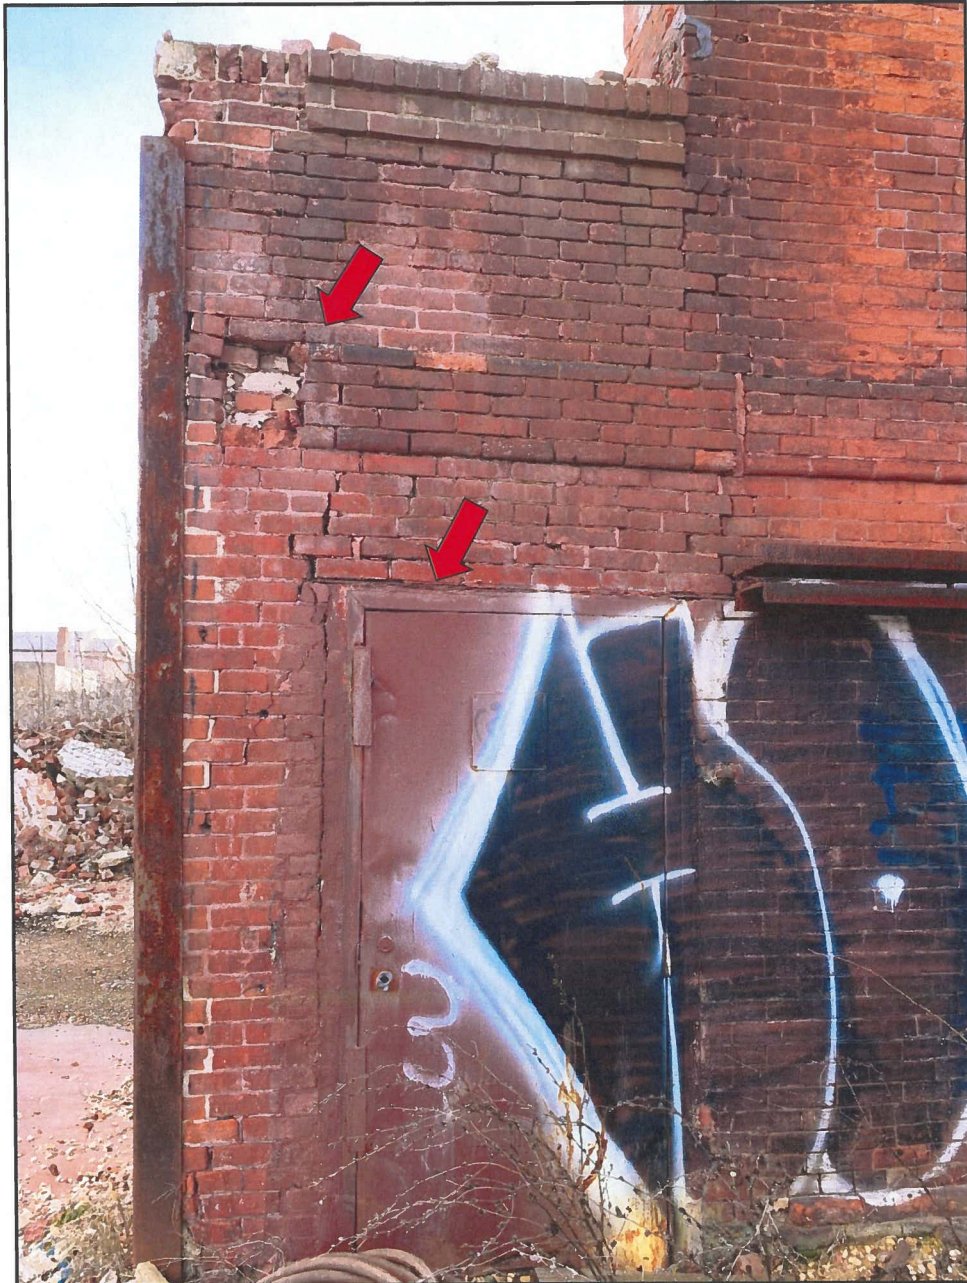
Photo 6
Hendler Building North Façade - Exterior Face
Note Deteriorated Brick and Eroded Mortar Joints,
and Deteriorated Lintel with Pack Rust

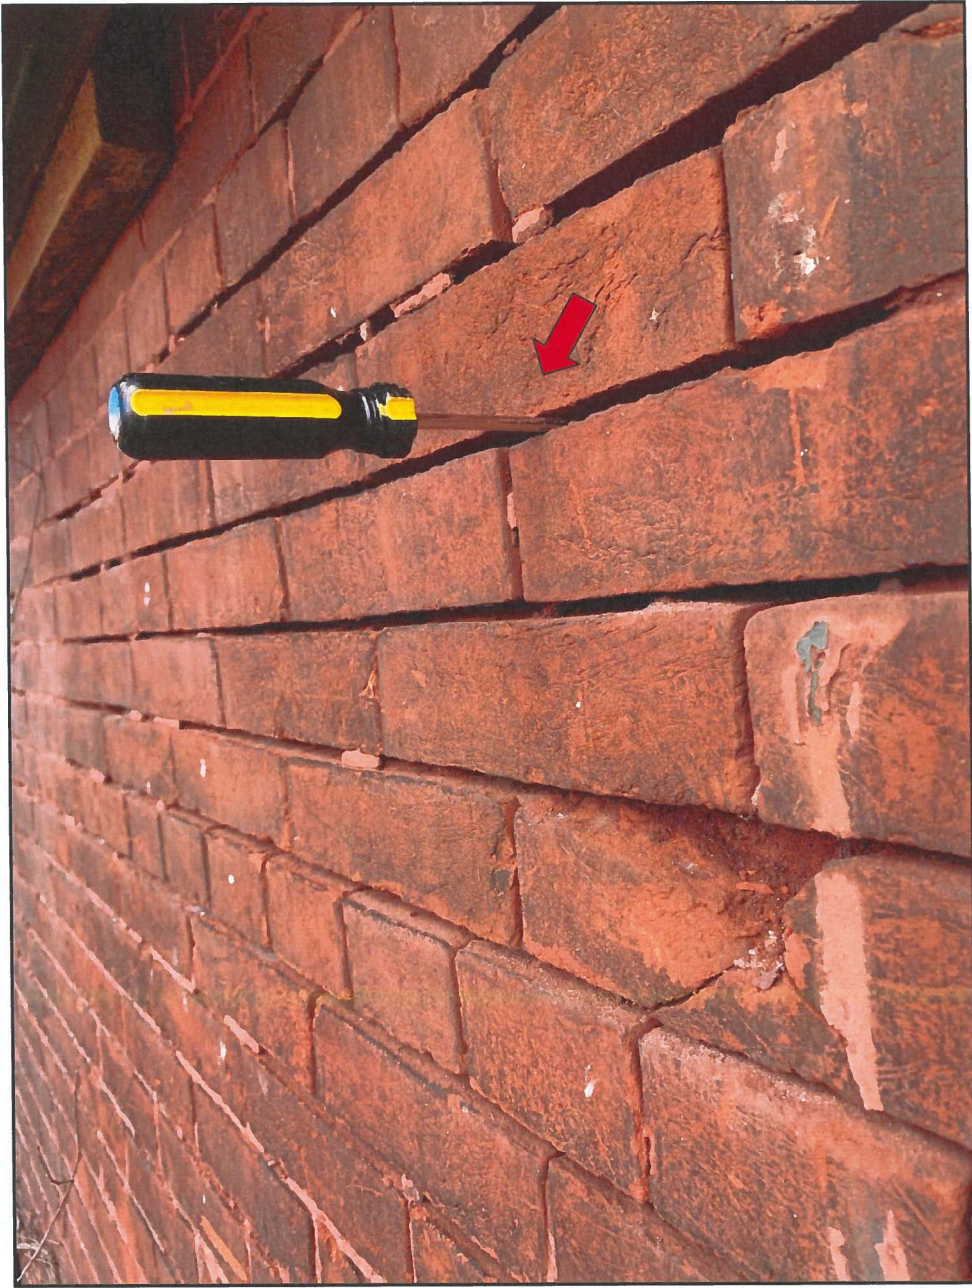
Photo 7
Hendler Building North Façade - Exterior Face
Note Deteriorated Brick and Eroded Mortar Joints,
Screwdriver Inserted to 3" Depth

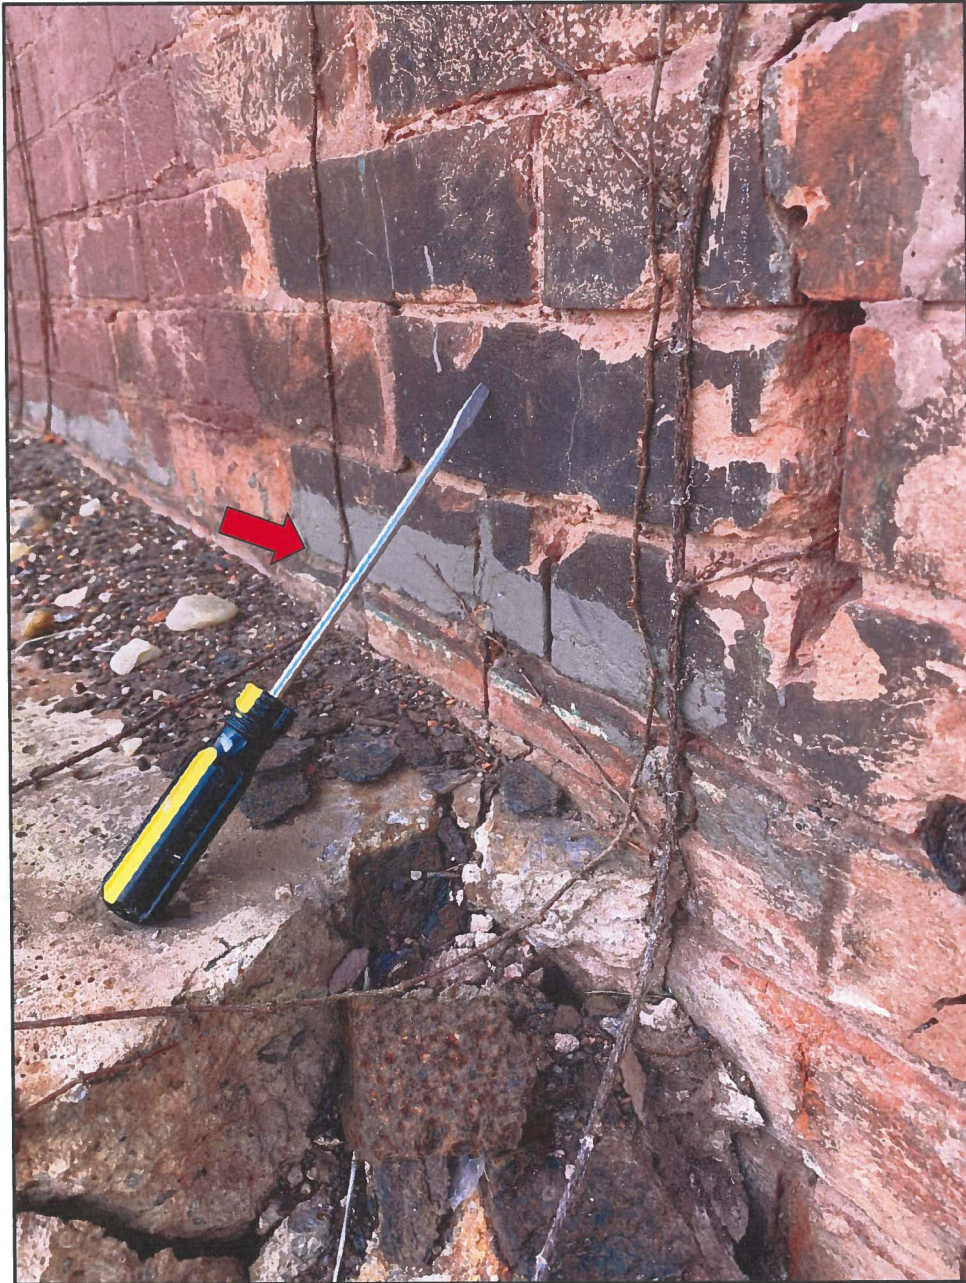
Photo 9
Hendler Building North Façade - Exterior Face
Note ¼" Diameter x 6" Long Screwdriver That
Was Used to Probe Mortar Joints

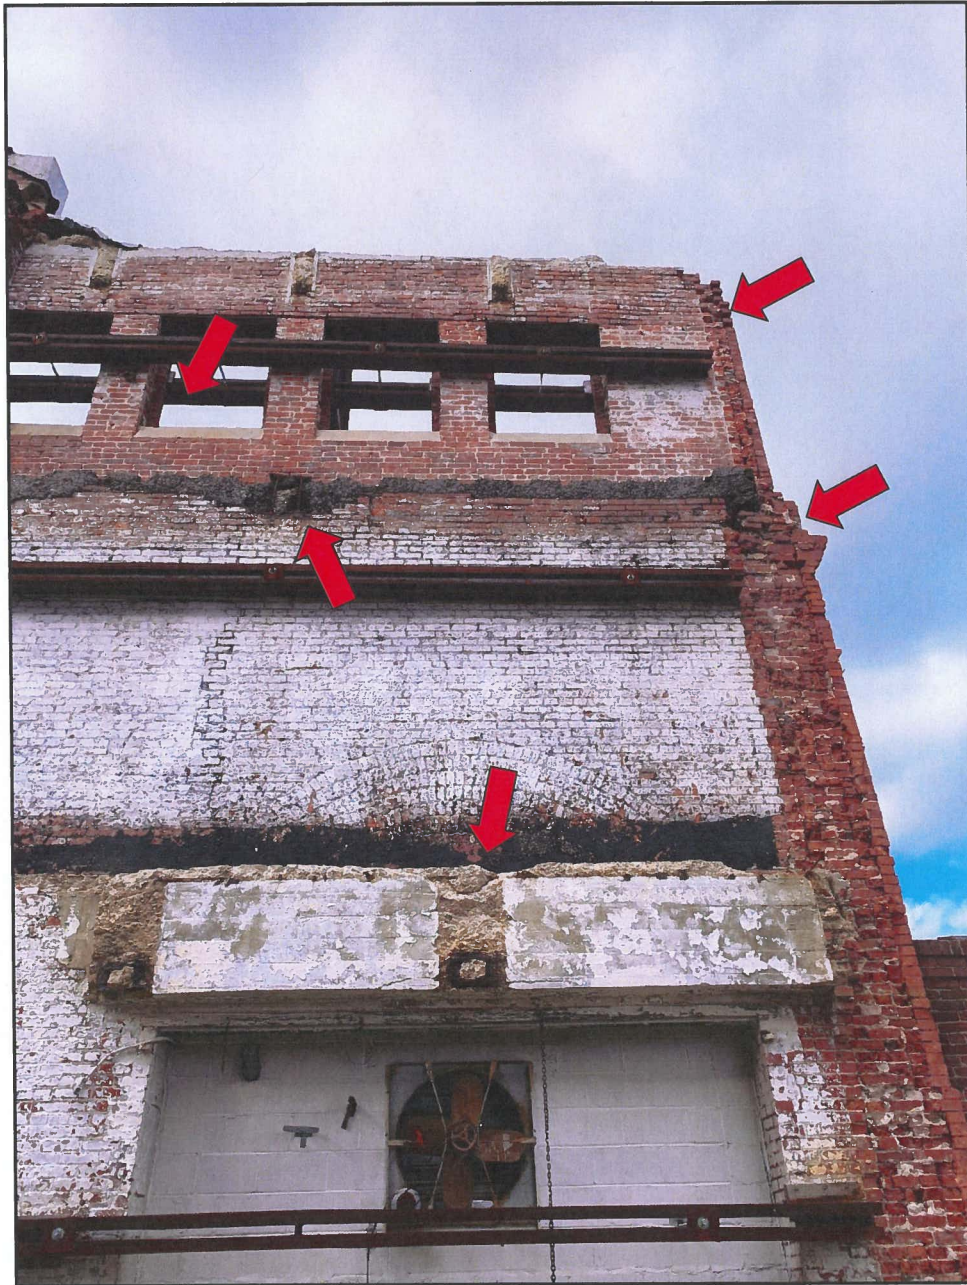
Photo 13
Hendler Building North Façade - Interior Face
Note Openings in Brick, Embedded Steel Beams, Missing
Window Frames and Embedded Concrete Floor

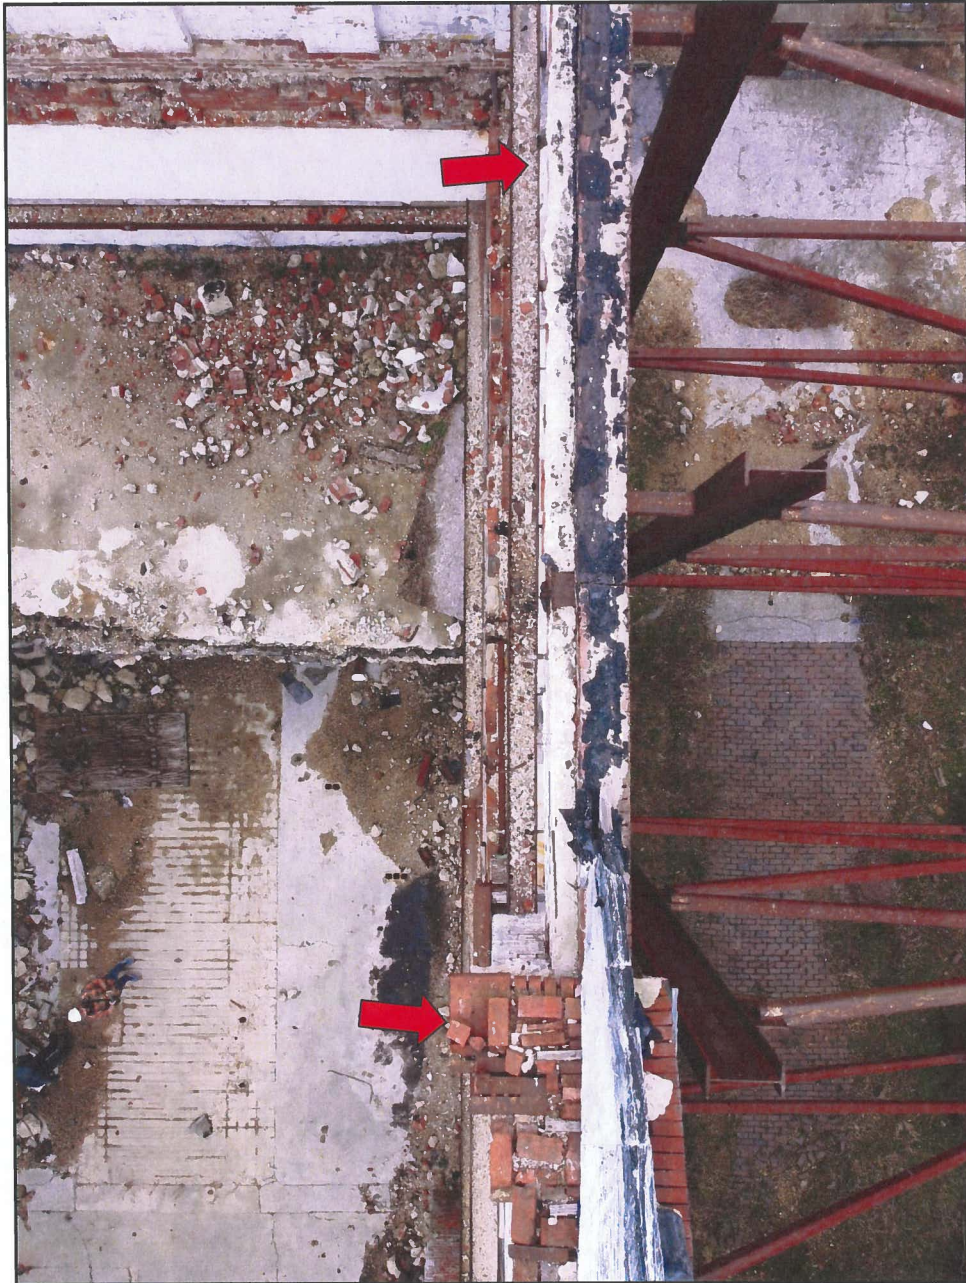
Photo 14
Hendler Building North Façade – Top Surface
Note Missing Coping and Openings in Brick

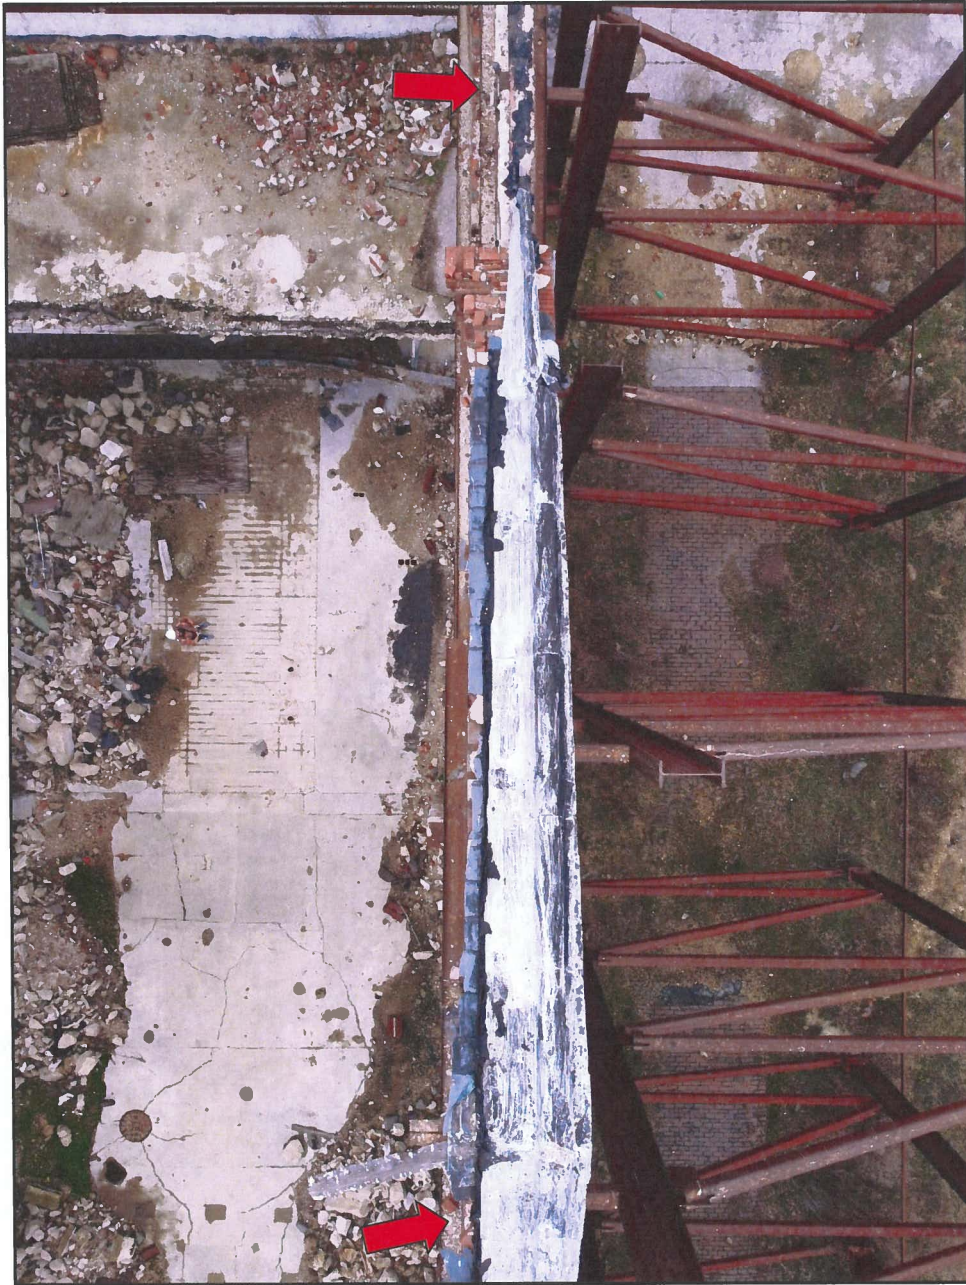
Photo 15
Hendler Building North Façade – Top Surface Above Pediment
Note Missing Coping and Openings in Brick

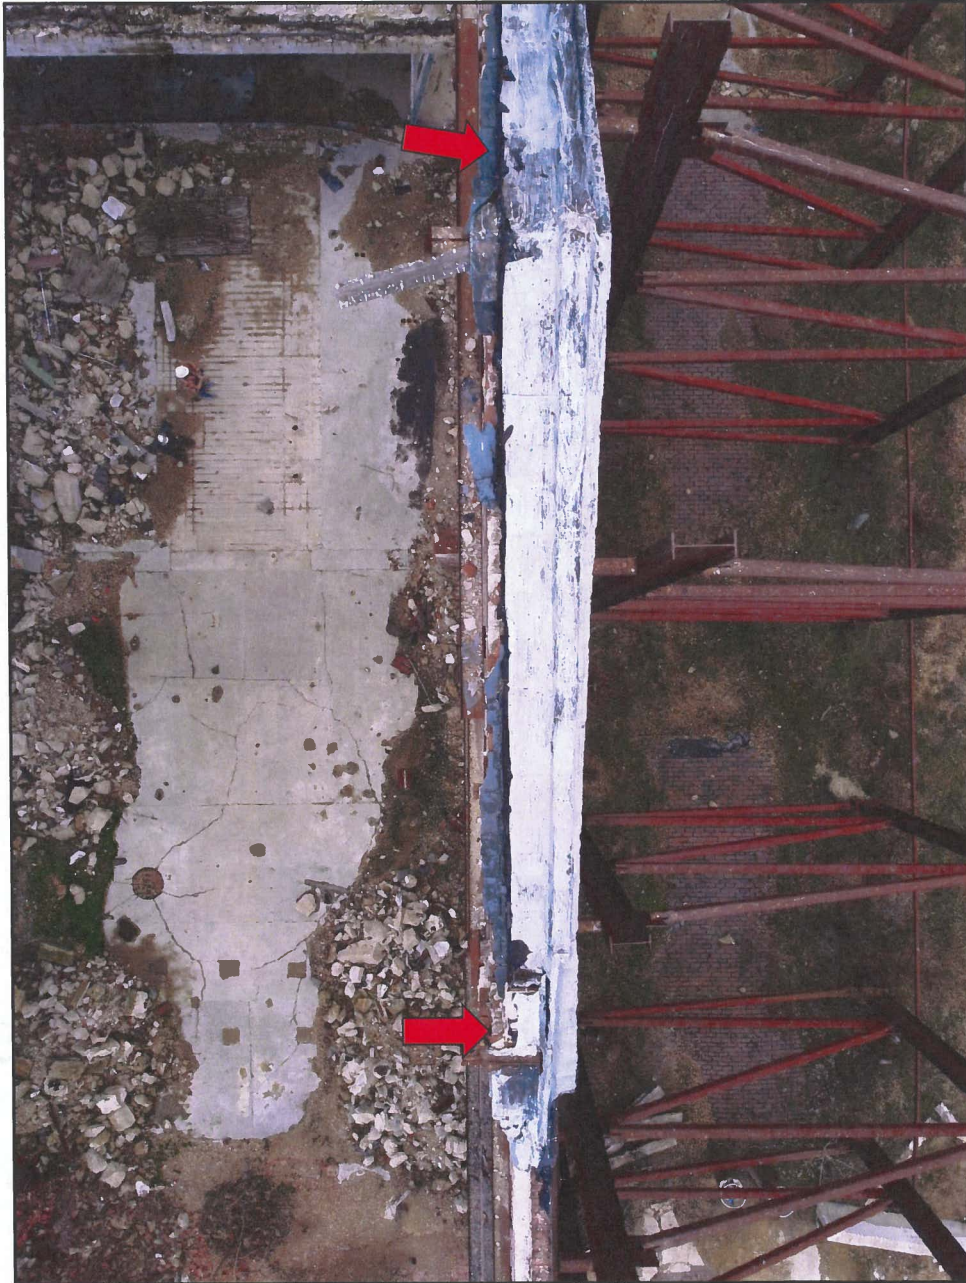
Photo 16
Hendler Building North Façade – Top Surface Above Pediment
Note Missing Coping and Openings in Brick

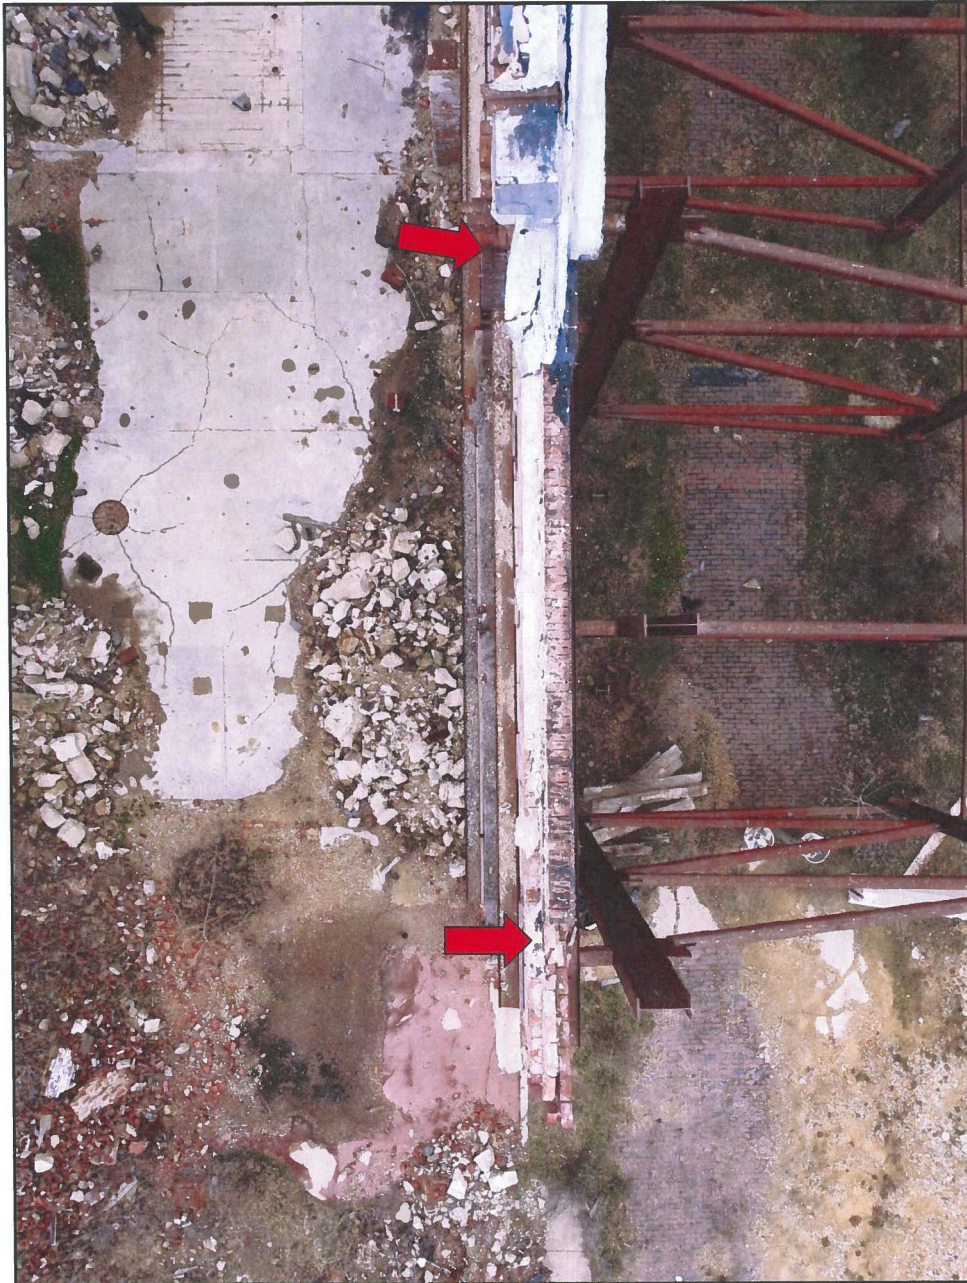
Photo 17
Hendler Building North Façade – Top Surface
Note Missing Coping and Openings in Brick
