# COMMISSION FOR HISTORICAL & ARCHITECTURAL PRESERVATION

#### STAFF REPORT

**REQUEST:** Retain vinyl windows installed at front façade without CHAP review/approval

**ADDRESS:** 105 Warren Avenue (Federal Hill Historic District)

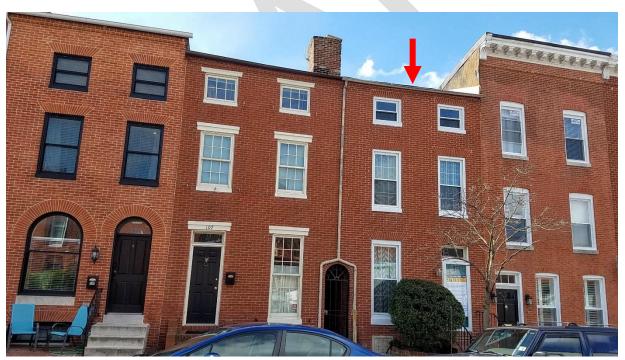
<u>Site Conditions</u>: The existing property is a masonry two-story-with-attic house, one of a row of four to the west of Jesus Our Redeemer Church (*Images 3 & 4*). The windows and the door opening with transom have jack arches. The house shares a sallyport on the east side with the neighboring house. Two or three rows of brick line the edge for the roof which has a half-round metal gutter with round downspout shared with 107 Warren Avenue. The windows are vinyl with grilles between glass.

Image 4: 105 Warren Avenue (arrow), April 2, 2021

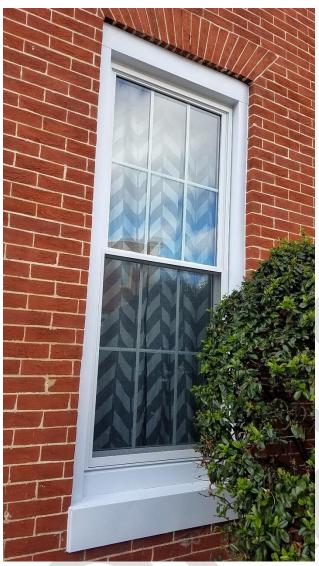
This application is a request to retain the new vinyl windows installed without CHAP review or approval. (*Image 8*).

The previously installed vinyl windows would not be considered by CHAP staff to be contributing to the historic character of the building, and so the replacement of the vinyl windows is permissible. Nevertheless, the replacements would need to match the detailing and overall appearance of the historic windows which this house contained at one time. The original material would have been wood. Acknowledging that alternative materials may be considered for windows, the Commission allows aluminum clad wood windows, because they can replicate the sash, frames and muntins of a historic window. In another acknowledgement of modern applications, the guidelines permit simulated divided lights by which the exterior muntin is integrated into the window sash and a spacer bar between the two layers of glass provided the appearance of a divided light. The guidelines do not permit grilles between glass.

The applicant purchased the house in 2014. The façade contained vinyl windows. Google street view shows that that house had vinyl windows for at least a dozen years. Federal Hill became a local historic district in December of 2017. The designation capped many years of effort by the Federal Hill Neighborhood Association and CHAP. The process included outreach to the residents and property owners by mail, neighborhood newsletters and email. With this designation came the requirement that any work affecting the exterior of a property in the district must be reviewed and approved by CHAP. The owner did not apply to CHAP because she says she did not know that her property was in a CHAP district. Had she applied, CHAP staff would have informed her that CHAP guidelines call for replacement windows at the façade to replicate historic windows, and that this can be achieved with wood windows or aluminum clad wood windows. Vinyl windows do not replicate historic windows.

Image 8: 105 Warren Avenue – Detail, newly installed vinyl window, April 2, 2021

Disapproval with applicant to work with CHAP staff to develop a schedule of replacement of the windows with approvable windows within a reasonable timeline agreed upon with the owner.
