**COMMISSION FOR
HISTORICAL & ARCHITECTURAL
PRESERVATION**

STAFF REPORT

REQUEST: Consent Agenda – Remove unapproved work; reconstruct original third floor; add deck to roof of reconstructed two-story addition

ADDRESS: 119 S. Gilmore Street (Union Square Historic District)

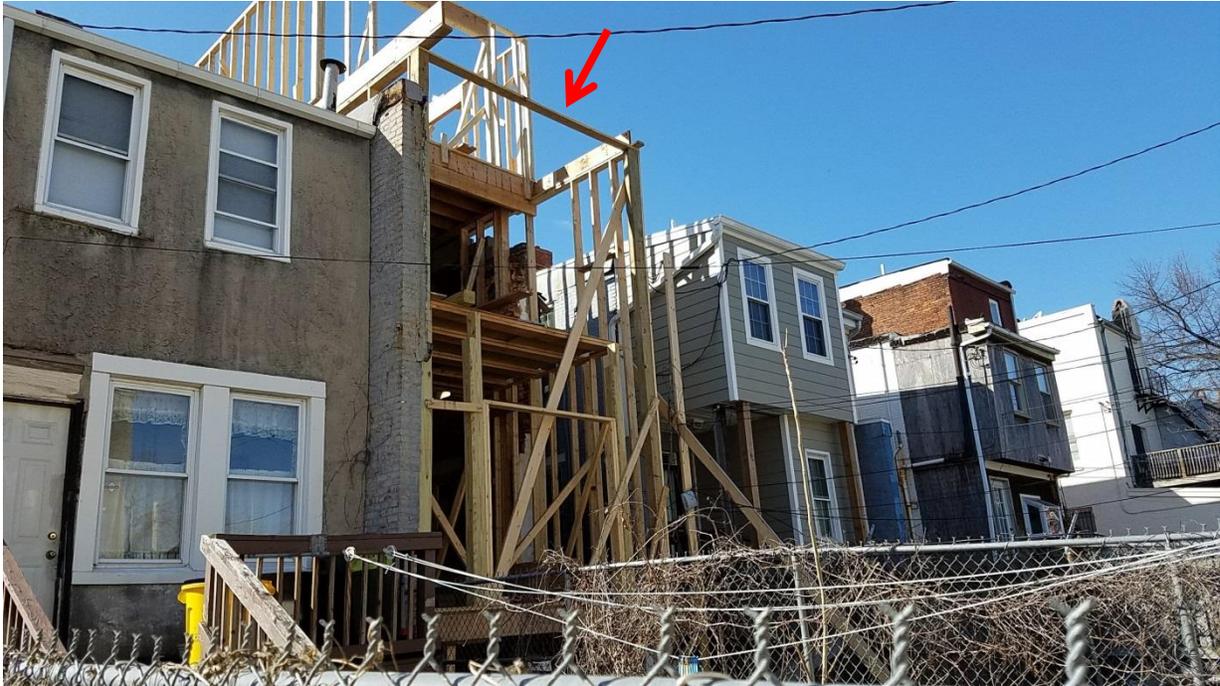
Today, the site shows that substantial construction was started at the rear without CHAP review and approval (*Images 5 & 6*). Before this construction began, the rear elevation included a small deck at the second floor, and a large deck at the first floor. The building has been in a deteriorated condition. State real estate records (SDAT) show that the owner purchased the property in August 2017.

Image 5: Rear of 119 S. Gilmor Street, unapproved work, February 28, 2018

Applicant proposes to remove unapproved work, reduce the third floor to the original length, and construct a deck on the roof of the rear two-story section.

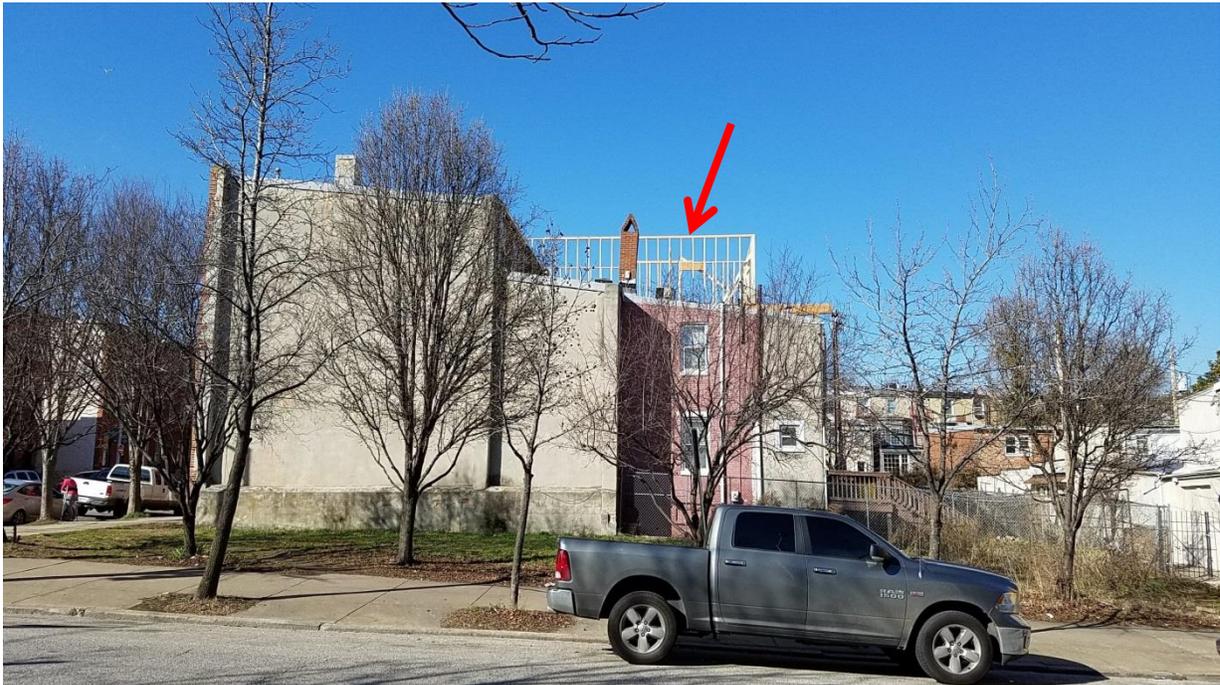
Image 6: 119 S. Gilmor Street from W. Pratt Street, unapproved work, February 28, 2018

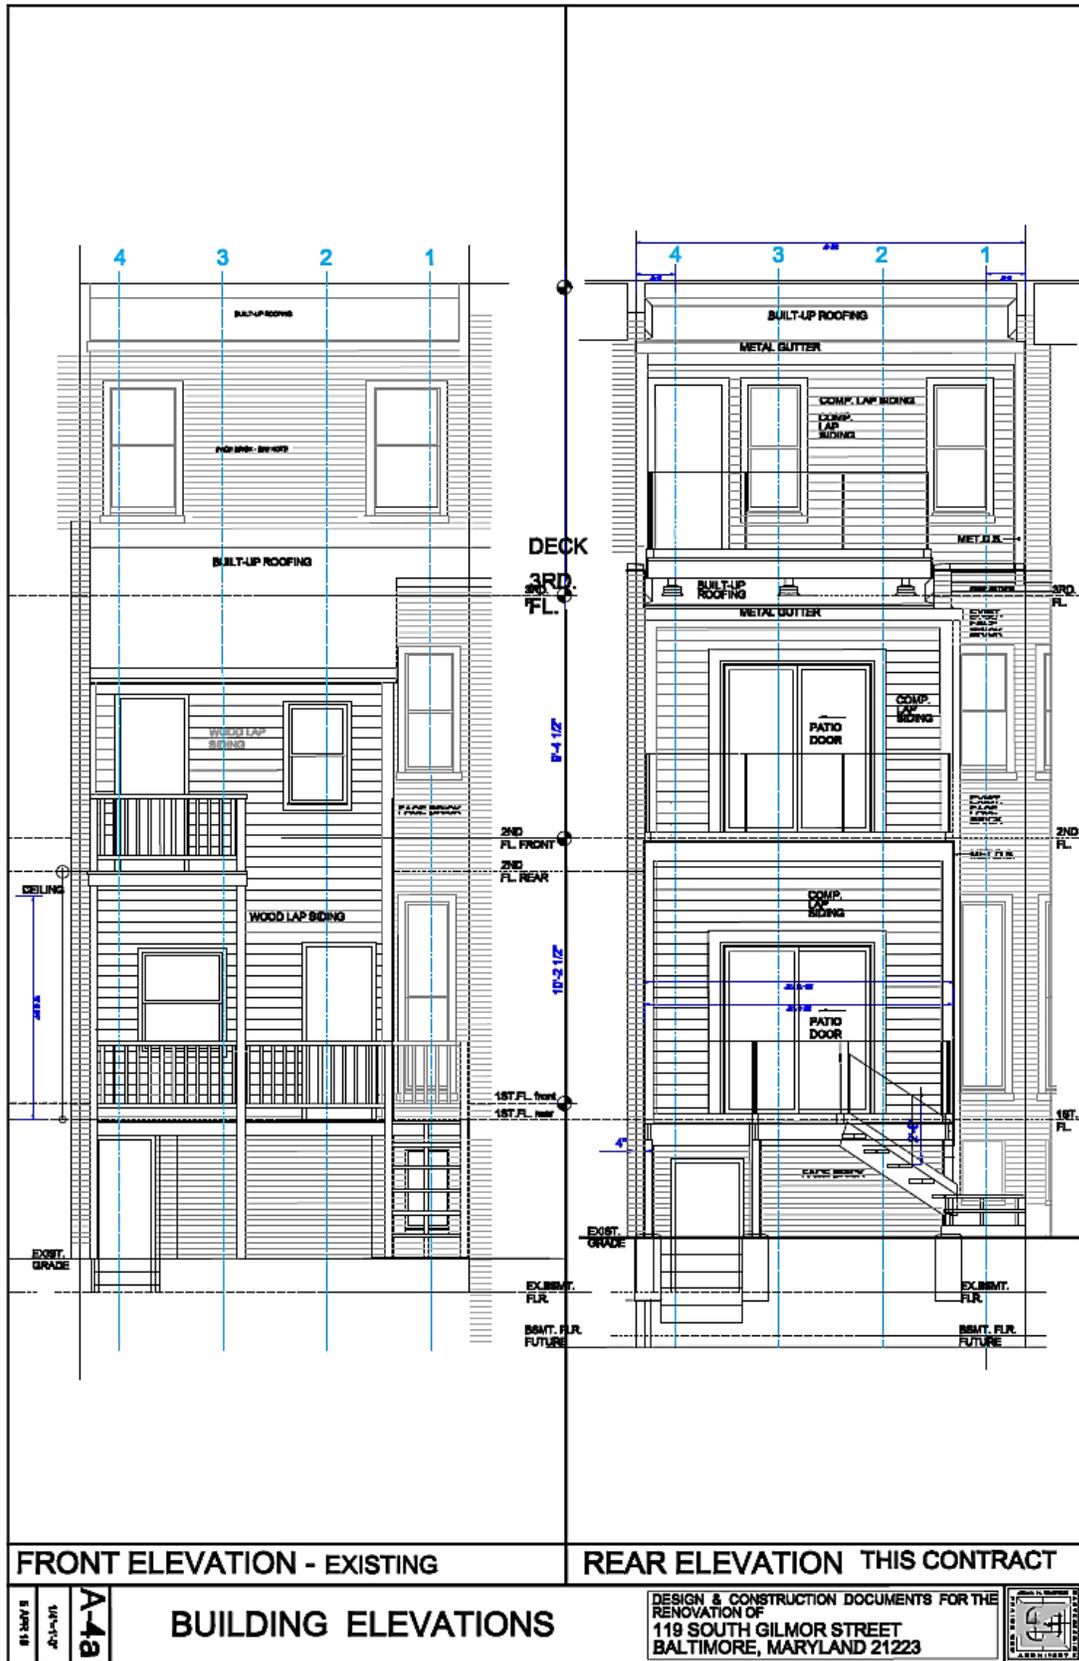
- *Guideline 2.5.1. Doors and Windows:* The windows and door at the proposed rear elevation are different from that of the previous elevation. In addition sliding glass doors are introduced at the first and second floors, where French doors would be more appropriate. Because this is the rear elevation, the design guidelines are partially met.

Image 9: Previous and proposed rear elevation, 119 S. Gilmor Street, April 5, 2018

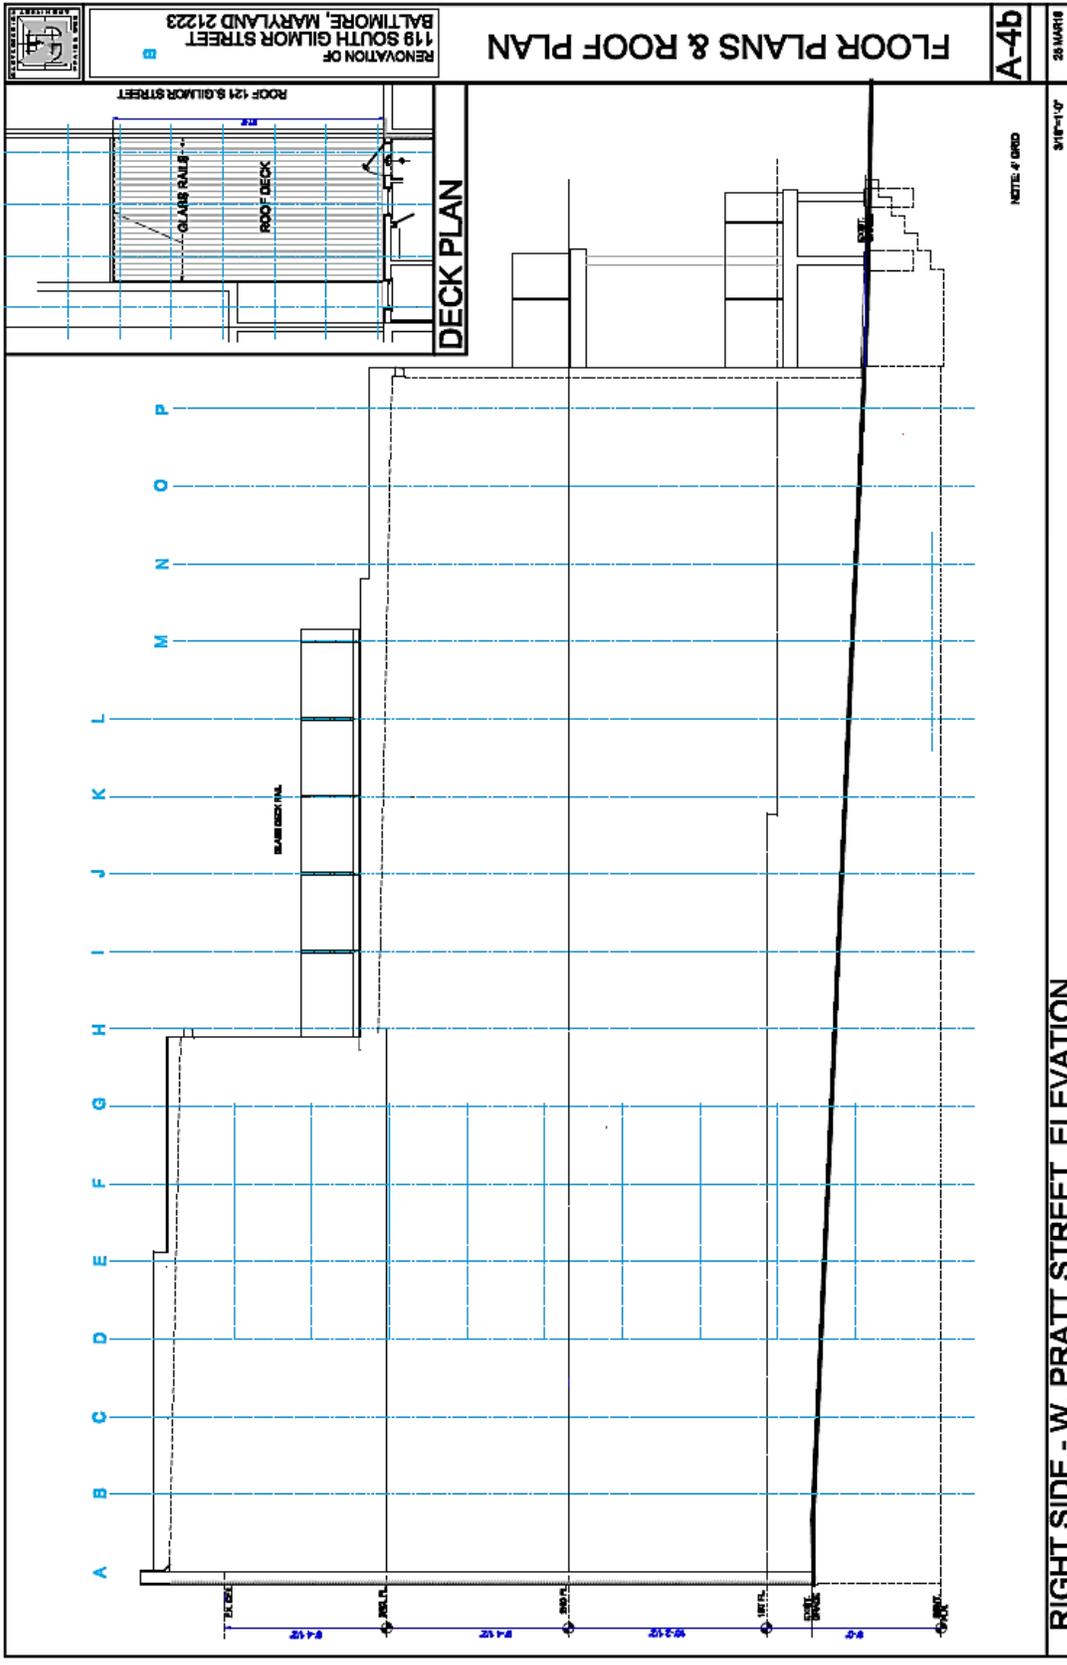
- *Guideline 1.8.10 Roof Decks:* The deck will not be visible from the front elevation. The roof deck atop the second floor will extend about 20 feet and be set back about 14 feet from the rear of the two-story building. It will be enclosed by a glass rail, making it only slightly visible, so it substantially meets the design guideline.

Image 10: W. Pratt Street (south) elevation and rooftop deck plan, 119 S. Gilmore Street, March 25, 2018

Staff recommends approval of the plan with rooftop deck details to be approved by staff.
