**COMMISSION FOR  
HISTORICAL & ARCHITECTURAL  
PRESERVATION**

**STAFF REPORT**

**REQUEST:** Economic Hardship to allow for installation of vinyl windows

**ADDRESS:** 1419 Eutaw Place (Bolton Hill Historic District)

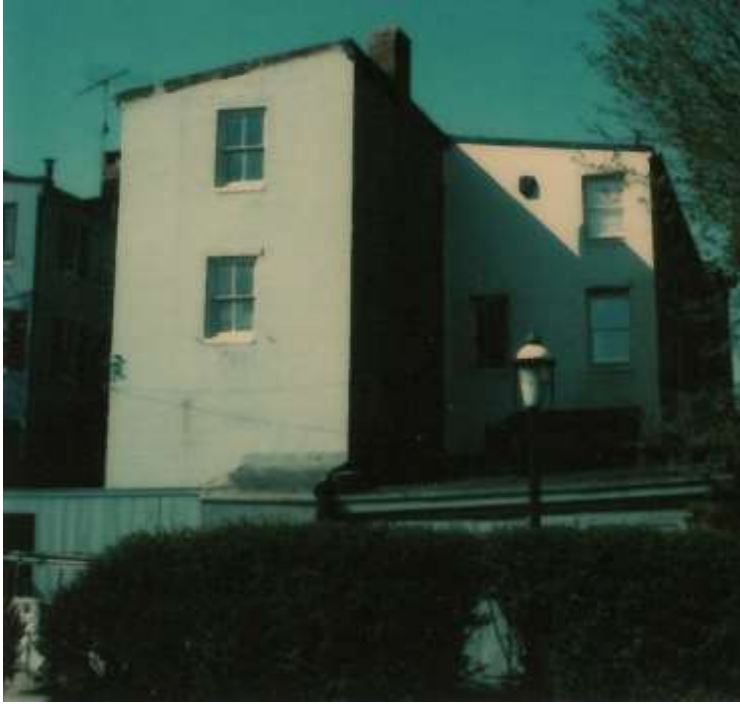
*Image 5:* Polaroid of rear elevation, undated. Note the 2/2 windows on the rear elevation, as well as the wooden wall and small rear addition. (All of which were removed without CHAP review at some point in the last 50 years)

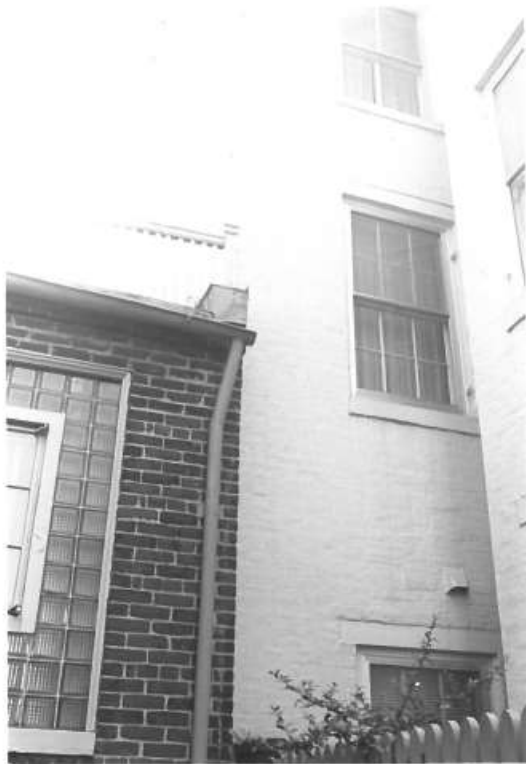
*Image 6:* Photograph of rear windows from 1980, demonstrating a mix of wood windows from several eras, including a 2/2 and 1/1 window, indicative of the late 19<sup>th</sup> and early 20<sup>th</sup> centuries. The 6/6 windows are likely early 20<sup>th</sup> century replacements. On the far right windows, note the lambs tongue lugs on the meeting rail, indicative of a late 19<sup>th</sup>/early 20<sup>th</sup> century window.

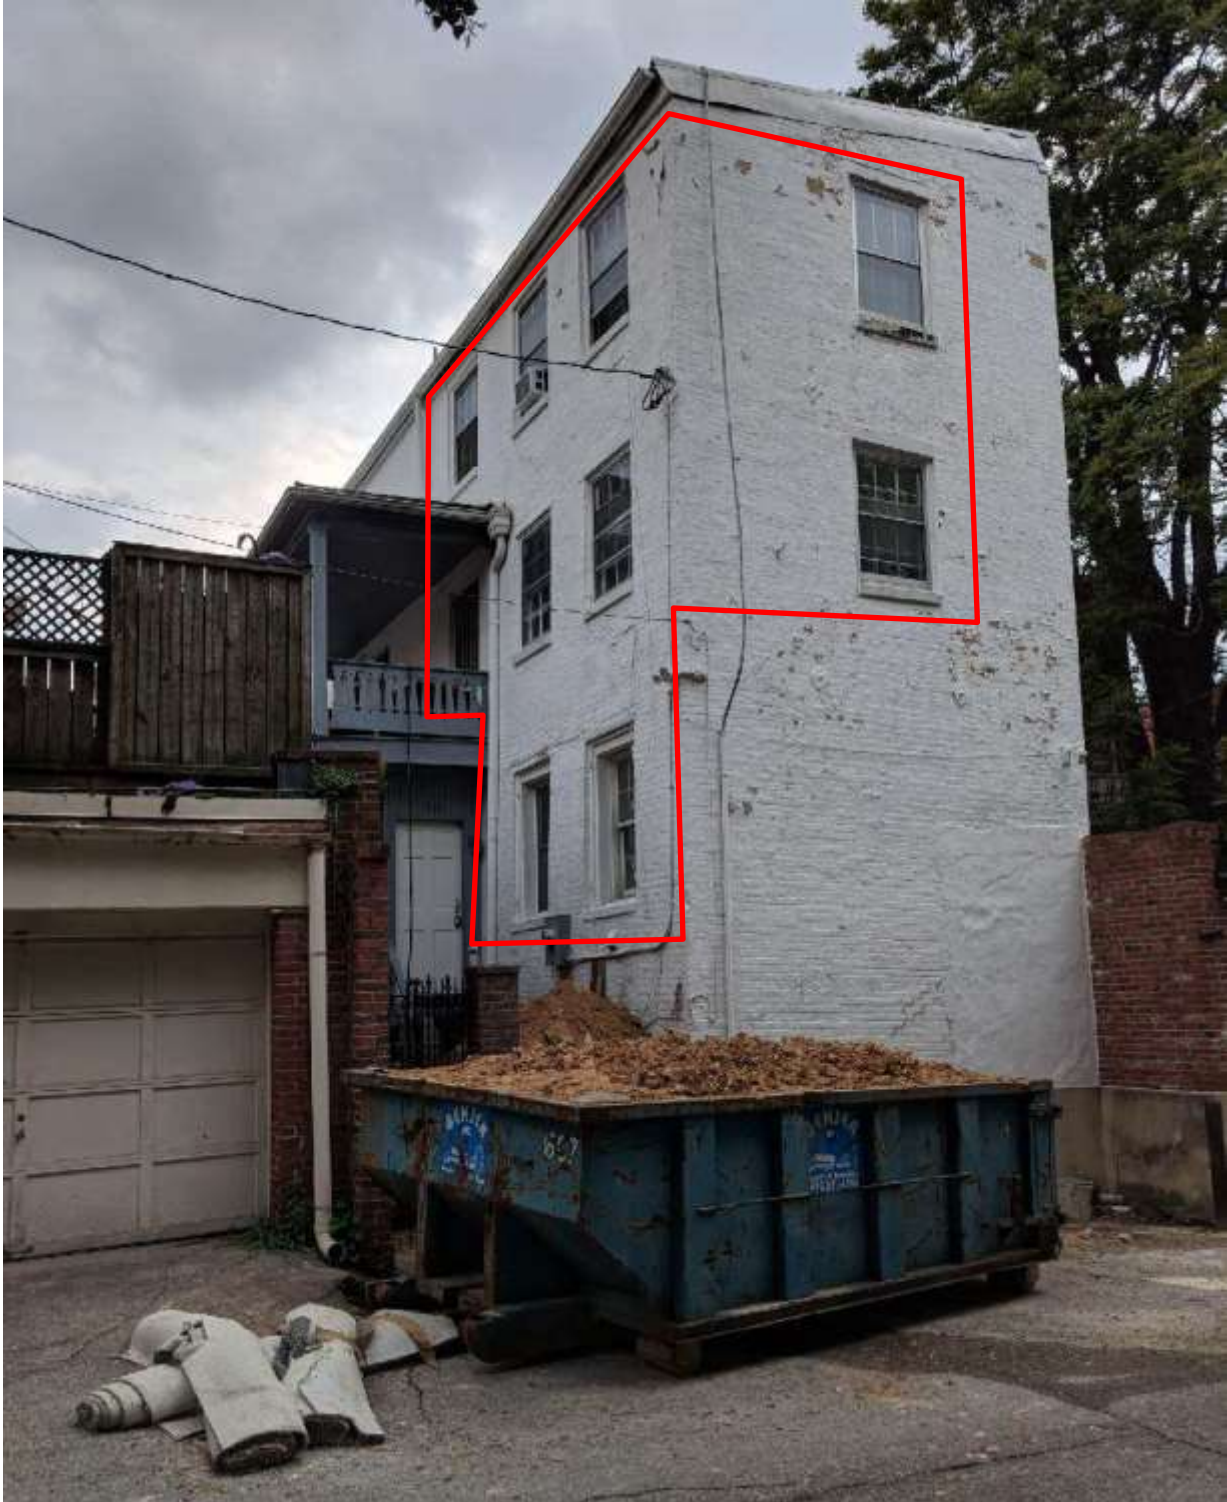
CHAP staff finds that the proposed vinyl window product, capping of wood sills, and capping of the original wood window framing does not comply with CHAP guidelines. If amenable to the Commission, staff suggests that only the ten windows that are highly visible from Jordan Street (as illustrated in *Image 8*) should be replaced with windows that fully meet CHAP guidelines. Staff further recommends that the remaining windows located on the side and rear

*Image 8:* Rear elevation from Jordan Street, highlighting the ten windows that are highly visible from this public right-of-way. All of these windows have been replaced sometime in the past 30 years without CHAP approval or building permits.

- **Replacement of the ten windows on Jordan Street with 1/1 windows that fully meet CHAP guidelines.**
- **Replacement of the remaining windows on the side and rear elevations (including the dining room casement windows) with 1/1 replacement windows that more closely meet the typical framing and detail of the historic windows and which do not require vinyl or aluminum wrapping.**

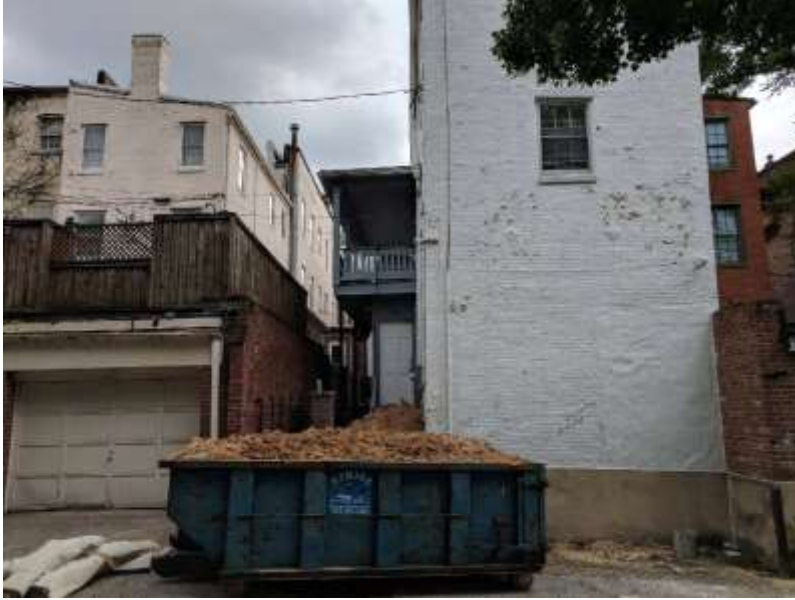
*Image 9:* Rear elevation from Jordan Street, highlighting the 10 windows that are highly visible from this public right of way.

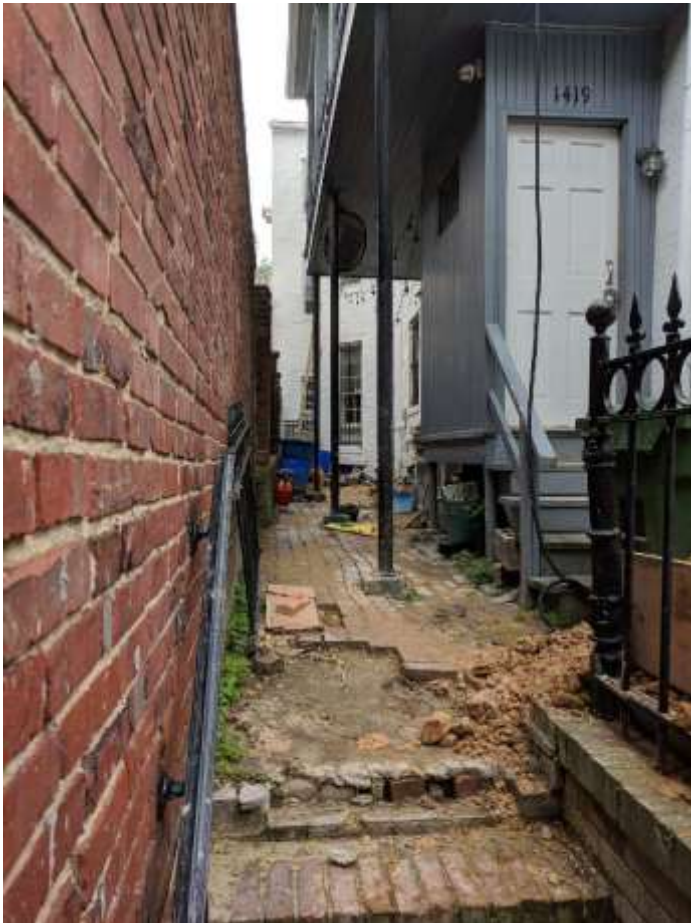
*Image 10:* The remaining 15 windows located on the rear and side elevation are not highly visible from Jordan Street. This view is from the back gate of the property. The windows at the rear are the same as in Image 6.

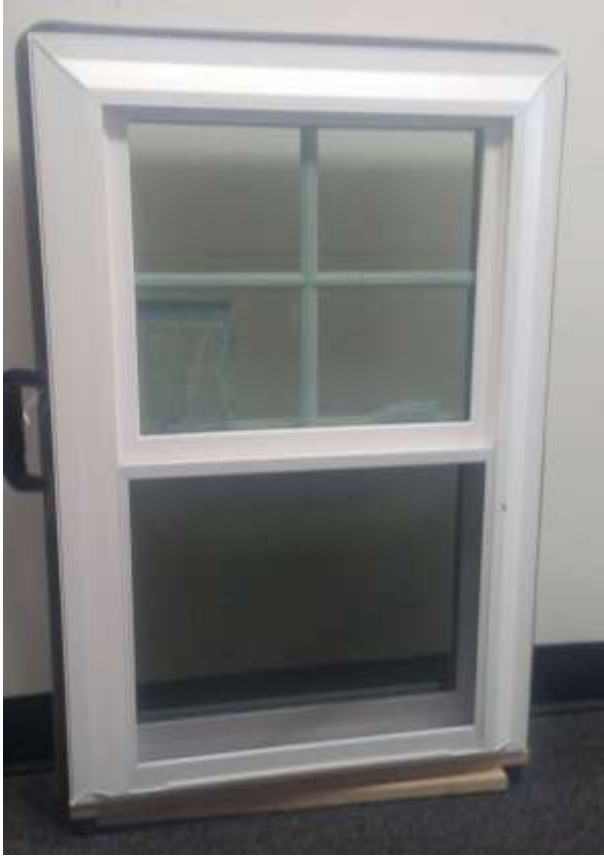
- Staff finds that the proposed window product does not replicate the historic wood windows in texture, detail or appearance. The proposed pocket frame vinyl windows do not adequately replicate the finish,

exterior profiles, or overall finish of the existing historic windows. Because this product requires the installation of a whole new frame within the existing historic window frame, the new pocket window frame is very thick and the dimensions of the window rails are incredibly thin to compensate. Thus, the proportions are very different even though the daylight opening dimensions are close. Additionally, the details of the proposed vinyl product (sheen, visible seams in the plastic, angled projecting frame profile) do not properly replicate the details of the historic windows.

*Image 12:* Sample of proposed vinyl window product. Note that the windows will not have grills between the glass.
