**COMMISSION FOR
HISTORICAL & ARCHITECTURAL
PRESERVATION**

STAFF REPORT

REQUEST: Renovation of the Hollins Market shed building

ADDRESS: 26 S. Arlington Avenue (Union Square Historic District)

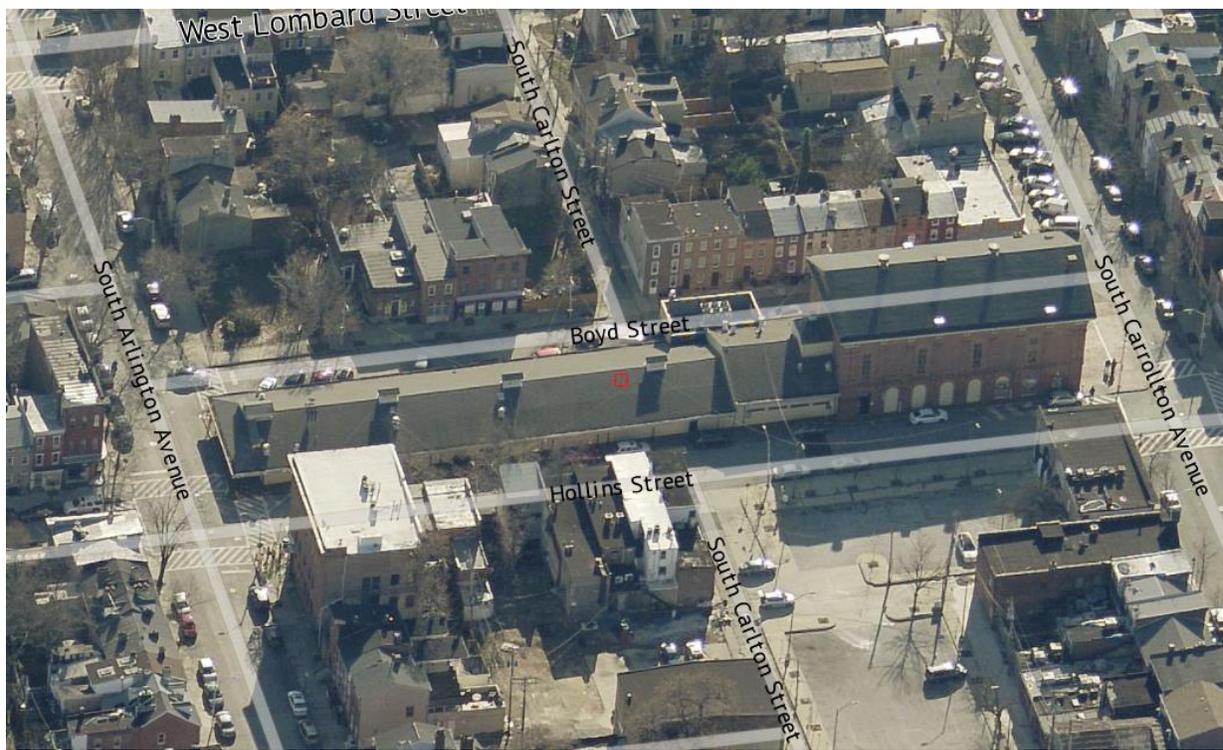
Image 2: Aerial view of Hollins Market from north, December 19, 2016

The existing property is a one-story wood clad market shed building most recently rehabilitated in the early 1980s. It is connected to the city's oldest surviving market building, which was constructed in 1864 (*Images 2 & 3*). The shed building, with a broad shallow sloped roof with overhangs over the sidewalks on three sides, is nearly 250 feet long. The roof has four monitors along the ridge and a sign built into the slightly raised gable at the S. Arlington Avenue (eastern) end. A 40-foot section of the roof at the western-most end of the shed where it touches the historic market building is raised a few feet and contains a wooden structure on top abutting the historic building. There are three doors into the shed building on the north and the south elevations, along with double doors on the east elevation. A series of raised window bands punctuate the north elevation, with a few on the south elevation as well.

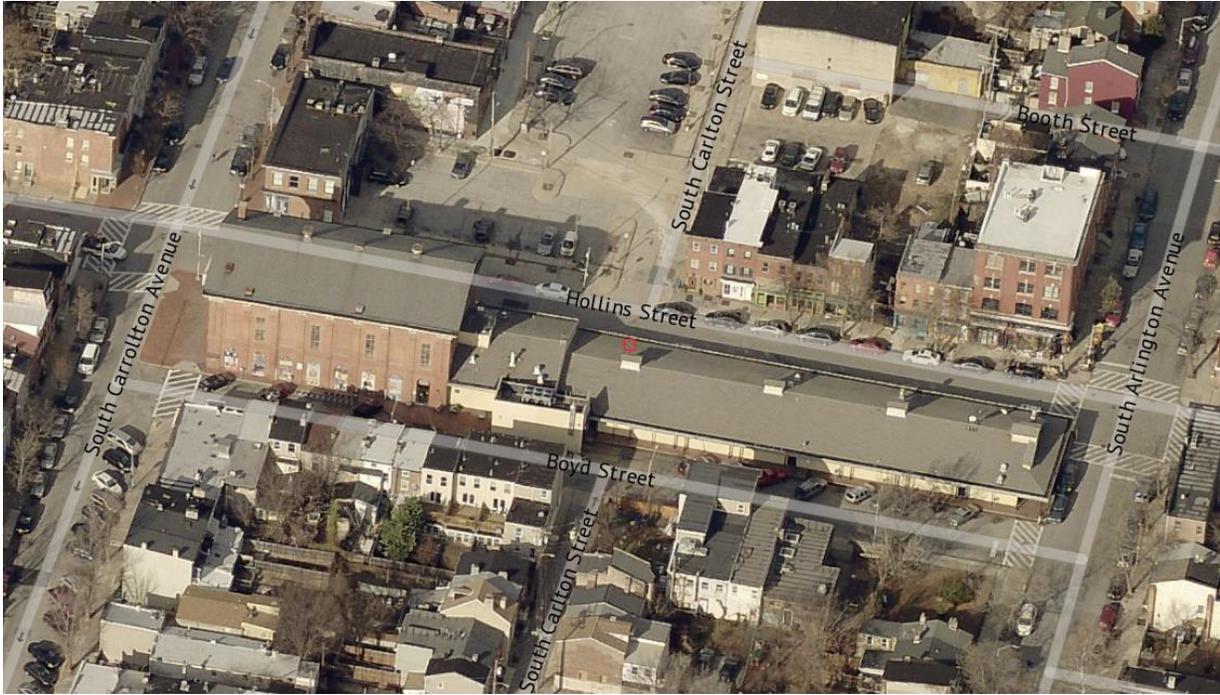
Image 3: Aerial view of Hollins Market from south, December 31, 2016

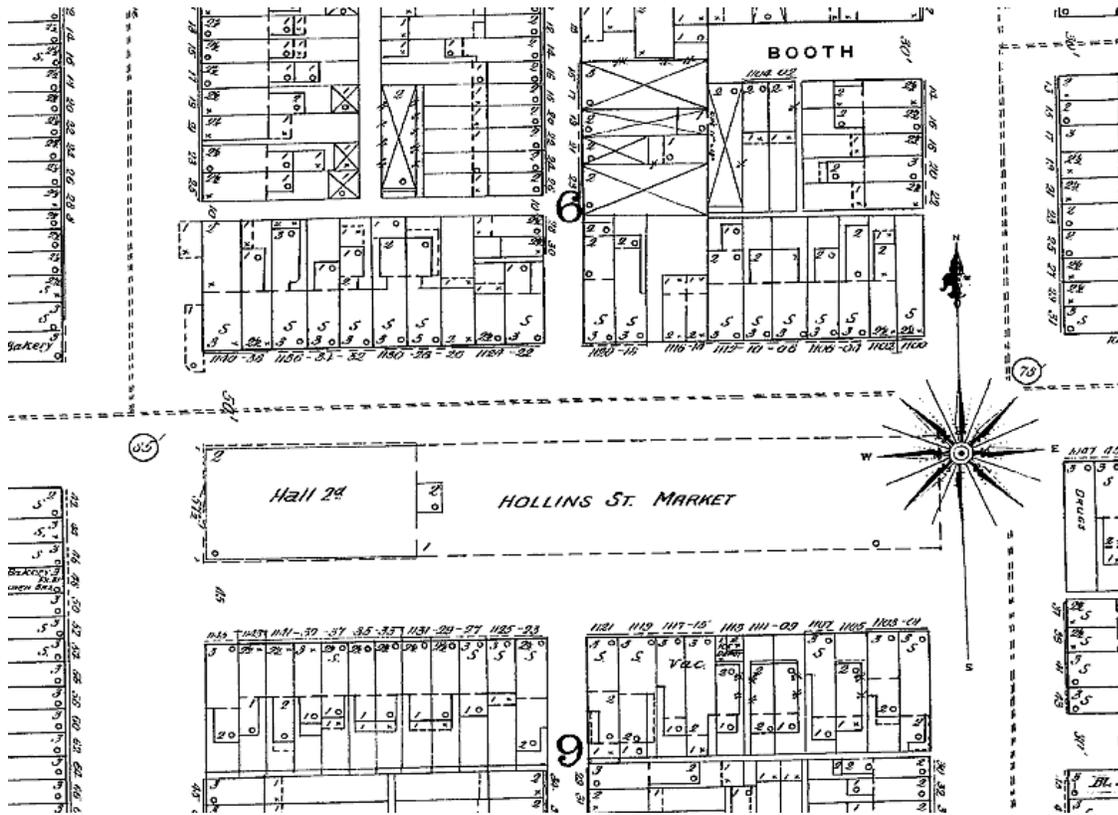
Image 4: Hollins Street Market, 1890 Sanborn Map

A public market has been in this location since 1835, built on land donated by banker George B. Dunbar. Some type of shed structure has stood here alongside the Italianate headhouse since its completion in 1864, and canvas-topped market stalls were erected on Hollins Street into the 20th century. The 1890 Sanborn map shows the outline of the single-story Hollins Market shed

and the two-story market hall (*Image 4*). Ten years later, the 1901-02 Sanborn map calls out the shed's details of concrete floor and skylights (*Image 5*). The market has gone through successive cycles of relative prosperity and decline through the years. A 1975 survey photograph of a portion of the shed building shows its deteriorated condition (*Image 6*). The post-World War II growth of supermarkets threatened Baltimore's public markets, but they received new attention with the establishment of local historic districts in the 1970s. In late 1977, Mayor Schaefer announced the first phase of a \$1.2 million renovation of Hollins Market, funded by a U.S. Economic Development Administration grant, which would replace the current wood shed building with one of concrete and wood siding and with air conditioning, new lighting, and new plumbing and restrooms. Work must have progressed very slowly, because 1979 images of the building still showed deteriorated conditions (*Images 7 & 8*). It's not clear exactly when the building achieved its present form.

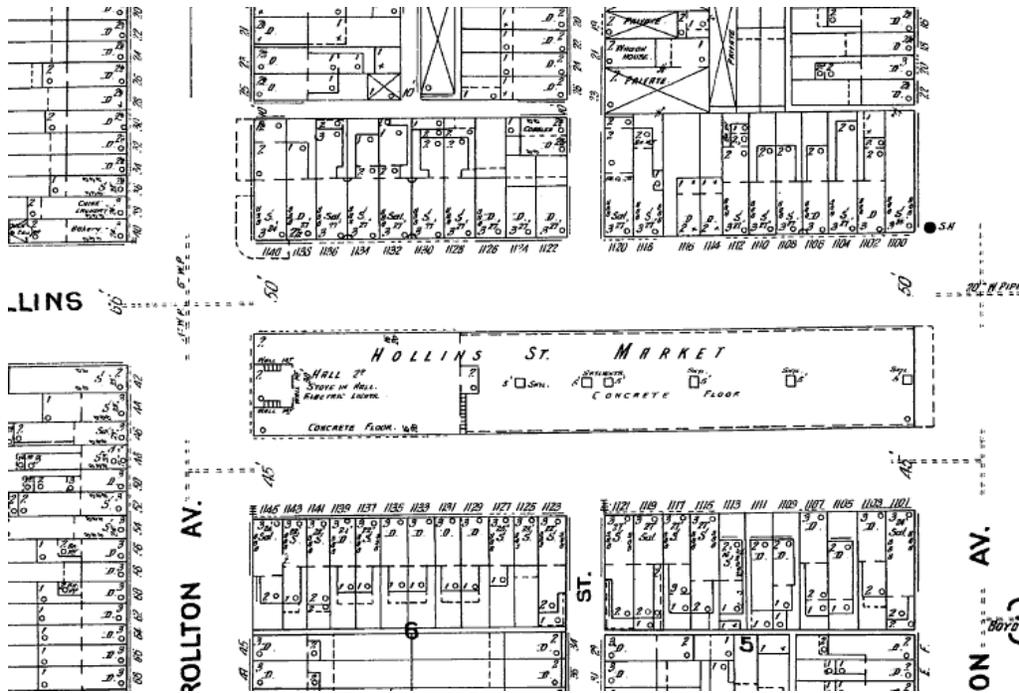
Image 5: Hollins Street Market, 1901-02 Sanborn Map

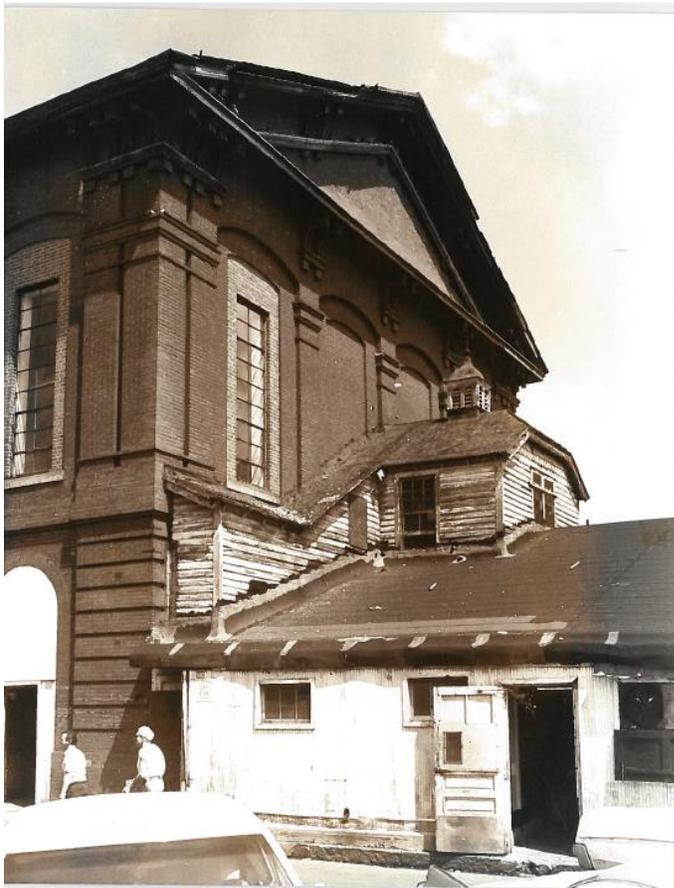
Image 6: Hollins Market headhouse and shed, south side - 1975

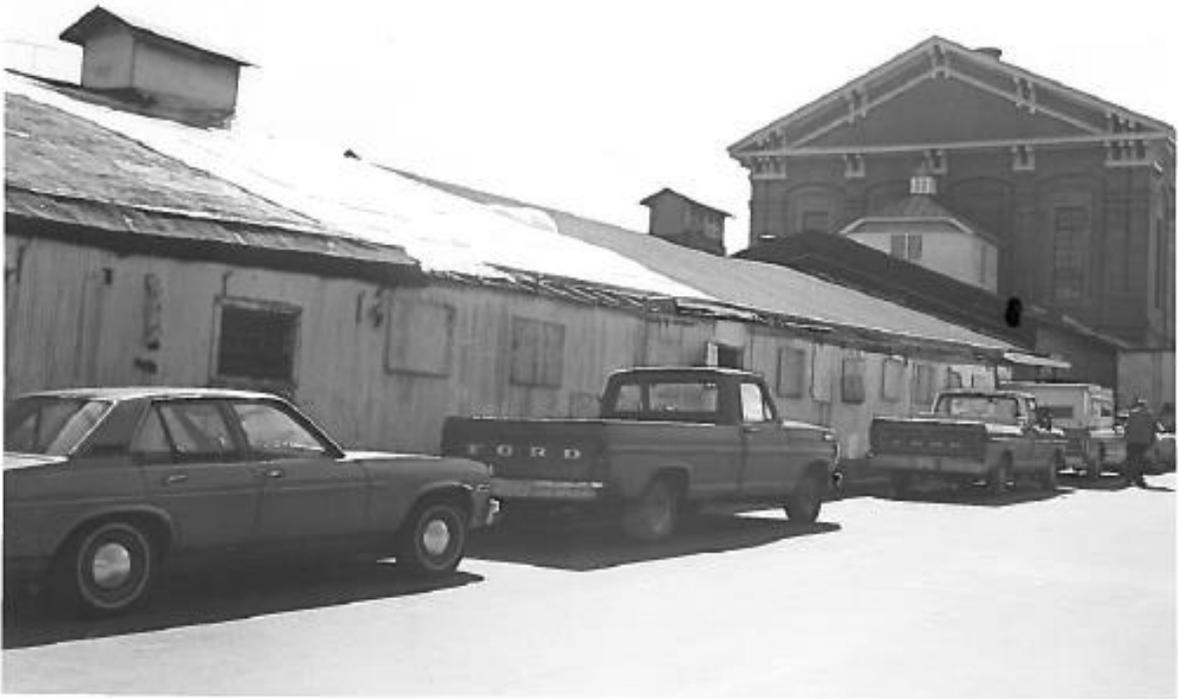
Image 7: Hollins Market shed and head house looking west, April 10, 1979

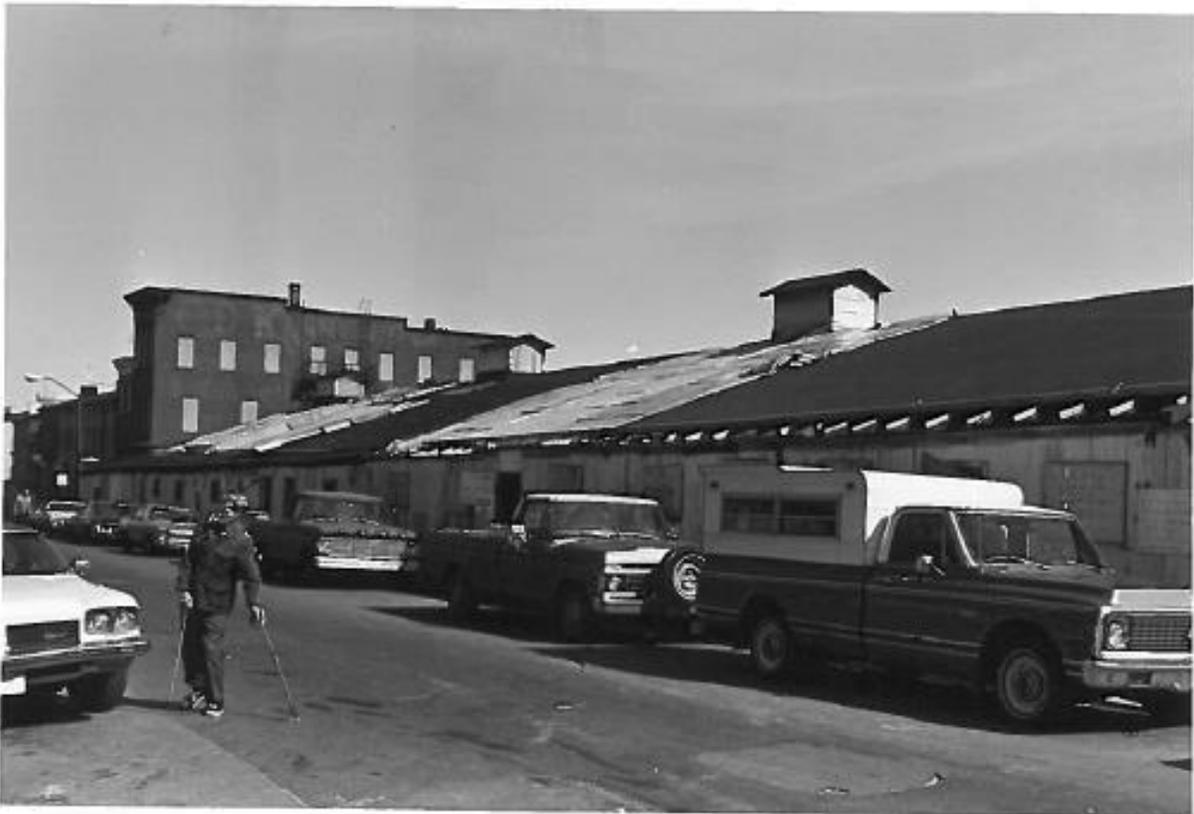
Image 8: Hollins Market shed looking east, April 10, 1979

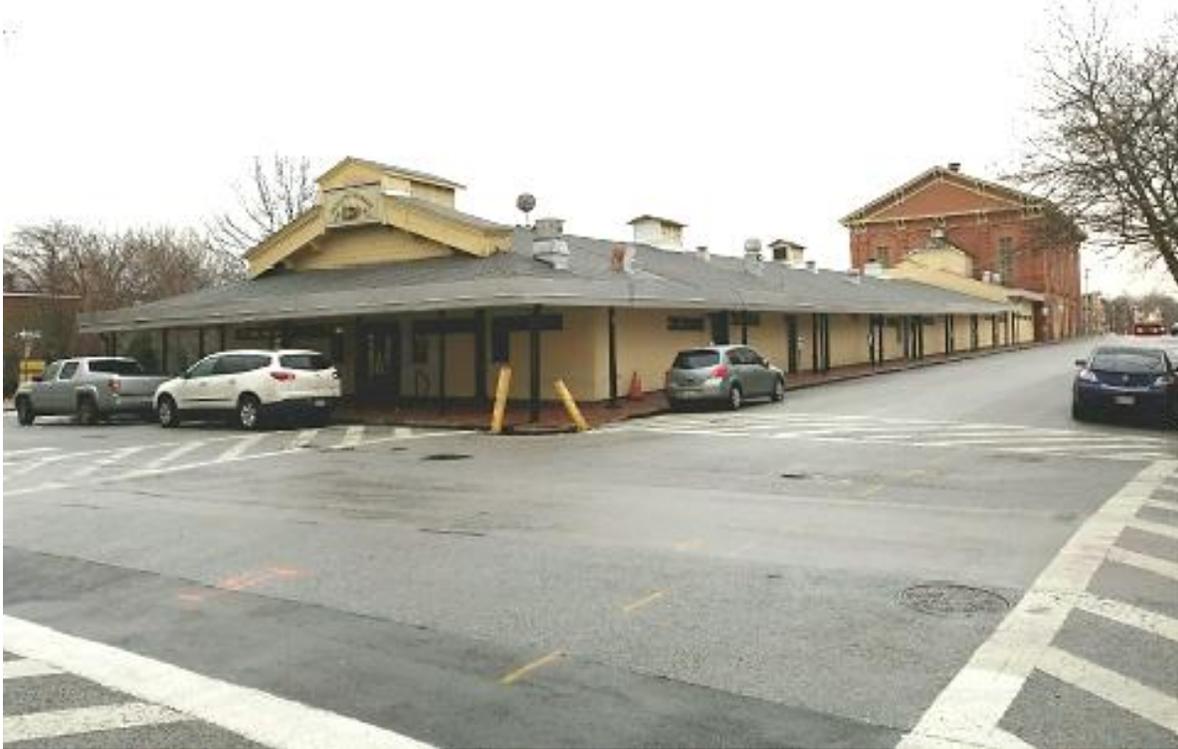
Image 9: 26 S. Arlington Avenue, Hollins Market shed looking west – Existing conditions

Applicant proposes to rehabilitate Hollins Market shed building, with the main exterior change being the construction of a new aluminum curtain wall entry on the north elevation which would entail changing a section of the roof plane (*Images 9 & 10*). Exterior work also includes: reconfiguring the windows and doors, adding windows to the rooftop monitors, replacing the shingle roofing, installing new signage, accommodating new rooftop air handlers on the south side, recladding the exterior, and widening a section of the sidewalk on the north side by 6'-0" (*Images 11 & 12*).

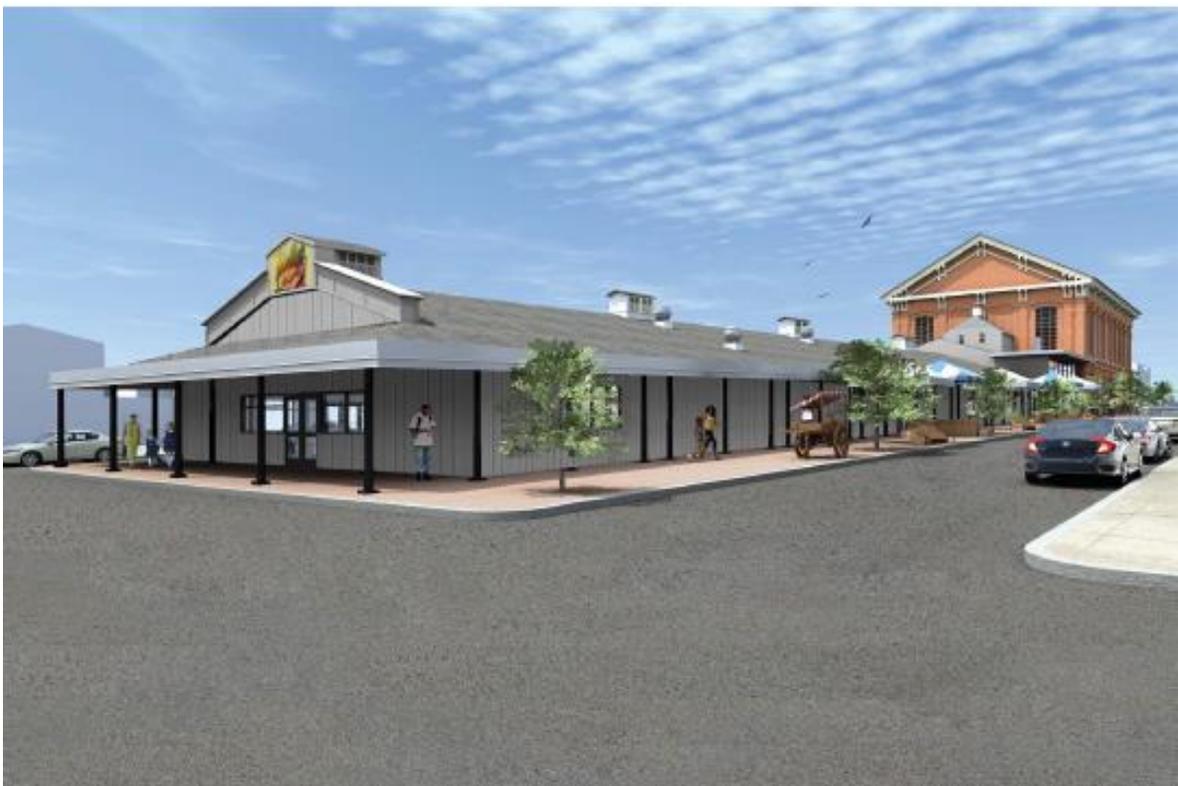
Image 10: 26 S. Arlington Avenue, Hollins Market shed looking west – Proposed

- *Guideline 2.4.1 Building Entrances:* The main exterior change to the building will be the new curtain wall entry on the north elevation next to the historic head house. This section will serve as a link between the market shed building and the historic building, while clearly defining the entrance and orienting the building to Hollins and the open space across the street. The lines are light and airy; the design is compatible with the market buildings. The proposal meets this guideline.

- *Guideline 2.4.5.Roofs:* The introduction of the new curtain wall to define a new entrance on the north side of the shed, will create a different roof plane from what is in this section now. The existing section of the roof is already higher by a few feet at this point. This alteration raises and flattens the roof in a contemporary style with metal and glass, which does not compete with the historic design of the Italianate masonry head house. The rooftop monitors are retained and become skylights with the introduction of glass in them, maintaining that aspect of the rooftop profile. Air handlers are tucked on the south side, minimally visible behind the roof slope. The design meets this guideline.

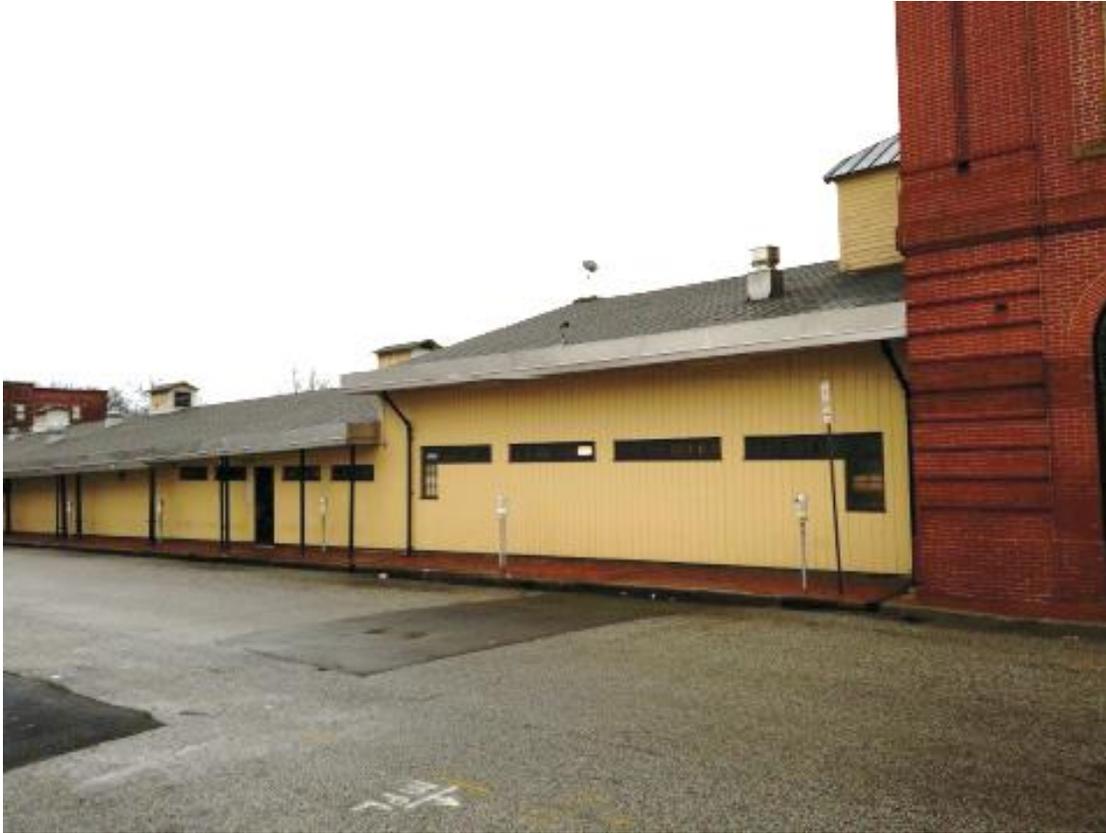
Image 11: Hollins Market – Existing north elevation

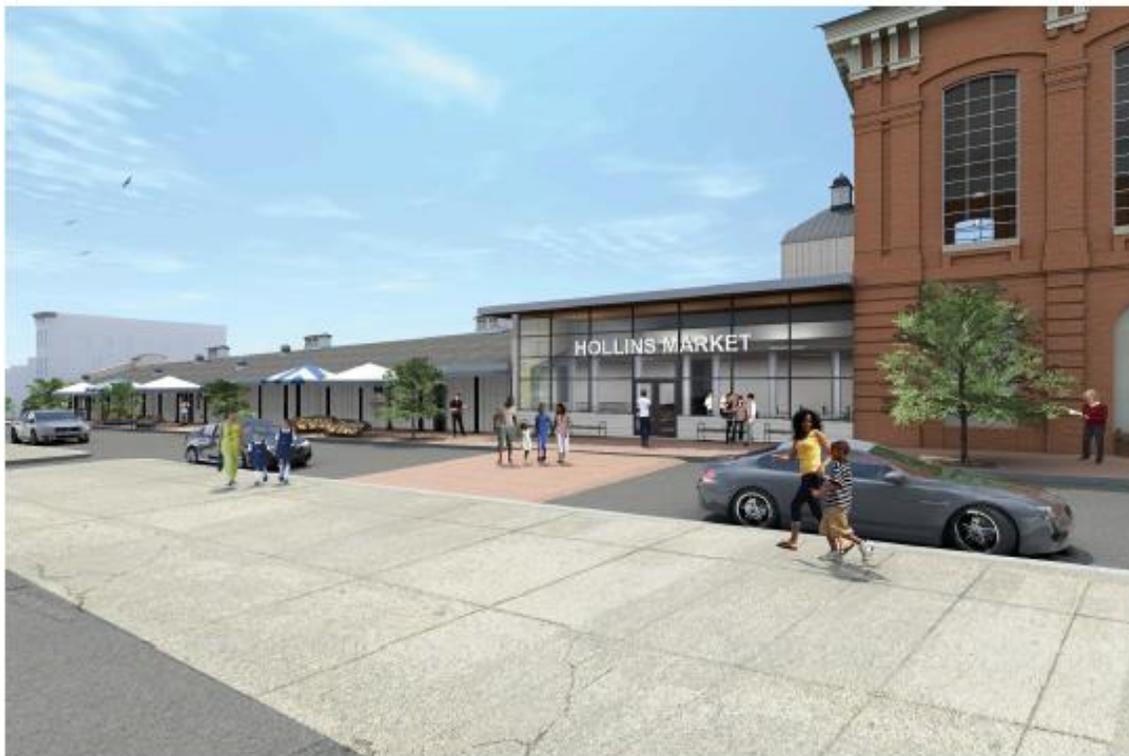
Image 12: Hollins Market – Proposed north elevation

- *Guideline 2.2 Site Design*: The proposed changes do not affect the footprint of the existing building. The new main entry and the other reconfigured entrances will more appropriately address the streets. The sidewalk on the north side of the building will be extended and addition 6'-0", enabling outdoor seating. While the sidewalk expansion sacrifices 10 parking spaces, it adds another amenity to the site. The proposal meets this guideline.
