**COMMISSION FOR  
HISTORICAL & ARCHITECTURAL  
PRESERVATION**

**STAFF REPORT**

**REQUEST:** Install new painted signage at the north and south elevations

**ADDRESS:** Eubie Blake Cultural Center at 847 N. Howard (Mount Vernon Historic District)

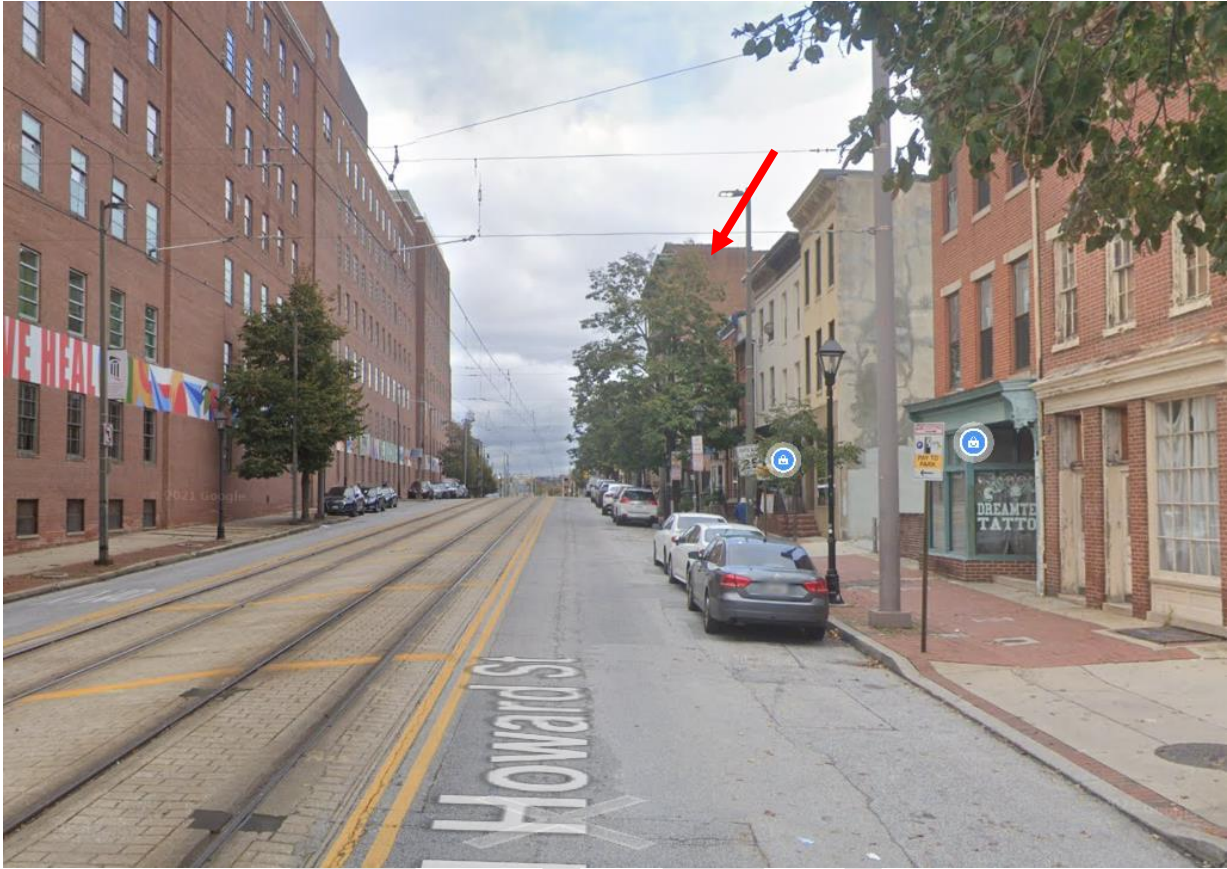
*Image 5: 847 N. Howard St. – Google Street view looking north of location of proposed signage on south elevation.*

The majority of the sidewall location proposed for the painted signs are already painted due to graffiti. These areas are composed of masonry and do not include any unique architectural features. The proposed signage locations have historically been ideal locations for historic painted signs and both new and historic signs can be found in similar locations throughout the city.

The proposed locations for the painted signage have largely been previously painted, are located on flat surfaces that would have historically received painted signs, and will not cause additional damage to the historic building.

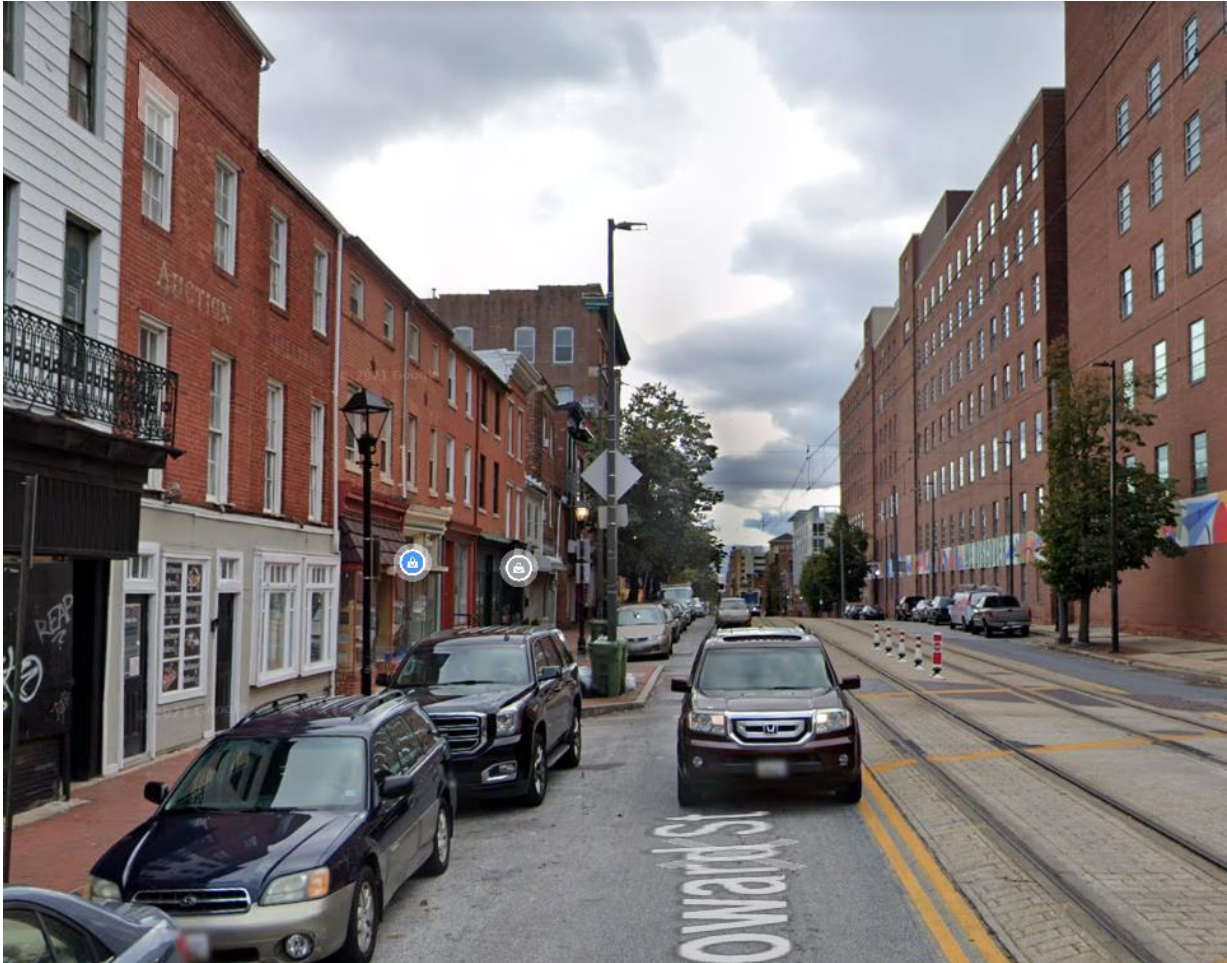
*Image 6:* 847 N. Howard St. – Google Street view looking south of location of proposed signage on north elevation.
