Landmark Designation Report

City Hall Rotunda – Public Interior

100 N. Holliday St
Baltimore, Maryland

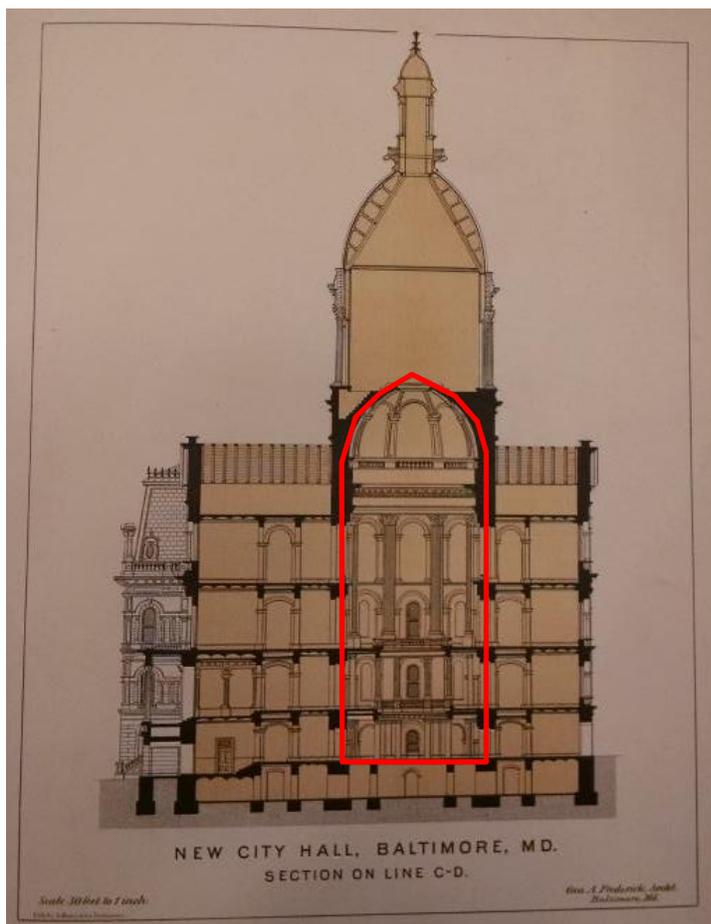
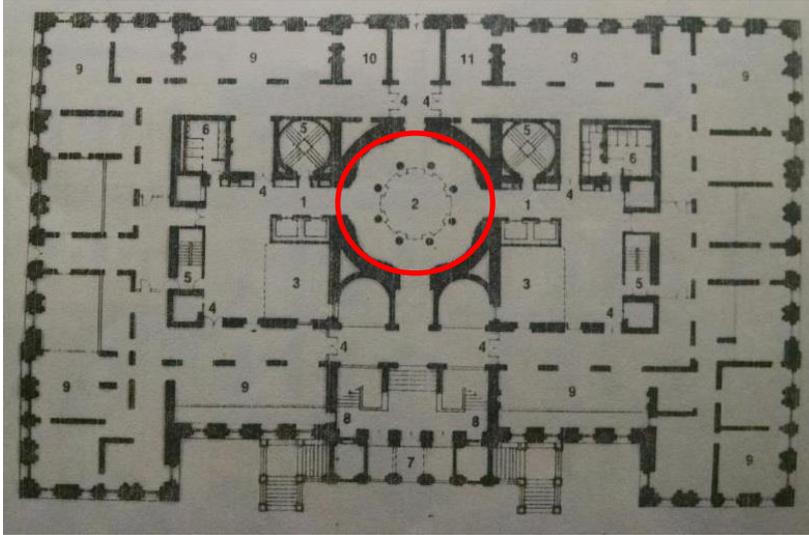
The designation of City Hall Rotunda includes the circular Rotunda space from the first floor to the crown of the interior dome.

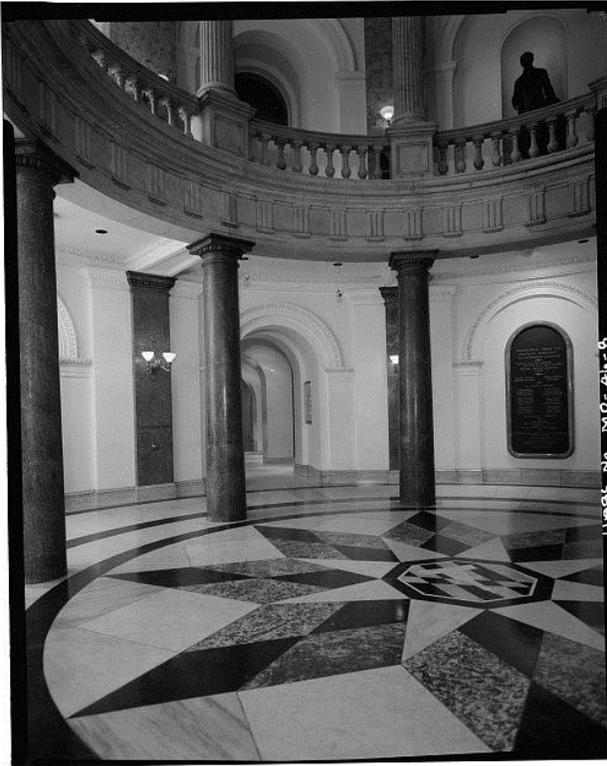
Historic American Building Survey, 8. rotunda, first and second floors - Baltimore City Hall, Holliday Street, Baltimore, Independent City, MD, HABS MD,4-BALT,123--8, Library of Congress Prints and Photographs Division Washington, D.C.

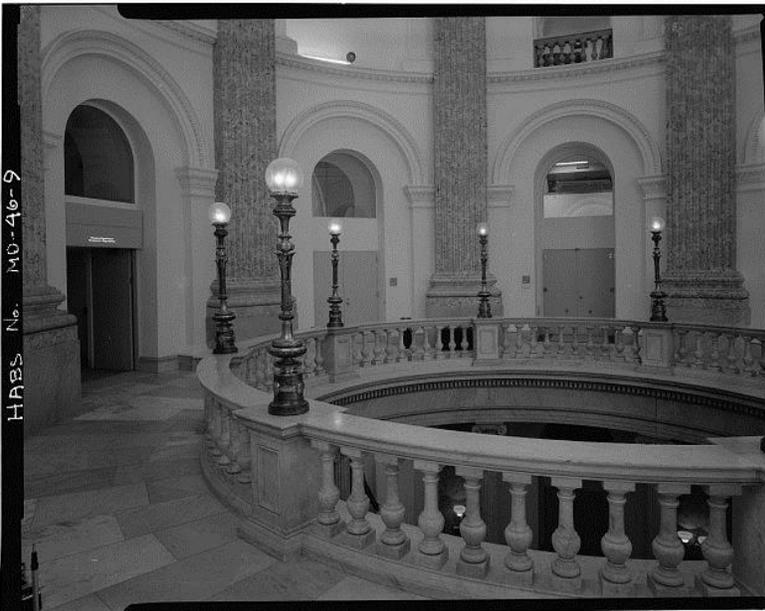
Historic American Building Survey, 9. rotunda, fourth floor- Baltimore City Hall, Holliday Street, Baltimore, Independent City, MD, HABS MD,4-BALT,123--9, Library of Congress Prints and Photographs Division Washington, D.C.

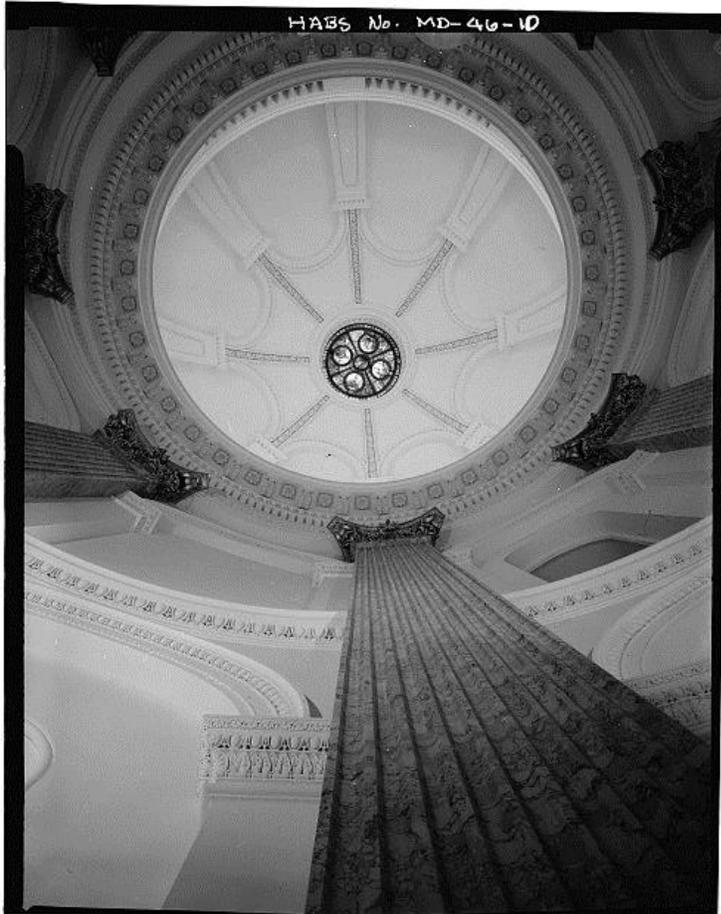
Historic American Building Survey, 10. ceiling and skylight above the rotunda - Baltimore City Hall, Holliday Street, Baltimore, Independent City, MD, HABS MD,4-BALT,123—10, Library of Congress Prints and Photographs Division Washington, D.C.

“The pilasters of the dome of ceiling of the rotunda (which, as also the whole body of the work, is built in brick) are paneled, crowned with appropriate caps, from which spring moulded semi-circular arches and smaller ribs; the latter mitreing with and forming a part of the decoration of the eye of the semi-sphere forming the ceiling referred to. The well, or eye, is 12 feet in diameter, and filled with a rich stained-glass light, divided by circular panels into a central and four surrounding compartments, the first bearing the seal of the city, the latter, emblematic female figures representing Commerce, Agriculture, Manufactures, and the Arts, the intervening space being filled in with classic trophies. On the dust board of the corona at the top of the entablature above referred to, and sufficiently back to be out of observation, is a circle of gaslights, over 200 in number, for the purpose of illuminating the rotunda when desired. They, as also the other lights already referred to, are lit by electricity by the simple turn of a crank. The galleries, of which mention has already been made, have a width of 11 feet 9 inches, entirely constructed of polished marble, and are supported on columns, the first story being Tennessee, of the Doric order; the second story of the Ionic order; and it, as also all the ballance of the work, of white Italian marble. The latter columns are elevated on pedestals, with polished marble balusters forming the rail. Each story has its appropriate entablature, that of the third story being finished with a balustrade, pedestals, and balusters similar to the one just described; the pedestals are surmounted with elaborate bronze posts 5 feet high, supporting coronas of lights. From the wall pilasters on each floor spring brackets to match.

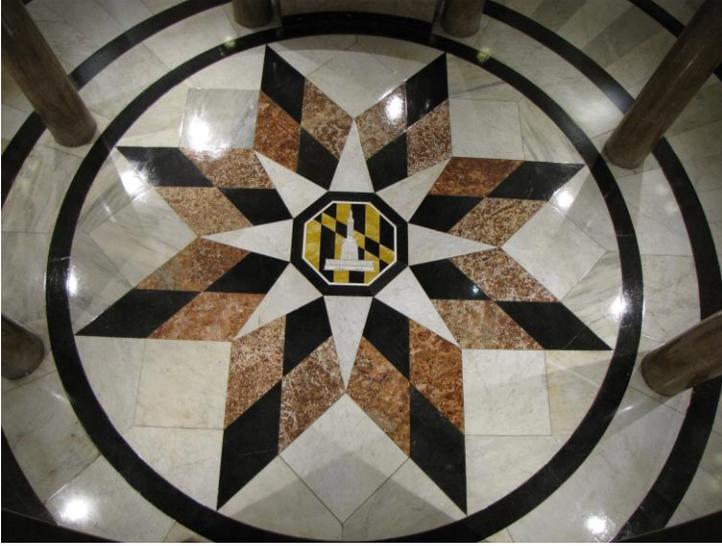
Marble mosaic floor

“The openings on the Mansard floor looking into the rotunda also have marble balustrades. The ceilings of the galleries are finished with ribs, and paneled; the floors are tiled in radiating courses, that of the first floor being of Mosaic pattern of variegated marbles, forming eight-pointed stars, which, starting from the centre and overlying each other, finish at the base of the

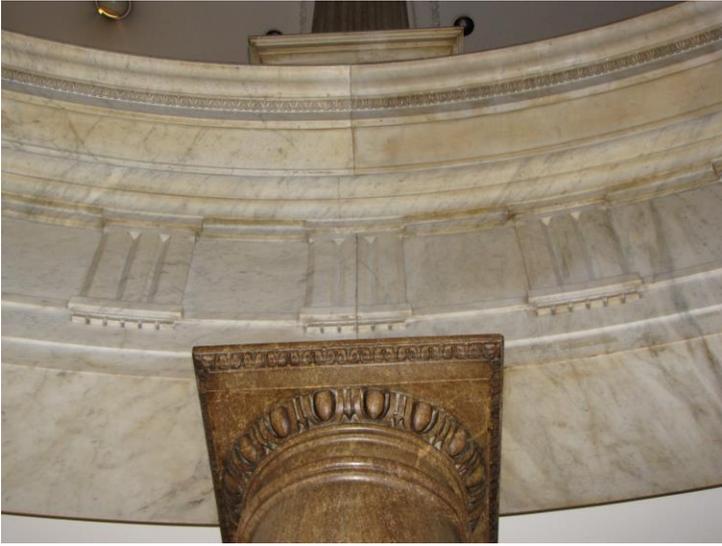
Marble by Hugh Sisson

Interior Marble Work – Hugh Sisson

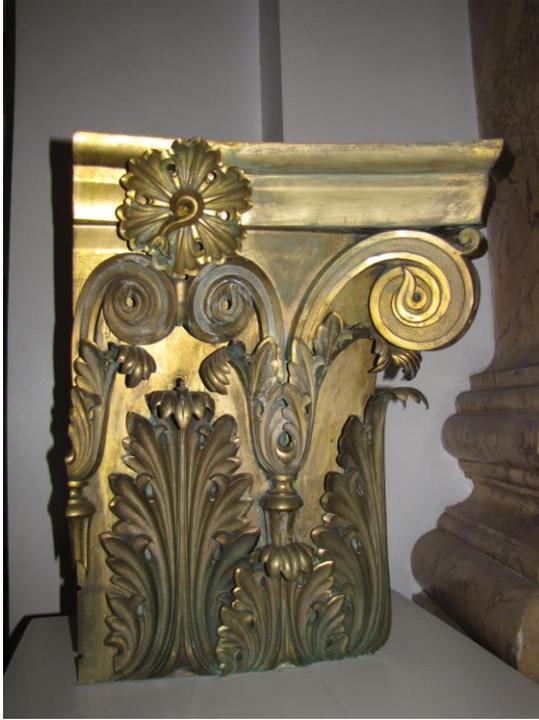
Brass capital.

Brass caps – Baker, Arnold & Co.

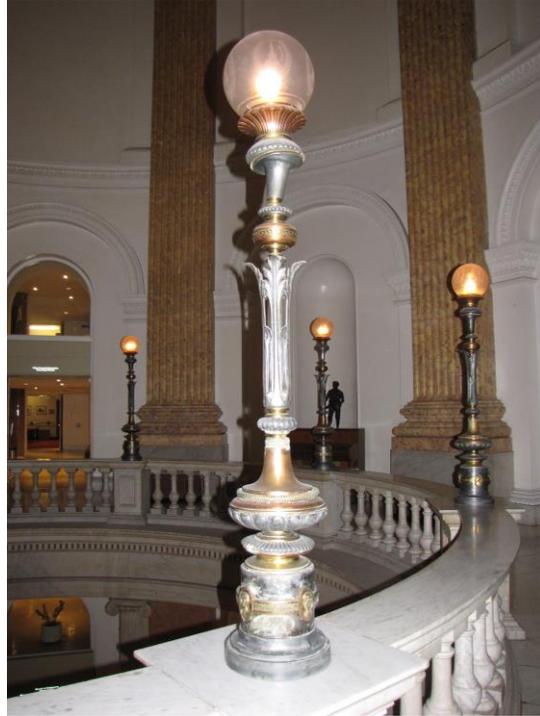
Ornate metal lamps, with globes decorated with an etched City Seal.
