**COMMISSION FOR
HISTORICAL & ARCHITECTURAL
PRESERVATION**

STAFF REPORT

REQUEST: Demolition Hearing 1- Determination of Architectural Significance

ADDRESS: 3406 Auchentoroly Terrace (Auchentoroly Terrace Historic District)

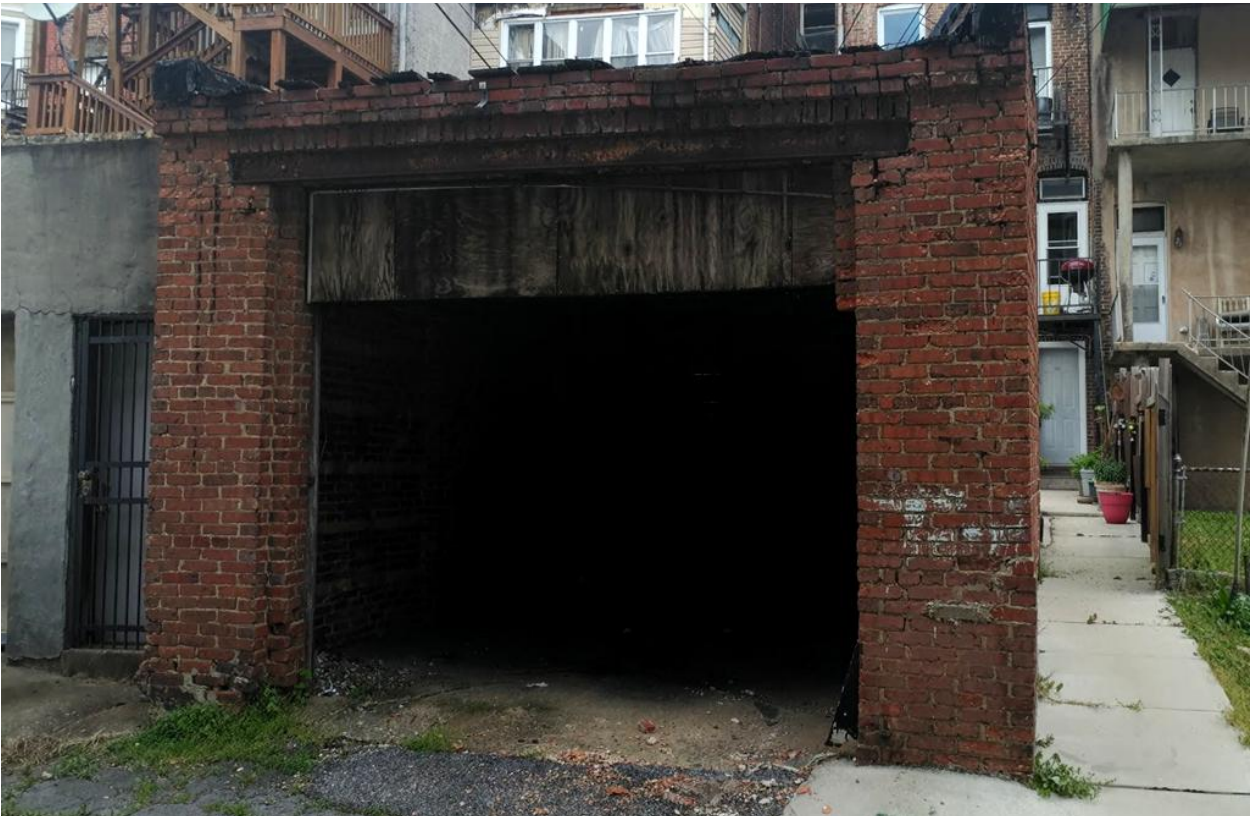
Exhibit 7. Current view- CHAP staff 2021

Building description: The detached garage is located in the rear alley, west of the main house. It stands one-story high with three brick walls and a wood frame flat roof. The north wall is attached to the adjoining neighbor's garage and the east and south (?) walls have arched lintels and deteriorated wood windows. The south elevation has a single doorway and several cracks and bulges. There are no garage doors extant on the building.

The staff believes that the building at 3406 Auchentoroly Terrace is contributing resource to the historic district. It is one of the earliest garages built along the alley behind the main houses on Auchentoroly Terrace. However, it has suffered some deterioration and developed wall bulges and several severe wall cracks. The style and method of building construction used in this garage can be found in few other examples in the neighborhood.

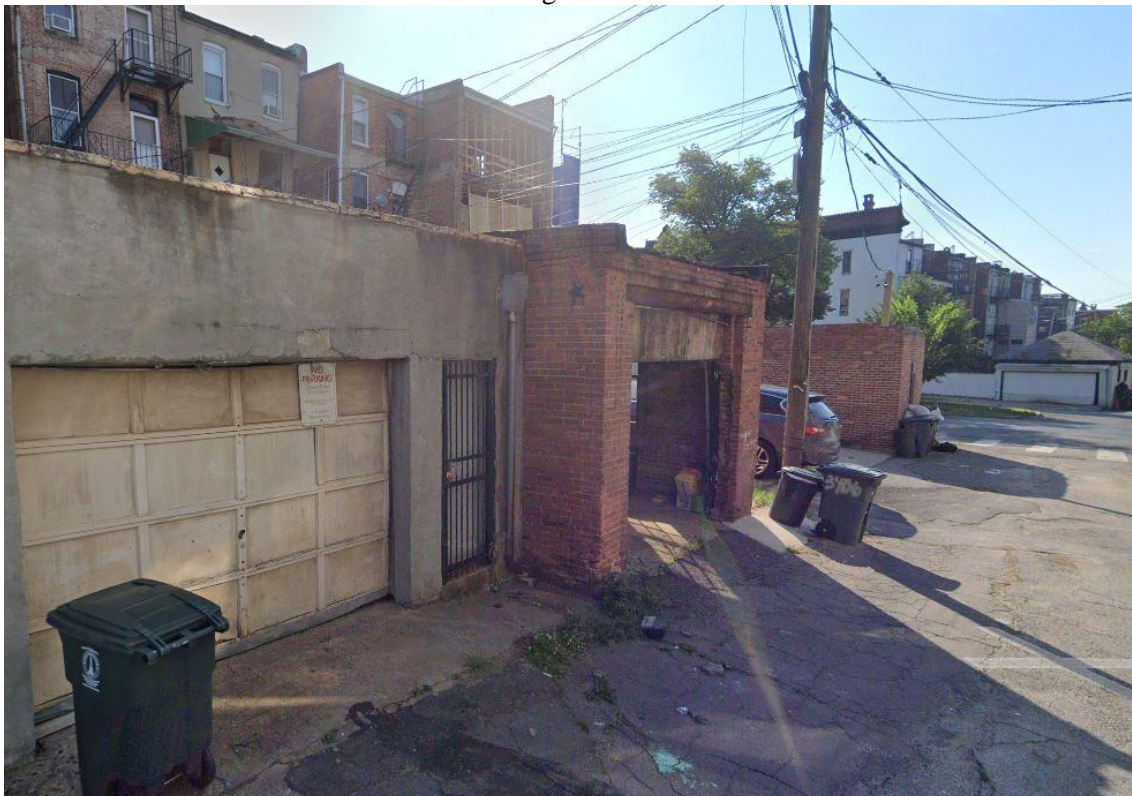
Exhibit 13. Sanborn Insurance Map of Baltimore- 1914-1915 vol. 7, 1915-Sheet 669

Historic maps do not clearly indicate when the garage was built historic mapping narrows the construction to sometime between 1910 and 1915. Historic mapping indicates that the garage is one of the earliest built in the neighborhood, but not necessarily the oldest. This garage was a departure from the carriage houses of the past as horse and buggies were being replaced by the automobile.
