# COMMISSION FOR HISTORICAL & ARCHITECTURAL PRESERVATION

#### STAFF REPORT

**REQUEST:** Retain vinyl windows installed at front façade without CHAP review/approval

**ADDRESS:** 105 Warren Avenue (Federal Hill Historic District)

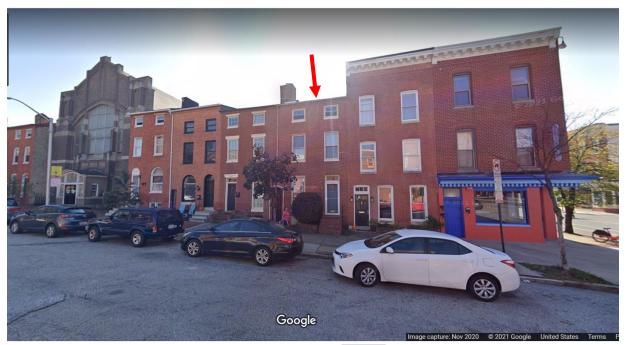
<u>Site Conditions</u>: The existing property is a masonry two-story-with-attic house, one of a row of four to the west of Jesus Our Redeemer Church (*Images 3 & 4*). The windows and the door opening with transom have jack arches. The house shares a sallyport on the east side with the neighboring house. Two or three rows of brick line the edge for the roof which has a half-round metal gutter with round downspout shared with 107 Warren Avenue. The windows are vinyl with grilles between glass.

Image 3: 105 Warren Avenue (arrow), Google Street View, November, 2020

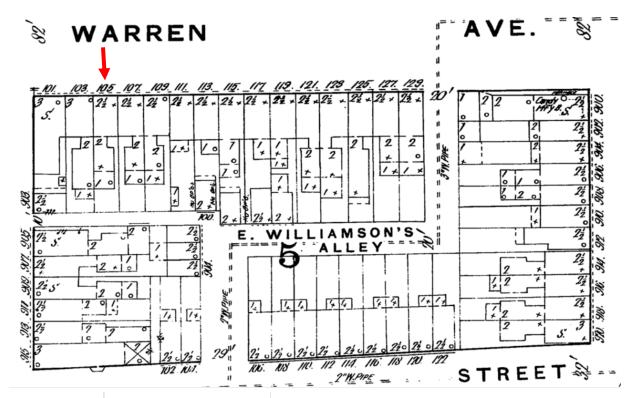
The house appears on the 1890 Sanborn map, in a row of thirteen 2 ½ story houses lining the south side of the block (*Image 5*). By 1914-1915, three of the houses in the middle of the block had been demolished for the construction of the Lee Street Memorial Church, a forerunner of today's congregation (*Image 6*).

Image 5: 105 Warren Avenue, 1890 Sanborn map

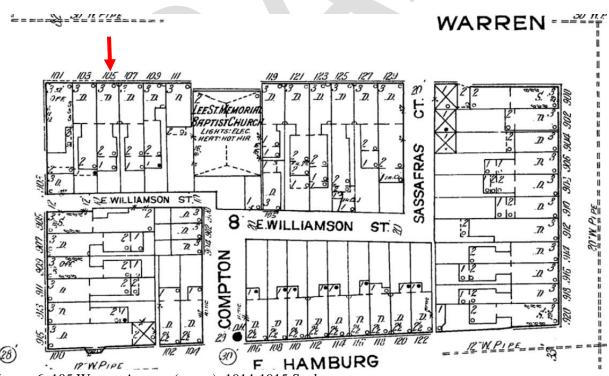
Image 6: 105 Warren Avenue (arrow), 1914-1915 Sanborn map
