Staff Report- March 12, 2013
713 Brinkwood Road
Baltimore City Historic District- Hunting Ridge

Plan: Replace tree damaged wood windows on front sunporch with metal clad windows

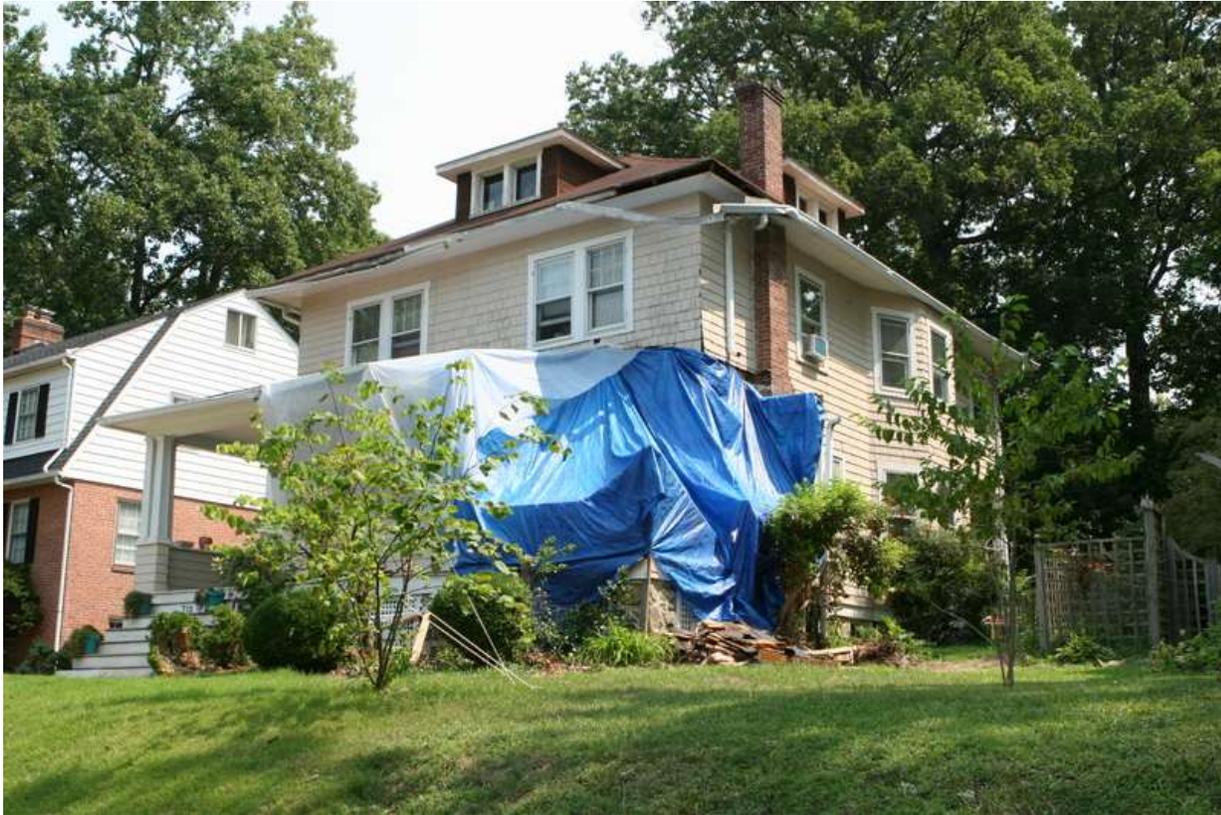
Existing Brinkwood Road Elevation Showing Damage to Sunporch

In the late summer of 2012, the sunporch on the front of the home at 713 Brinkwood Road was destroyed when a tree fell on the porch during a storm. The applicant came to CHAP to rebuild the porch and was granted a Notice to Proceed to rebuild to match the original porch. The applicant since requested that the application be amended to allow for metal clad windows in place of the original wood casement windows on the front porch.

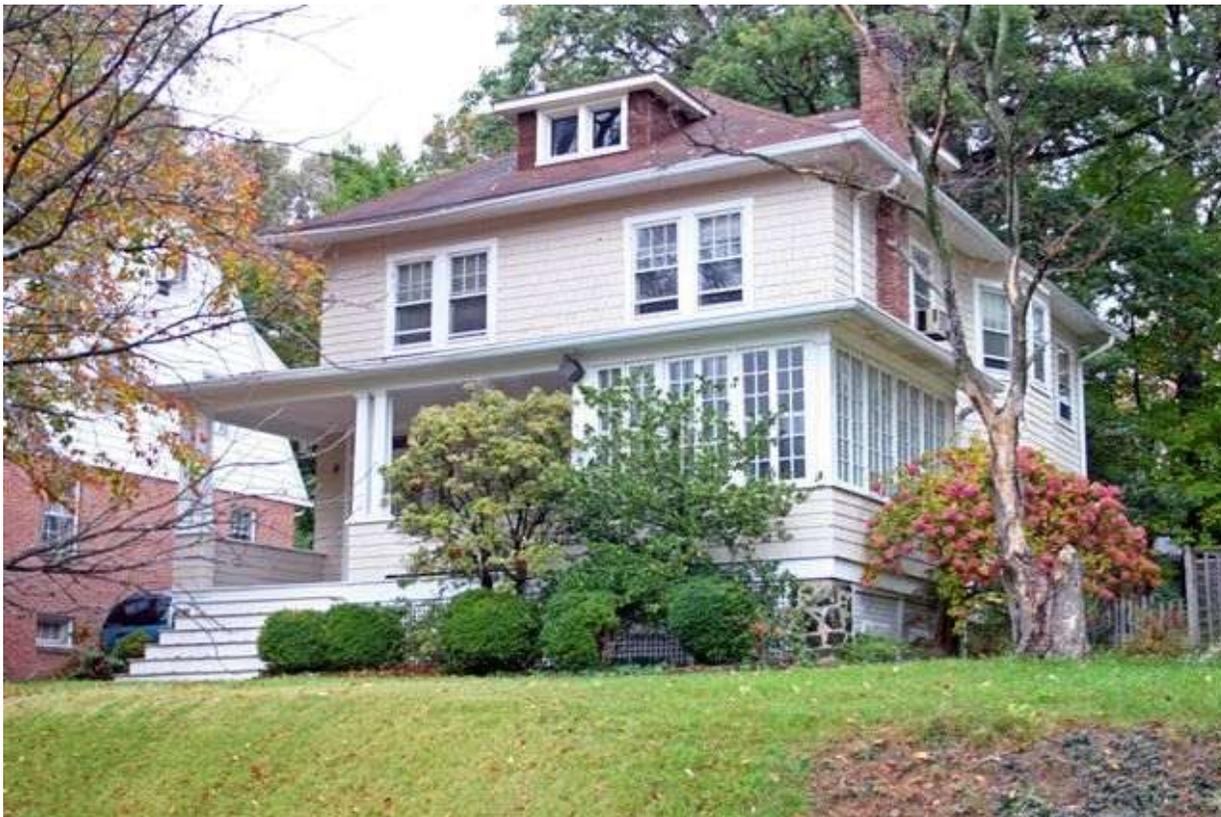
Brinkwood Road Elevation Prior to Storm Damage

The historic windows on the sunporch were wood and wood casement windows to match are available. The sunporch is located on the front of the house and therefore has a high level of visibility. In this case, CHAP’s window Guidelines have been applied strictly. Per the Guidelines, the windows should be replaced to match the historic wood windows.
