Staff Report – June 11, 2013
Washington Monument
Mount Vernon Historic District

Plan: Restore Monument – Concept Review

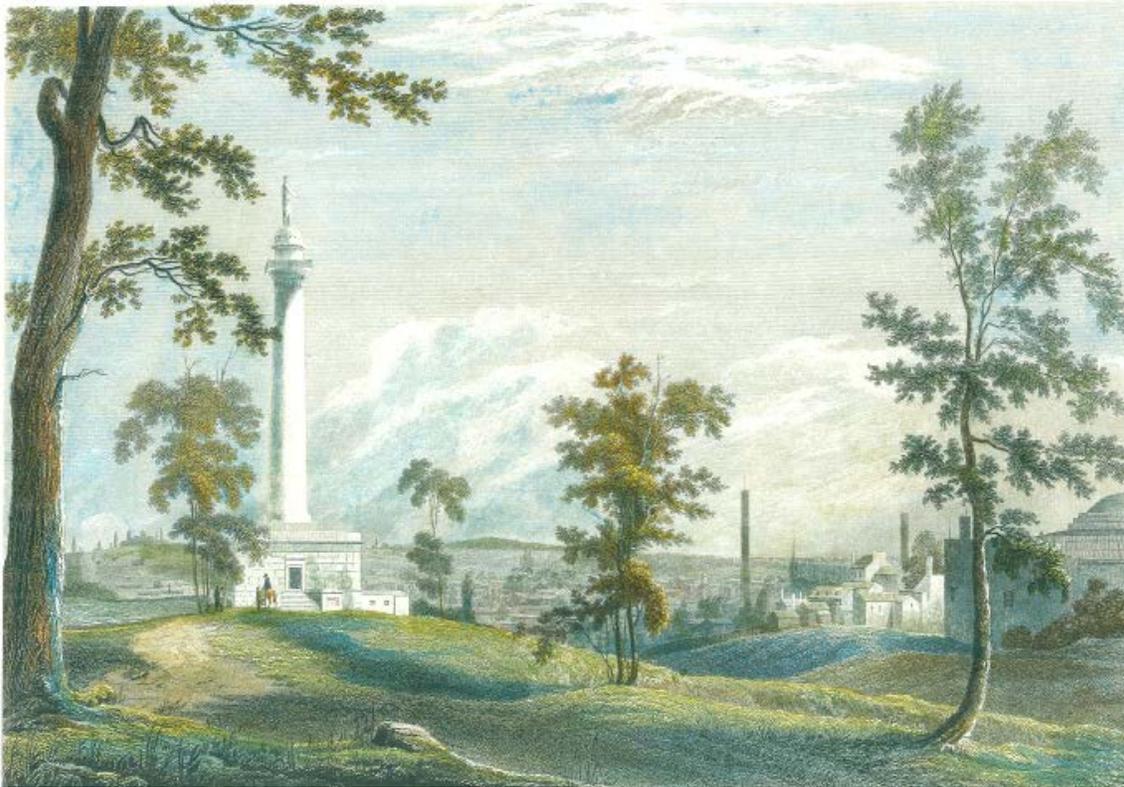
This is a hand colored print that appeared in the New York Mirror in 1835. Image is Cator Print 027 from the Enoch Pratt Free Library
