**COMMISSION FOR  
HISTORICAL & ARCHITECTURAL  
PRESERVATION**

**STAFF REPORT**

**March 14, 2023**

**REQUEST:** Demolish Structure – Demolition Hearing One – Determination of Historic Significance (Jonestown Historic District)

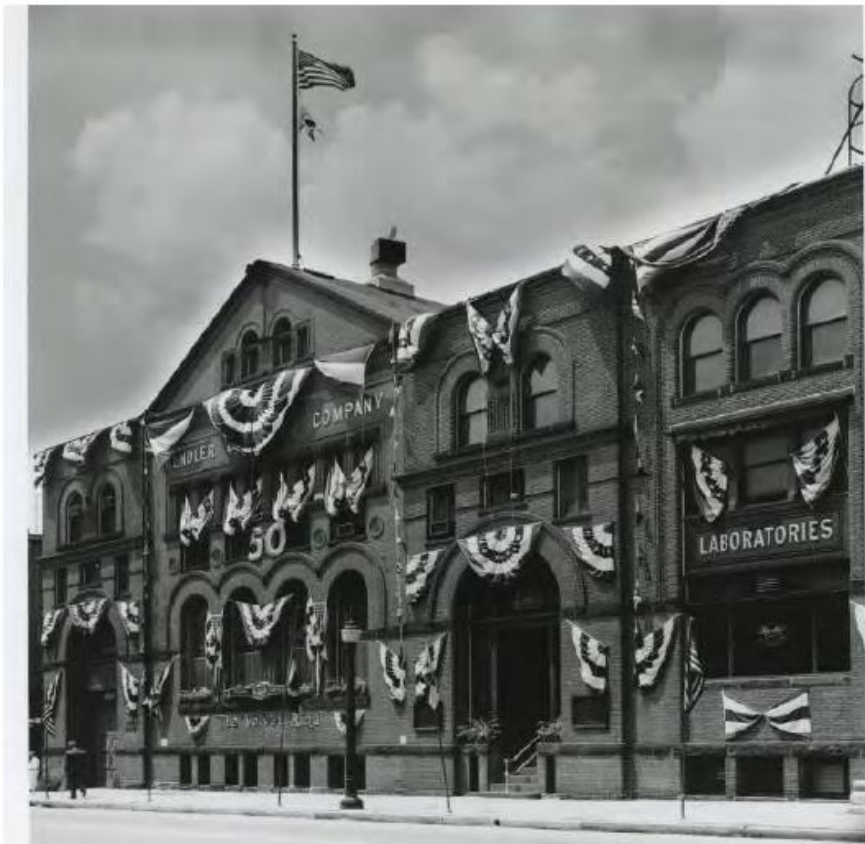
*Image 10: Hendler Building 1915-1920*

completely automated ice cream plant. Between 1914 and 1915, Hendler added a third floor, and a bay to the eastern side of the structure (*Image 6*). The Hendler Company continued making ice cream until 1971 when Borden Company acquired the business. Ice cream was made at the site until the mid-1980s. The building has been underused and vacant ever since (*Image 7*).

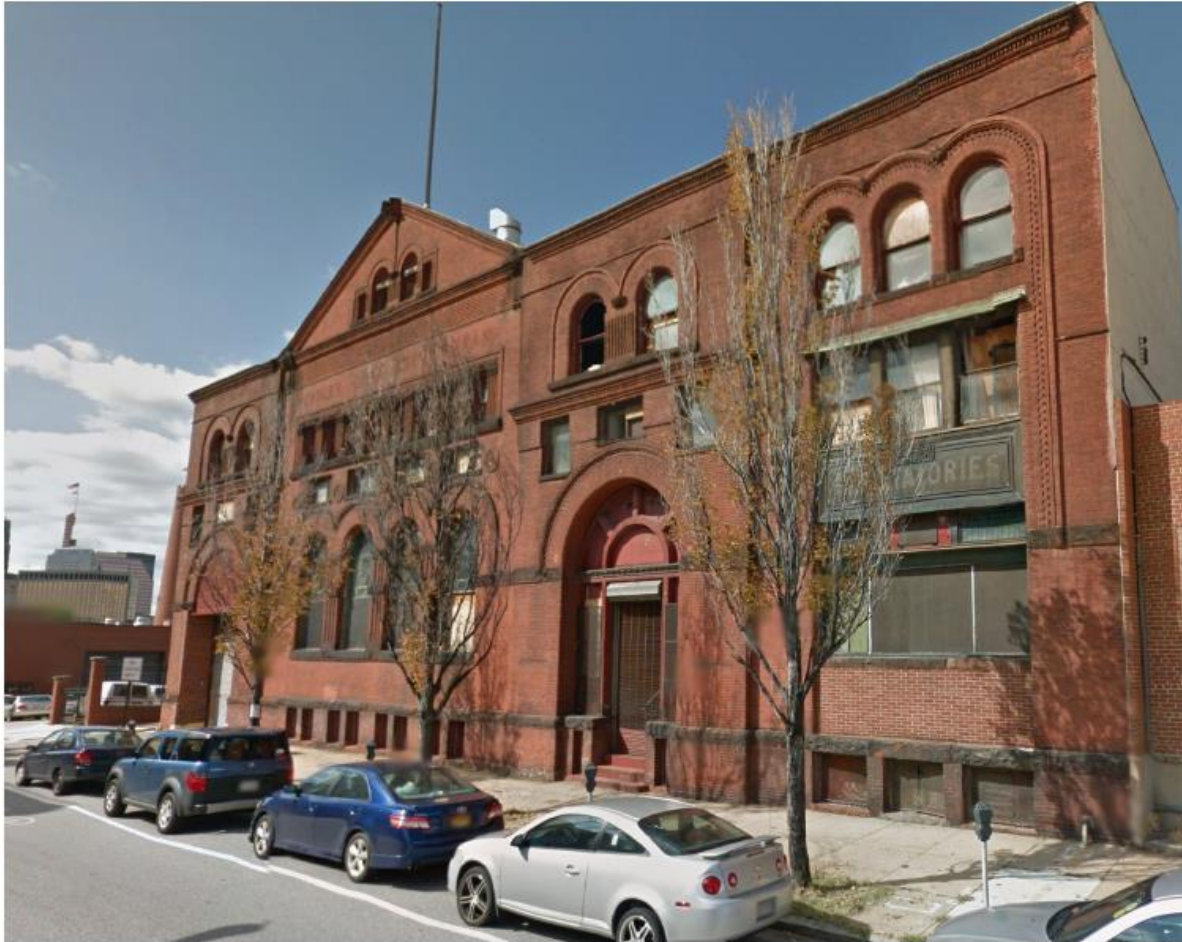
*Image 11: Main (South) Facade, Hendler Building, 2017*

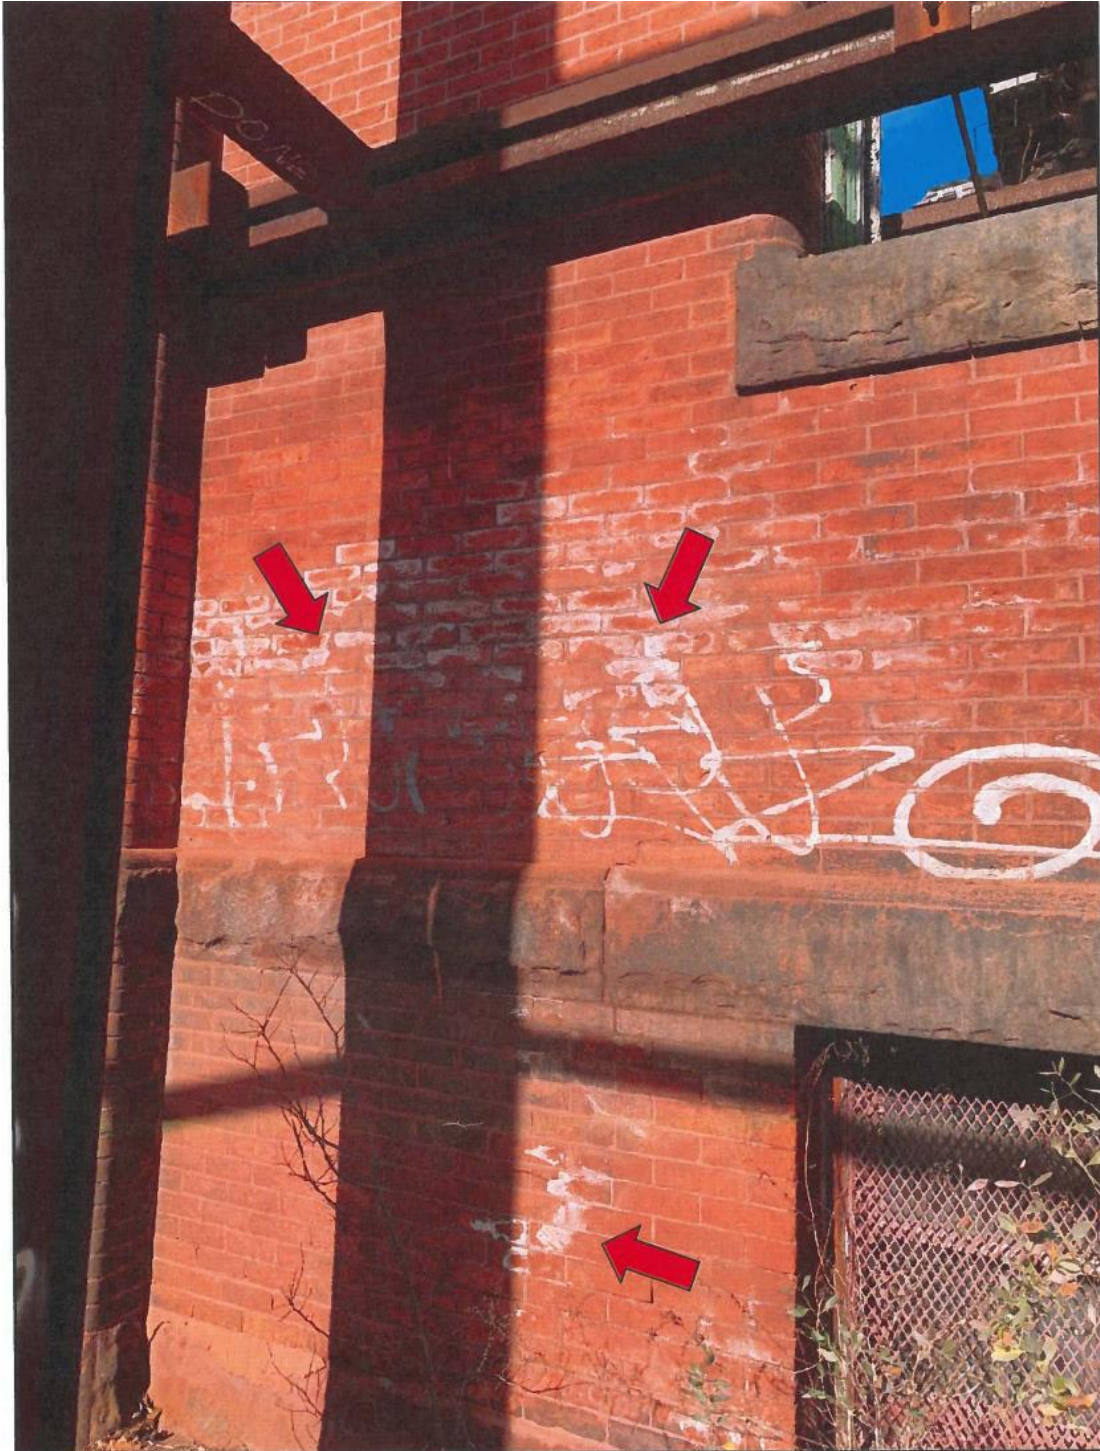
*Image 12: Existing Conditions, Hendler Building, 2023*

The deteriorated condition of the building is not surprising. The building has sat vacant and/or underused since the mid-1980s. In August of 2018, the eastern wall, roof and interior were removed and the remaining walls were shored up. For four and a half years, these walls have sat like this.

- Much of the mortar is in moderate and poor condition, allowing for water infiltration,
- The interior surface of the walls was constructed with soft brick that is deteriorating rapidly. These bricks were not meant to be exposed to weather.
- Cut-off iron beams stick out of the interior walls and have swelled with pack rust.
- Steel lintels, too, have swelled with pack rust and are actively stressing the building.
- Portions of a concrete upper floor is still embedded into the wall and are allowing water infiltration.
- There is no evidence that the outer brick is tied into the inner portion of the walls.

- There are cracks and delamination of the inner surface of the walls.
- On the outer wall, especially the west elevation, efflorescence indicates water infiltration. Significant amount of brick has lost its protective (vitrified) skin and need to be replaced because of significant deterioration. Much of this condition may have been caused by sandblasting of the building decades ago.
- The tops of the walls have no “cap” and allow for water infiltration (for more information, please review the engineer’s report).

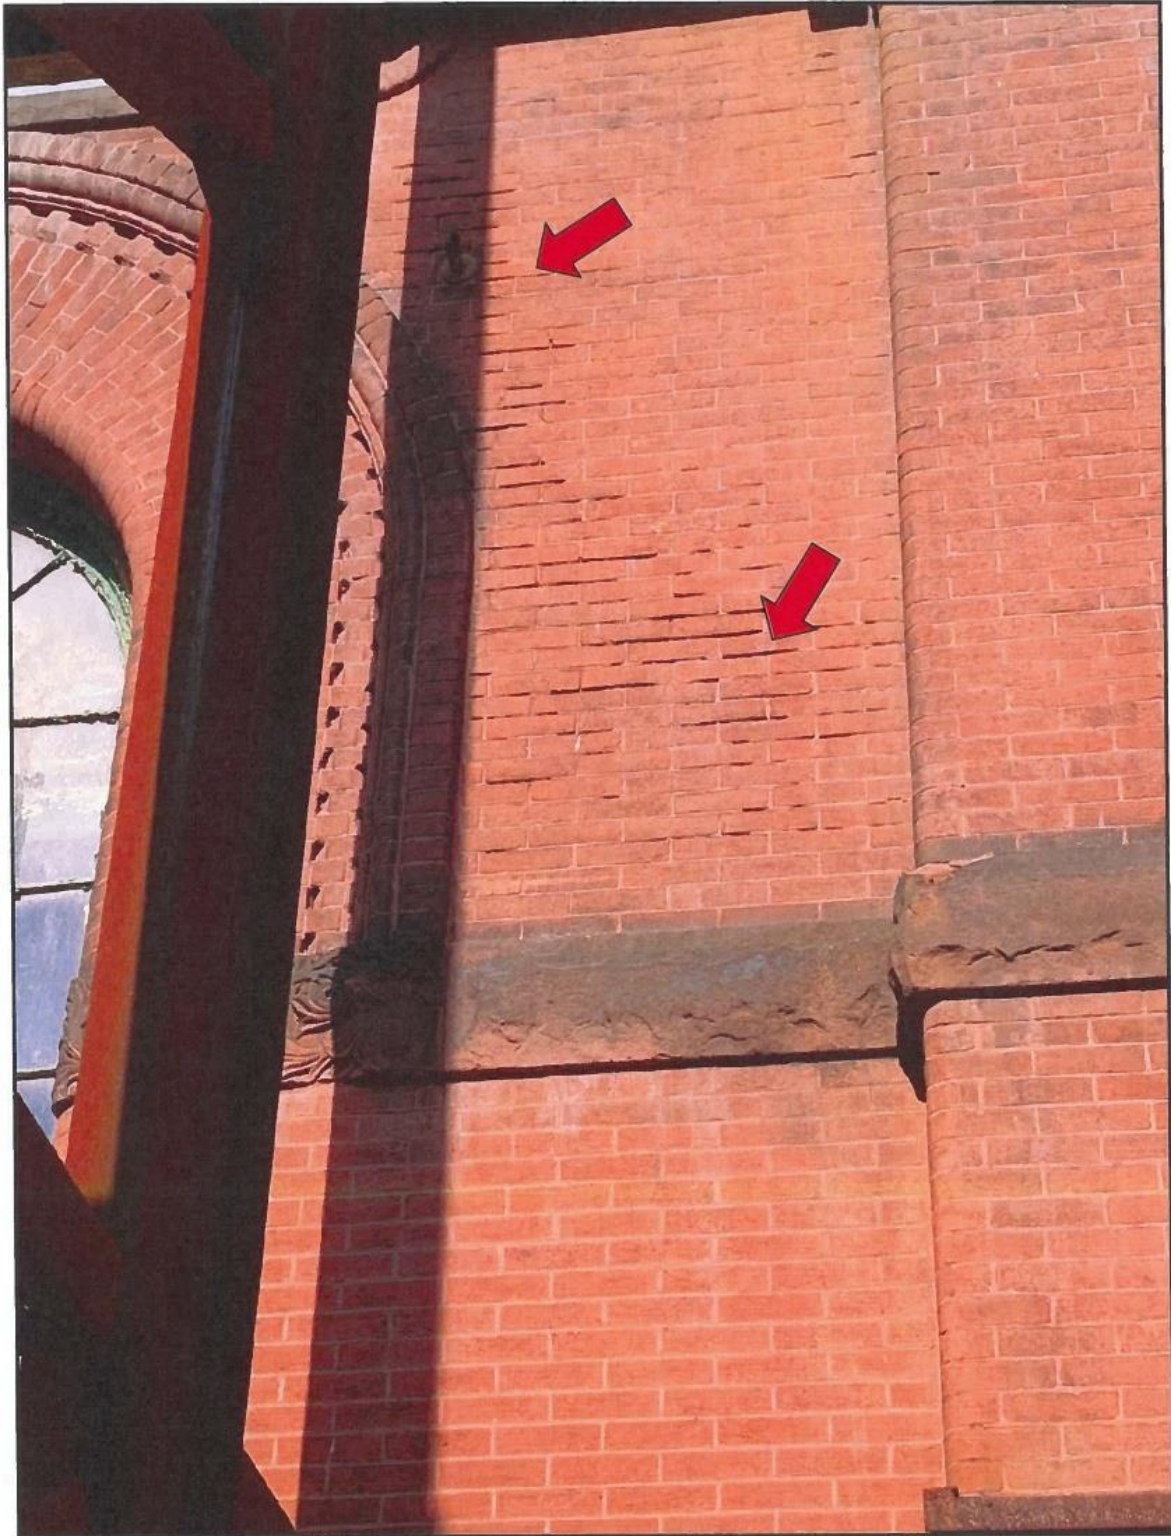
*Image 13: Existing Conditions, Hendler Building, 2023*
